Manhole Inspection Report

Date:	04/06/2018	Weather:		Coding:	RZMACP
MH#:	M-707-062	Owner:	NA	Len. Surveyed:	11.2
P.O.#:		Surveyor:	John Kuglmaier	Rim to Invert:	11.6
Customer:		Cert. #:	U-1215-07002349	Wall Material:	Concrete (reinforced)

Street:	Lake Park Ave. 121' South of 12th St.	Project:	Hobart, IN
City:	Hobart, IN	GPS Northing:	0.0
Location:		GPS Easting:	0.0
Drain Area:	Southwest	GPS Accuracy:	Nearest Meter
Cover Shape:	Circular	Evidence of Surcharge:	No
Cover Size:	22.5	Potential for Runoff:	None
Comments:

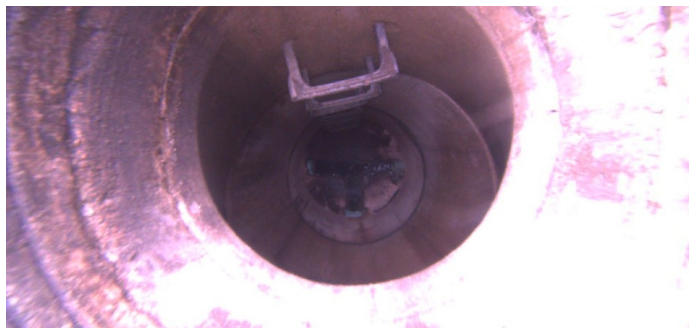
Code: **MGP**
Description: **General Photo**

Distance (ft): **.0**
Structural Grade: **0**
O&M Grade: **0**
Clock Start/From:
Clock To:
1st Value:
2nd Value:
Value Percent:
Step: **NO**
Remarks:

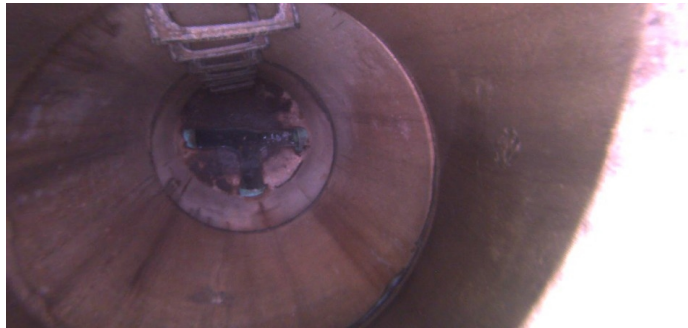
Code: **IS**
Description: **Infil Stain**

Distance (ft): **1.3**
Structural Grade: **0**
O&M Grade: **0**
Clock Start/From: **4**
Clock To:
1st Value:
2nd Value:
Value Percent:
Step: **NO**
Remarks:

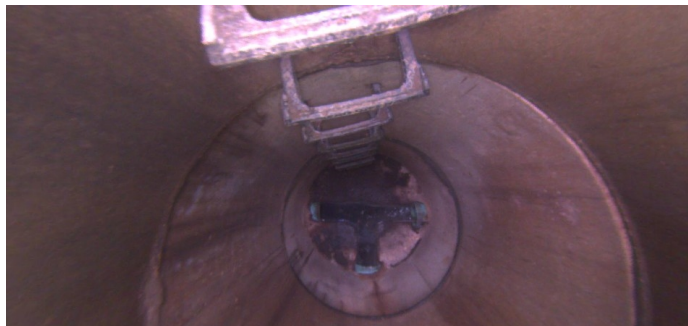
Code: **IS**
Description: **Infil Stain**

Distance (ft): **1.8**
Structural Grade: **0**
O&M Grade: **0**
Clock Start/From: **9**
Clock To: **10**
1st Value:
2nd Value:
Value Percent:
Step: **NO**
Remarks:

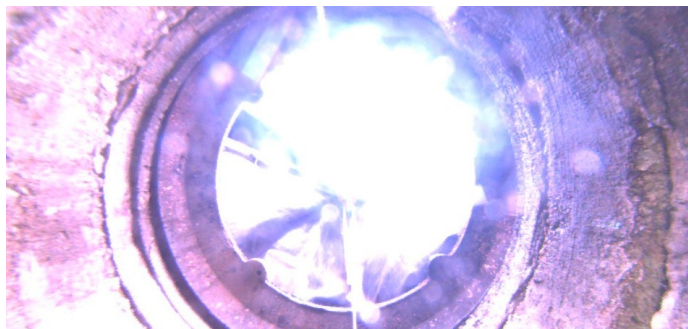
Code: **MGP**
Description: **General Photo**

Distance (ft): **2.5**
Structural Grade: **0**
O&M Grade: **0**
Clock Start/From:
Clock To:
1st Value:
2nd Value:
Value Percent:
Step: **NO**
Remarks:

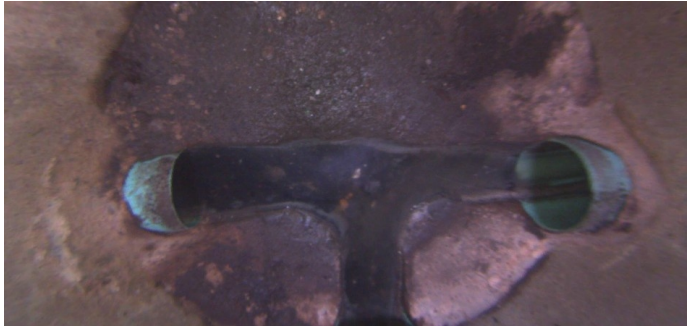
Code:	MGO
Description:	General Observation
Distance (ft):	9.3
Structural Grade:	0
O&M Grade:	0
Clock Start/From:	
Clock To:	
1st Value:	
2nd Value:	
Value Percent:	
Step:	NO
Remarks:	Ins. Comp.
