Manhole Inspection Report

Date:	04/23/2018	Weather:		Coding:	RZMACP
MH#:	M-707-063	Owner:	NA	Len. Surveyed:	6.1
P.O.#:		Surveyor:	Jen Costello	Rim to Invert:	5.5
Customer:	8.7	Cert. #:	U-907-5518	Wall Material:	Concrete (reinforced)

Street:	Intersection of 11th St. and 11th Pl.	Project:	Hobart, IN
City:	Hobart, IN	GPS Northing:	0.0
Location:		GPS Easting:	0.0
Drain Area:	Southeast	GPS Accuracy:	Nearest Meter
Cover Shape:	Circular	Evidence of Surcharge:	No
Cover Size:	22.5	Potential for Runoff:	None
Comments:

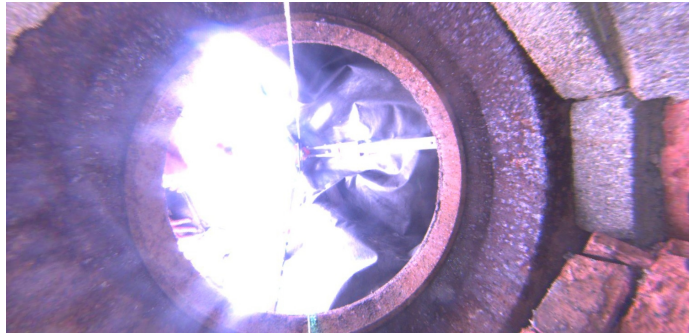
Code: **MGP**
Description: **General Photo**

Distance (ft): **1.9**
Structural Grade: **0**
O&M Grade: **0**
Clock Start/From:
Clock To:
1st Value:
2nd Value:
Value Percent:
Step: **NO**
Remarks: **underside of frame**

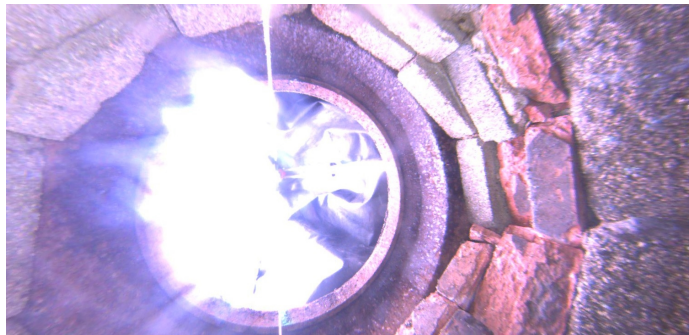
Code: **SSS**
Description: **Surface Spalling**

Distance (ft): **2.3**
Structural Grade: **2**
O&M Grade: **0**
Clock Start/From: **8**
Clock To: **10**
1st Value:
2nd Value:
Value Percent:
Step: **NO**
Remarks:
