Manhole Inspection Report

Date:	04/23/2018	Weather:		Coding:	RZMACP
MH#:	M-707-068	Owner:	NA	Len. Surveyed:	4.9
P.O.#:		Surveyor:	Jen Costello	Rim to Invert:	4.6
Customer:	8.7	Cert. #:	U-907-5518	Wall Material:	Brick

Street:	Intersection of Lake St. and 10th St.	Project:	Hobart, IN
City:	Hobart, IN	GPS Northing:	0.0
Location:		GPS Easting:	0.0
Drain Area:	Southeast	GPS Accuracy:	Nearest Meter
Cover Shape:	Circular	Evidence of Surcharge:	No
Cover Size:	22.5	Potential for Runoff:	None
Comments:

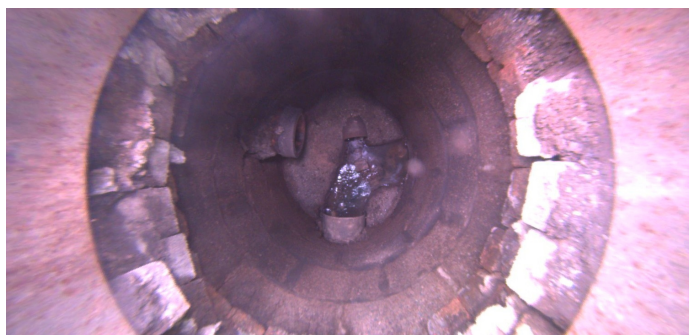
Code: **MGO**
Description: **General Observation**

Distance (ft): **.0**
Structural Grade: **0**
O&M Grade: **0**
Clock Start/From:
Clock To:
1st Value:
2nd Value:
Value Percent:
Step: **NO**
Remarks: **access mh**

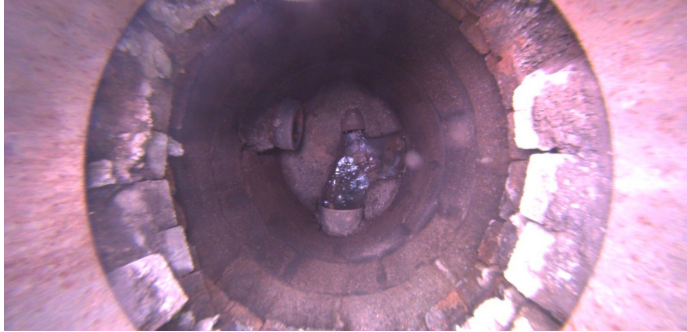
Code: **DB**
Description: **Displaced Brick**

Distance (ft): **.0**
Structural Grade: **3**
O&M Grade: **0**
Clock Start/From: **12**
Clock To: **12**
1st Value:
2nd Value:
Value Percent:
Step: **NO**
Remarks:

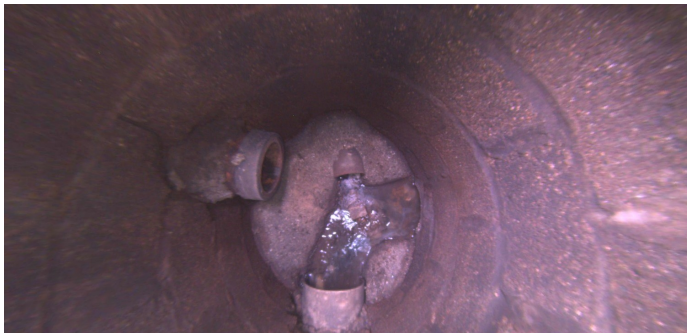
Code: **SAV**
Description: **Surface Aggregate Visible**

Distance (ft): **1.2**
Structural Grade: **3**
O&M Grade: **0**
Clock Start/From: **12**
Clock To: **12**
1st Value:
2nd Value:
Value Percent:
Step: **NO**
Remarks:

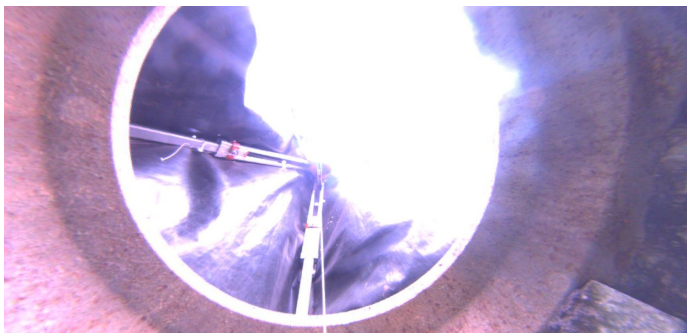
Code: **MGO**
Description: **General Observation**

Distance (ft): **1.8**
Structural Grade: **0**
O&M Grade: **0**
Clock Start/From:
Clock To:
1st Value:
2nd Value:
Value Percent:
Step: **NO**
Remarks: **underside of frame**

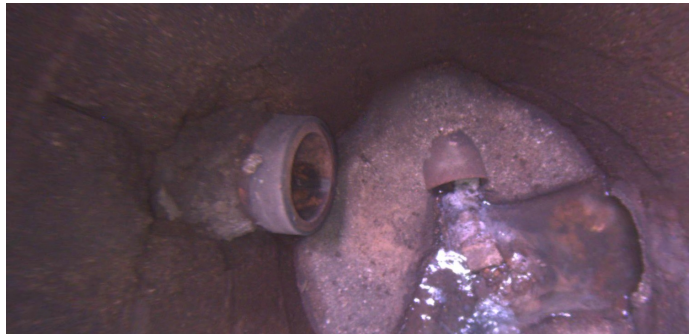
Code: **FL**
Description: **Fracture Longitudinal**

Distance (ft): **1.8**
Structural Grade: **3**
O&M Grade: **0**
Clock Start/From: **9**
Clock To:
1st Value:
2nd Value:
Value Percent:
Step: **NO**
Remarks:

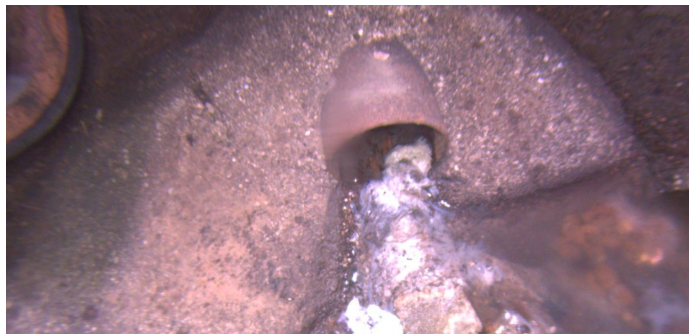
Code: **SAP**
Description: **Surface Aggregate Projecting**

Distance (ft): **3.7**
Structural Grade: **3**
O&M Grade: **0**
Clock Start/From: **12**
Clock To: **12**
1st Value:
2nd Value:
Value Percent:
Step: **NO**
Remarks:

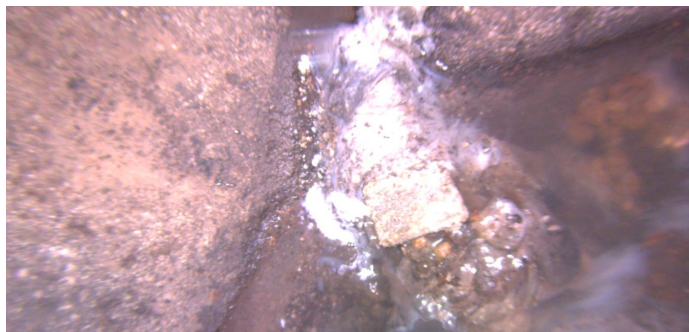
Code: **OBR**
Description: **Obstacle Rocks**

Distance (ft): **4.1**
Structural Grade: **0**
O&M Grade: **2**
Clock Start/From: **5**
Clock To: **7**
1st Value:
2nd Value:
Value Percent: **10.000**
Step: **NO**
Remarks:

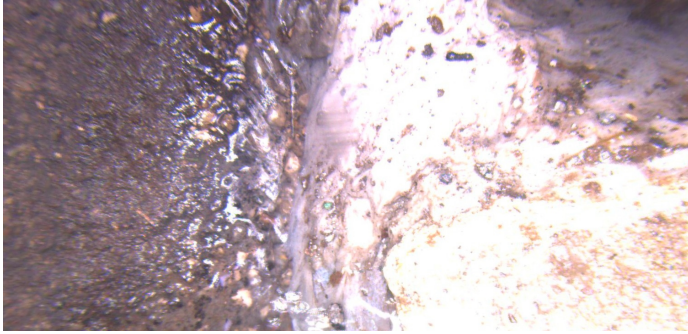
Code:	MGO
Description:	General Observation
Distance (ft):	4.9
Structural Grade:	0
O&M Grade:	0
Clock Start/From:	
Clock To:	
1st Value:	
2nd Value:	
Value Percent:	
Step:	NO
Remarks:	end survey
