# Manhole Inspection Report

Date:	04/23/2018	Weather:		Coding:	RZMACP
MH#:	M-707-069	Owner:	NA	Len. Surveyed:	4.7
P.O.#:		Surveyor:	John Kuglmaier	Rim to Invert:	4.4
Customer:	8.7	Cert. #:	U-1215-07002349	Wall Material:	Concrete (reinforced)

Street:	Intersection of 10th St. and Water St	Project:	Hobart, IN
City:	Hobart, IN	GPS Northing:	0.0
Location:		GPS Easting:	0.0
Drain Area:	Southeast	GPS Accuracy:	Nearest Meter
Cover Shape:	Circular	Evidence of Surcharge:	No
Cover Size:	22.5	Potential for Runoff:	None
Comments:

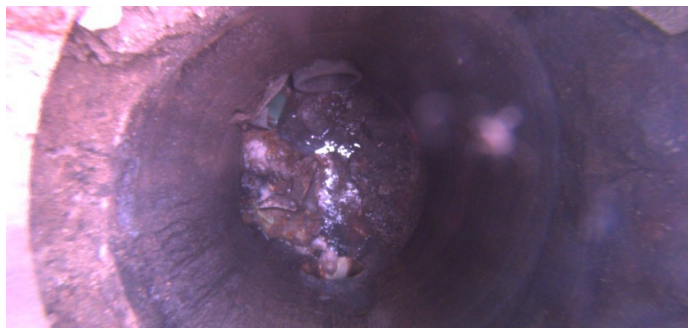
Code: **MGP**  
Description: **General Photo**

Distance (ft): **.0**  
Structural Grade: **0**  
O&M Grade: **0**  
Clock Start/From:  
Clock To:  
1st Value:  
2nd Value:  
Value Percent:  
Step: **NO**  
Remarks:

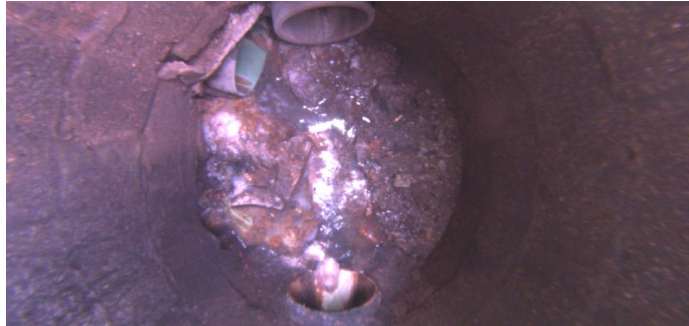
Code:	<b>DAZ</b>
Description:	<b>Deposits Attached Other</b>
Distance (ft):	<b>1.5</b>
Structural Grade:	<b>0</b>
O&M Grade:	<b>3</b>
Clock Start/From:	<b>12</b>
Clock To:	<b>12</b>
1st Value:	
2nd Value:	
Value Percent:	<b>15.000</b>
Step:	<b>NO</b>
Remarks:	<b>Mixed materials</b>

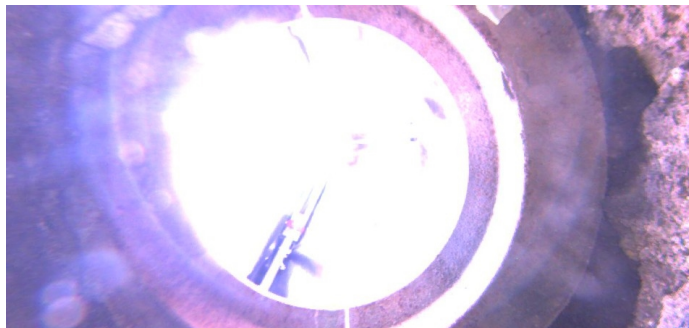
Code:	<b>MGP</b>
Description:	<b>General Photo</b>
Distance (ft):	<b>2.5</b>
Structural Grade:	<b>0</b>
O&M Grade:	<b>0</b>
Clock Start/From:	
Clock To:	
1st Value:	
2nd Value:	
Value Percent:	
Step:	<b>NO</b>
Remarks:

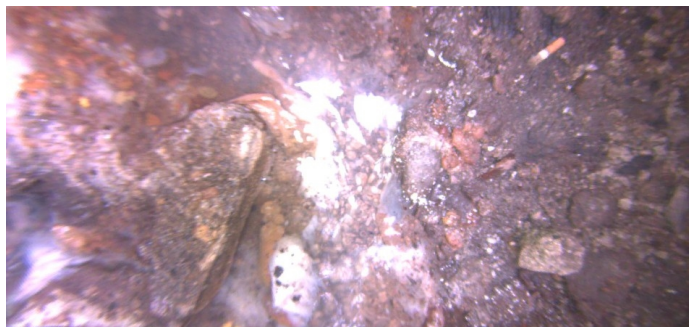
Code:	<b>MGO</b>
Description:	<b>General Observation</b>
Distance (ft):	<b>3.9</b>
Structural Grade:	<b>0</b>
O&M Grade:	<b>0</b>
Clock Start/From:	
Clock To:	
1st Value:	
2nd Value:	
Value Percent:	
Step:	<b>NO</b>
Remarks:	<b>Ins. Comp.</b>
