Manhole Inspection Report

Date:	04/16/2018	Weather:		Coding:	RZMACP
MH#:	M-707-070	Owner:	NA	Len. Surveyed:	10.4
P.O.#:		Surveyor:	John Kuglmaier	Rim to Invert:	10.9
Customer:		Cert. #:	U-1215-07002349	Wall Material:	Concrete (reinforced)

Street:	13th Pl. 159' East of Lake Park Ave.	Project:	Hobart, IN
City:	Hobart, IN	GPS Northing:	2904811.364
Location:		GPS Easting:	2904811.364
Drain Area:	Southwest	GPS Accuracy:	Sub-Meter
Cover Shape:	Circular	Evidence of Surcharge:	No
Cover Size:	29.0	Potential for Runoff:	None
Comments:

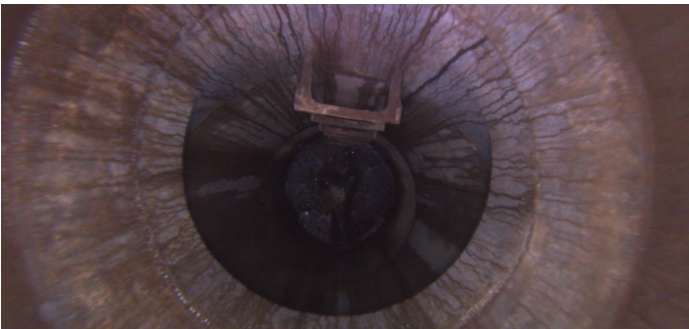
Code: **MGP**
 Description: **General Photo**

Distance (ft): **.0**
 Structural Grade: **0**
 O&M Grade: **0**
 Clock Start/From:
 Clock To:
 1st Value:
 2nd Value:
 Value Percent:
 Step: **NO**
 Remarks:

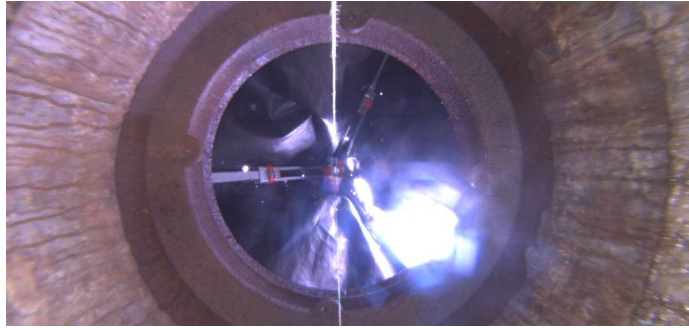
Code: **MGP**
Description: **General Photo**

Distance (ft): **2.5**
Structural Grade: **0**
O&M Grade: **0**
Clock Start/From:
Clock To:
1st Value:
2nd Value:
Value Percent:
Step: **NO**
Remarks:

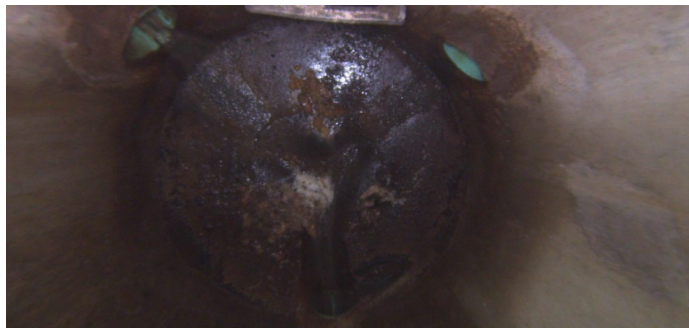
Code: **DAZ**
Description: **Deposits Attached Other**

Distance (ft): **7.1**
Structural Grade: **0**
O&M Grade: **2**
Clock Start/From: **12**
Clock To: **12**
1st Value:
2nd Value:
Value Percent: **5.000**
Step: **NO**
Remarks: **Mixed materials**

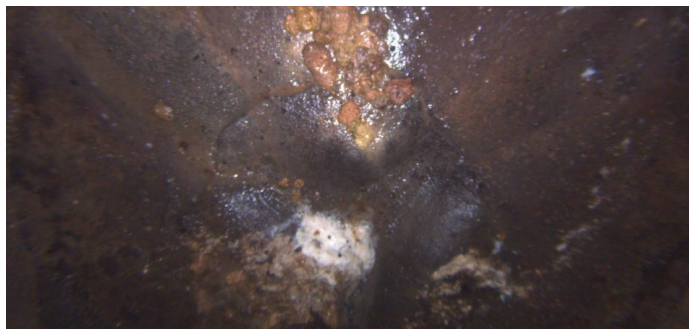
Code: **MGO**
Description: **General Observation**

Distance (ft): **9.3**
Structural Grade: **0**
O&M Grade: **0**
Clock Start/From:
Clock To:
1st Value:
2nd Value:
Value Percent:
Step: **NO**
Remarks: **Ins. Comp.**
