Manhole Inspection Report

Date:	04/17/2018	Weather:		Coding:	RZMACP
MH#:	M-707-072	Owner:	NA	Len. Surveyed:	3.8
P.O.#:		Surveyor:	John Kuglmaier	Rim to Invert:	5.2
Customer:		Cert. #:	U-1215-07002349	Wall Material:	Concrete (reinforced)

Street:	182' South of 11th St. 228' West of 1	Project:	Hobart, IN
City:	Hobart, IN	GPS Northing:	2905594.448
Location:		GPS Easting:	2905594.448
Drain Area:	Southeast	GPS Accuracy:	Sub-Meter
Cover Shape:	Circular	Evidence of Surcharge:	No
Cover Size:	22.5	Potential for Runoff:	None
Comments:

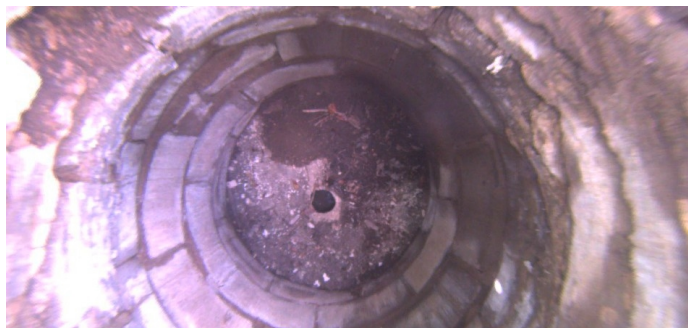
Code: **MGP**
Description: **General Photo**

Distance (ft): **.0**
Structural Grade: **0**
O&M Grade: **0**
Clock Start/From:
Clock To:
1st Value:
2nd Value:
Value Percent:
Step: **NO**
Remarks:

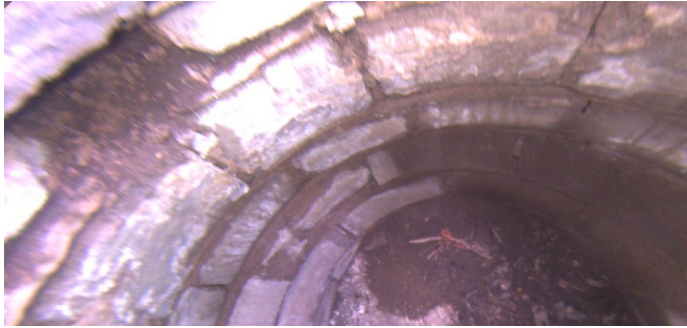
Code: **MB**
Description: **Missing Brick**

Distance (ft): **.7**
Structural Grade: **4**
O&M Grade: **0**
Clock Start/From: **10**
Clock To:
1st Value:
2nd Value:
Value Percent:
Step: **NO**
Remarks:

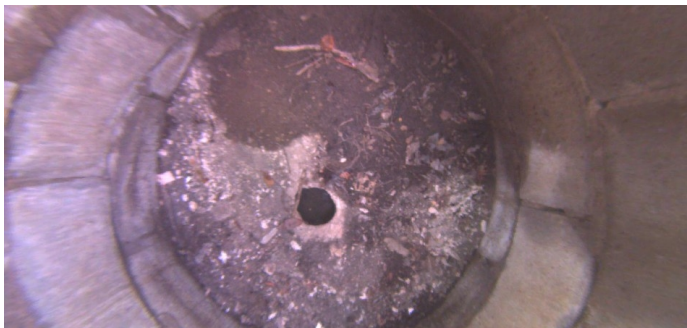
Code: **DAZ**
Description: **Deposits Attached Other**

Distance (ft): **1.8**
Structural Grade: **0**
O&M Grade: **2**
Clock Start/From: **12**
Clock To: **12**
1st Value:
2nd Value:
Value Percent: **10.000**
Step: **NO**
Remarks: **Mixed materials**

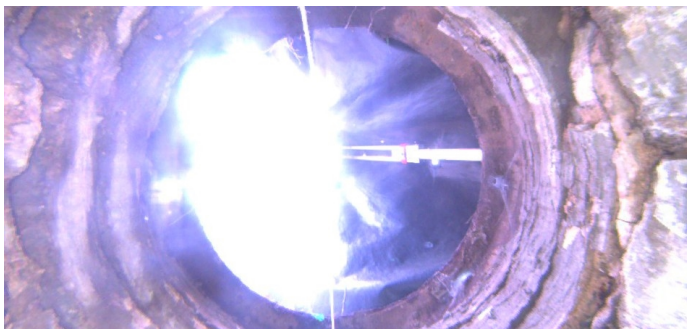
Code: **MGP**
Description: **General Photo**

Distance (ft): **2.2**
Structural Grade: **0**
O&M Grade: **0**
Clock Start/From:
Clock To:
1st Value:
2nd Value:
Value Percent:
Step: **NO**
Remarks:

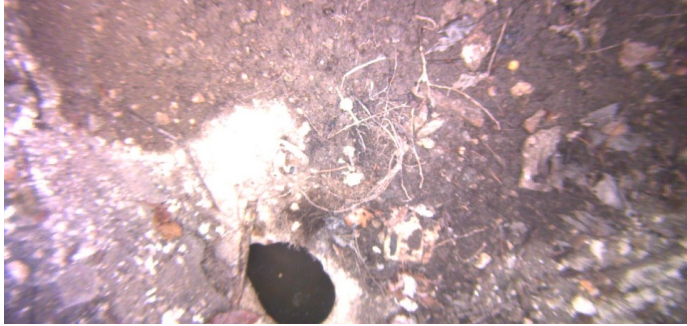
Code:	MGO
Description:	General Observation
Distance (ft):	3.4
Structural Grade:	0
O&M Grade:	0
Clock Start/From:	
Clock To:	
1st Value:	
2nd Value:	
Value Percent:	
Step:	NO
Remarks:	Ins. Comp.
