Manhole Inspection Report

Date:	04/17/2018	Weather:		Coding:	RZMACP
MH#:	M-707-073	Owner:	NA	Len. Surveyed:	3.1
P.O.#:		Surveyor:	John Kuglmaier	Rim to Invert:	3.4
Customer:		Cert. #:	U-1215-07002349	Wall Material:	Concrete (reinforced)

Street:	181' South of 11th St. 183' North of	Project:	Hobart, IN
City:	Hobart, IN	GPS Northing:	2905388.695
Location:		GPS Easting:	2905388.695
Drain Area:	Southeast	GPS Accuracy:	Sub-Meter
Cover Shape:	Circular	Evidence of Surcharge:	No
Cover Size:	22.5	Potential for Runoff:	None
Comments:

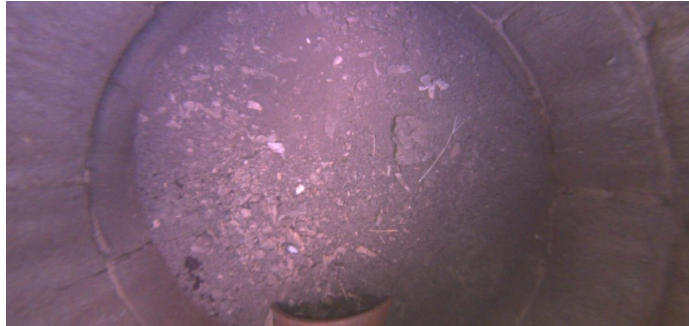
Code: **DSF**
Description: **Deposits Settled Fine**

Distance (ft): **.8**
Structural Grade: **0**
O&M Grade: **3**
Clock Start/From: **12**
Clock To: **12**
1st Value:
2nd Value:
Value Percent: **20.000**
Step: **NO**
Remarks:

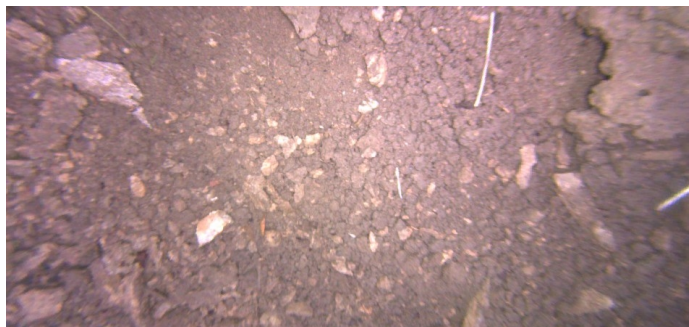
Code: **MGO**
Description: **General Observation**

Distance (ft): **2.7**
Structural Grade: **0**
O&M Grade: **0**
Clock Start/From:
Clock To:
1st Value:
2nd Value:
Value Percent:
Step: **NO**
Remarks: **Ins. Comp.**
