# Manhole Inspection Report

| MH#: | <b>M-707-075</b> | Owner: | <b>NA</b> | Len. Surveyed: | <b>8.0</b> |

| Street: | <b>On State St. 50' South of 10th St.</b> | Project: | <b>Hobart, IN</b> |

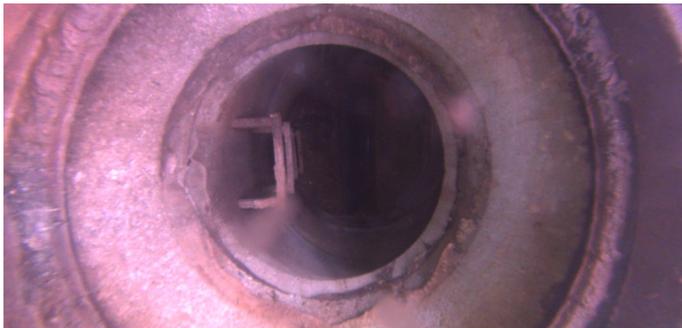
Code: **MGO**  
Description: **General Observation**

Distance (ft): **.0**  
Structural Grade: **0**  
O&M Grade: **0**  
Clock Start/From:  
Clock To:  
1st Value:  
2nd Value:  
Value Percent:  
Step: **NO**  
Remarks: **ACCESS MH**

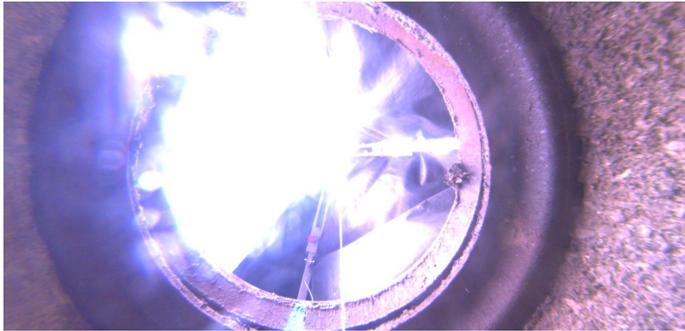
Code: **MGP**  
Description: **General Photo**

Distance (ft): **2.0**  
Structural Grade: **0**  
O&M Grade: **0**  
Clock Start/From:  
Clock To:  
1st Value:  
2nd Value:  
Value Percent:  
Step: **NO**  
Remarks: **Underside of frame**

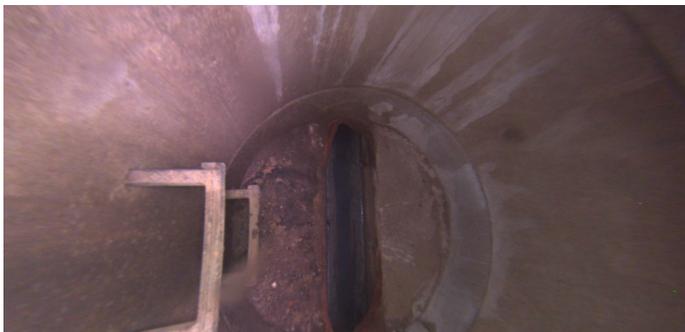
Code: **IS**  
Description: **Infil Stain**

Distance (ft): **4.4**  
Structural Grade: **0**  
O&M Grade: **0**  
Clock Start/From: **12**  
Clock To: **12**  
1st Value:  
2nd Value:  
Value Percent:  
Step: **NO**  
Remarks:

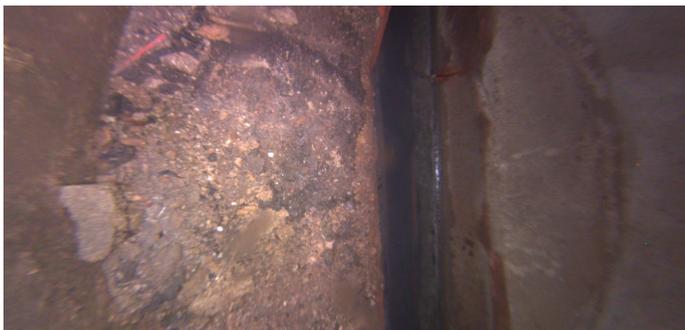
| Position | Code | Observation | Video (sec) | Grade |
|---|---|---|---|---|
| 6.9 | DSF | Deposits Settled Fine | 61 | M 2 |

Code: **DSF**  
Description: **Deposits Settled Fine**

Distance (ft): **6.9**  
Structural Grade: **0**  
O&M Grade: **2**  
Clock Start/From: **12**  
Clock To: **6**  
1st Value:  
2nd Value:  
Value Percent: **5.000**  
Step: **NO**  
Remarks:

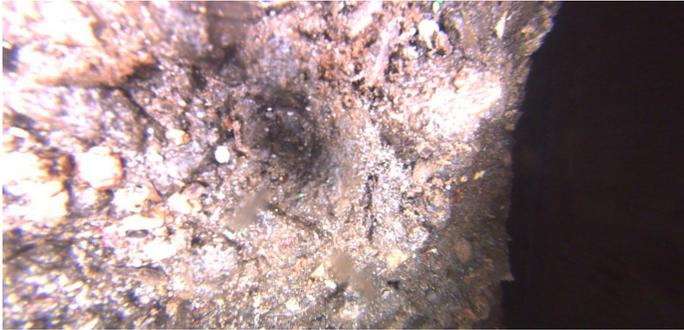
Code: **MGO**  
Description: **General Observation**

Distance (ft): **8.0**  
Structural Grade: **0**  
O&M Grade: **0**  
Clock Start/From:  
Clock To:  
1st Value:  
2nd Value:  
Value Percent:

Step: **NO**  
Remarks: **end survey**
