Manhole Inspection Report

Date:	04/17/2018	Weather:		Coding:	RZMACP
MH#:	M-707-076	Owner:	NA	Len. Surveyed:	6.0
P.O.#:		Surveyor:	Jen Costello	Rim to Invert:	6.5
Customer:		Cert. #:	U-907-5518	Wall Material:	Concrete (reinforced)

Street:	State St. 250' South of 13th St.	Project:	Hobart, IN
City:	Hobart, IN	GPS Northing:	2906227.6
Location:		GPS Easting:	2906227.6
Drain Area:	Southeast	GPS Accuracy:	Sub-Meter
Cover Shape:	Circular	Evidence of Surcharge:	No
Cover Size:	22.5	Potential for Runoff:	None
Comments:

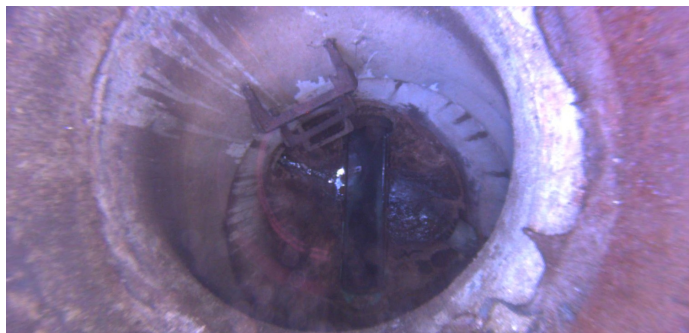
Code: **MGO**
Description: **General Observation**

Distance (ft): **.0**
Structural Grade: **0**
O&M Grade: **0**
Clock Start/From:
Clock To:
1st Value:
2nd Value:
Value Percent:
Step: **NO**
Remarks: **ACCESS MH**

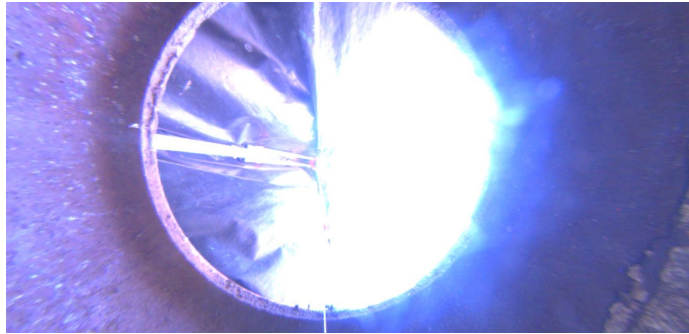
Code: **MGO**
Description: **General Observation**

Distance (ft): **1.5**
Structural Grade: **0**
O&M Grade: **0**
Clock Start/From:
Clock To:
1st Value:
2nd Value:
Value Percent:
Step: **NO**
Remarks: **UNDERSIDE OF FRAME**

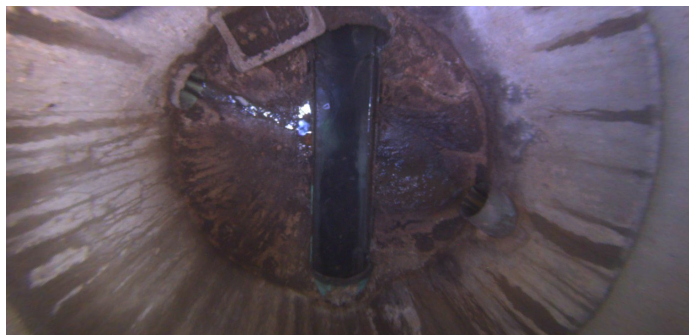
Code: **IW**
Description: **Infil Weeper**

Distance (ft): **2.6**
Structural Grade: **0**
O&M Grade: **2**
Clock Start/From: **12**
Clock To: **12**
1st Value:
2nd Value:
Value Percent:
Step: **NO**
Remarks:

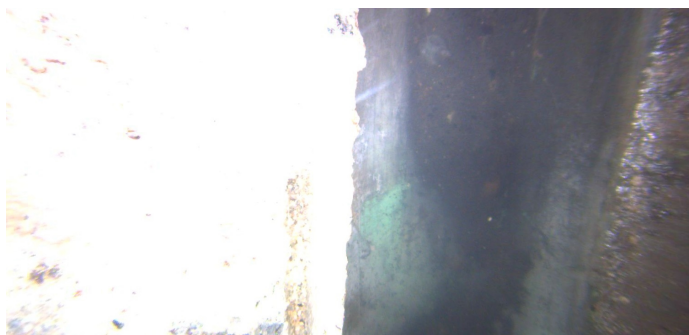
Code: **MGO**
Description: **General Observation**

Distance (ft): **6.0**
Structural Grade: **0**
O&M Grade: **0**
Clock Start/From:
Clock To:
1st Value:
2nd Value:
Value Percent:
Step: **NO**
Remarks: **END SURVEY**
