Manhole Inspection Report

Date:	04/17/2018	Weather:		Coding:	RZMACP
MH#:	M-707-079	Owner:	NA	Len. Surveyed:	6.9
P.O.#:		Surveyor:	John Kuglmaier	Rim to Invert:	7.0
Customer:		Cert. #:	U-1215-07002349	Wall Material:	Concrete (reinforced)

Street:	State St. 247' North of 13th St.	Project:	Hobart, IN
City:	Hobart, IN	GPS Northing:	2906219.202
Location:		GPS Easting:	2906219.202
Drain Area:	Southeast	GPS Accuracy:	Sub-Meter
Cover Shape:	Circular	Evidence of Surcharge:	No
Cover Size:	22.5	Potential for Runoff:	None
Comments:

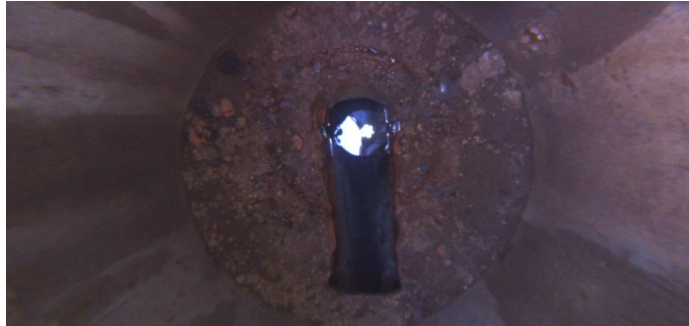
Code: **DAZ**
Description: **Deposits Attached Other**

Distance (ft): **2.7**
Structural Grade: **0**
O&M Grade: **2**
Clock Start/From: **12**
Clock To: **12**
1st Value:
2nd Value:
Value Percent: **10.000**
Step: **NO**
Remarks: **Mixed materials**

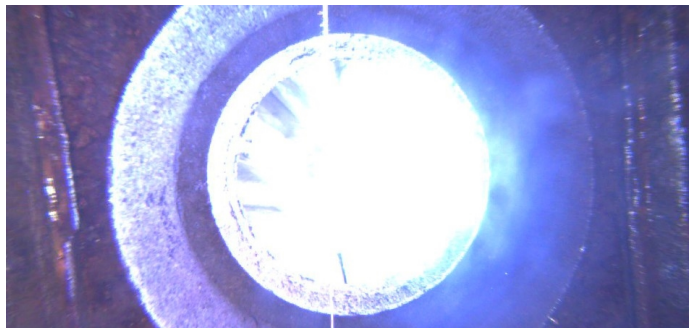
Code: **MGP**
Description: **General Photo**

Distance (ft): **2.7**
Structural Grade: **0**
O&M Grade: **0**
Clock Start/From:
Clock To:
1st Value:
2nd Value:
Value Percent:
Step: **NO**
Remarks:

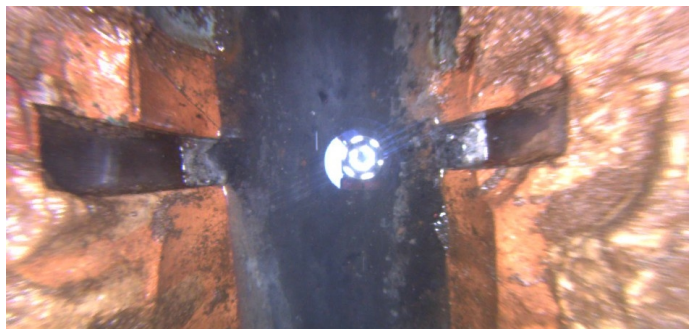
Code: **MGO**
Description: **General Observation**

Distance (ft): **6.0**
Structural Grade: **0**
O&M Grade: **0**
Clock Start/From:
Clock To:
1st Value:
2nd Value:
Value Percent:
Step: **NO**
Remarks: **Ins. Comp.**
