Manhole Inspection Report

Date:	04/18/2018	Weather:		Coding:	RZMACP
MH#:	M-708-003	Owner:	NA	Len. Surveyed:	9.1
P.O.#:		Surveyor:	John Kuglmaier	Rim to Invert:	9.4
Customer:		Cert. #:	U-1215-07002349	Wall Material:	Concrete (reinforced)

Street:	Lincoln St. 645' South of 14th St.	Project:	Hobart, IN
City:	Hobart, IN	GPS Northing:	2906568.423
Location:		GPS Easting:	2906568.423
Drain Area:	Southeast	GPS Accuracy:	Sub-Meter
Cover Shape:	Circular	Evidence of Surcharge:	No
Cover Size:	22.5	Potential for Runoff:	None
Comments:

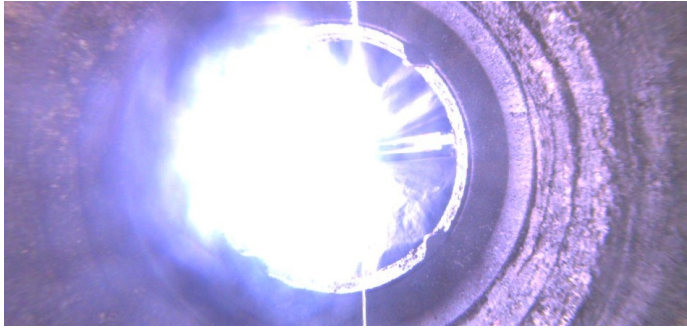
Code:	MGP
Description:	General Photo
Distance (ft):	2.6
Structural Grade:	0
O&M Grade:	0
Clock Start/From:	
Clock To:	
1st Value:	
2nd Value:	
Value Percent:	
Step:	NO
Remarks:

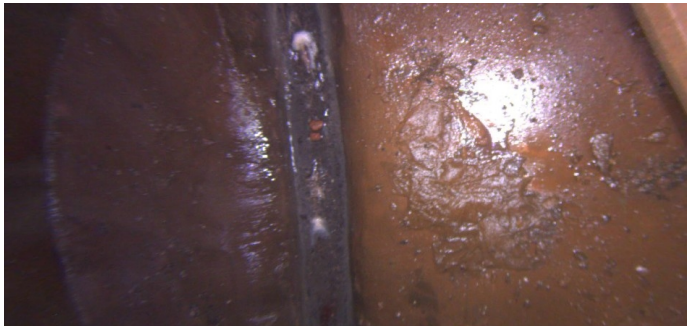
Code:	MGO
Description:	General Observation
Distance (ft):	7.9
Structural Grade:	0
O&M Grade:	0
Clock Start/From:	
Clock To:	
1st Value:	
2nd Value:	
Value Percent:	
Step:	NO
Remarks:	Ins. Comp.
