Manhole Inspection Report

Date:	04/18/2018	Weather:		Coding:	RZMACP
MH#:	M-708-004	Owner:	NA	Len. Surveyed:	9.8
P.O.#:		Surveyor:	John Kuglmaier	Rim to Invert:	10.3
Customer:		Cert. #:	U-1215-07002349	Wall Material:	Concrete (reinforced)

Street:	Lincoln St. 305' South of 14th St.	Project:	Hobart, IN
City:	Hobart, IN	GPS Northing:	2906566.294
Location:		GPS Easting:	2906566.294
Drain Area:	Southeast	GPS Accuracy:	Sub-Meter
Cover Shape:	Circular	Evidence of Surcharge:	No
Cover Size:	22.5	Potential for Runoff:	None
Comments:

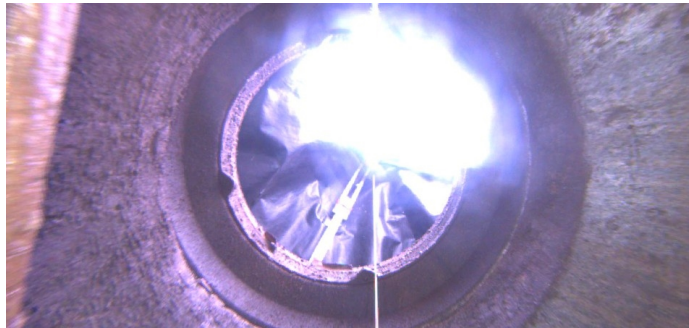
Code: **MGP**
Description: **General Photo**

Distance (ft): **2.7**
Structural Grade: **0**
O&M Grade: **0**
Clock Start/From:
Clock To:
1st Value:
2nd Value:
Value Percent:
Step: **NO**
Remarks:

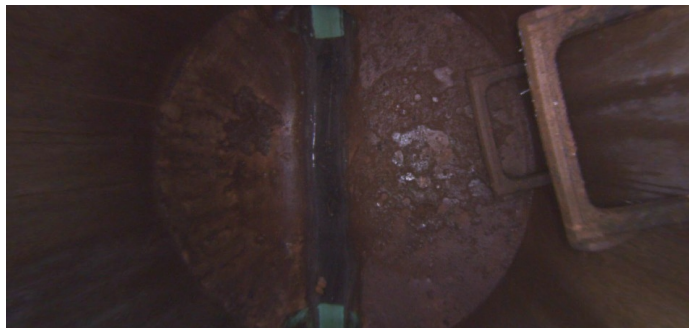
Code: **DSF**
Description: **Deposits Settled Fine**

Distance (ft): **7.1**
Structural Grade: **0**
O&M Grade: **2**
Clock Start/From: **12**
Clock To: **12**
1st Value:
2nd Value:
Value Percent: **5.000**
Step: **NO**
Remarks:

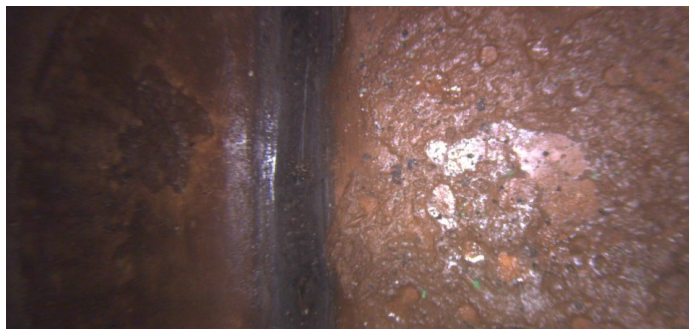
Code: **MGO**
Description: **General Observation**

Distance (ft): **9.0**
Structural Grade: **0**
O&M Grade: **0**
Clock Start/From:
Clock To:
1st Value:
2nd Value:
Value Percent:
Step: **NO**
Remarks: **Ins. Comp.**
