Manhole Inspection Report

Date:	04/18/2018	Weather:		Coding:	RZMACP
MH#:	M-708-006	Owner:	NA	Len. Surveyed:	5.1
P.O.#:		Surveyor:	John Kuglmaier	Rim to Invert:	5.3
Customer:		Cert. #:	U-1215-07002349	Wall Material:	Concrete (reinforced)

Street:	State St. North of 16th St.	Project:	Hobart, IN
City:	Hobart, IN	GPS Northing:	2906175.263
Location:		GPS Easting:	2906175.263
Drain Area:	Southeast	GPS Accuracy:	Sub-Meter
Cover Shape:	Circular	Evidence of Surcharge:	Yes
Cover Size:	22.5	Potential for Runoff:	None
Comments:

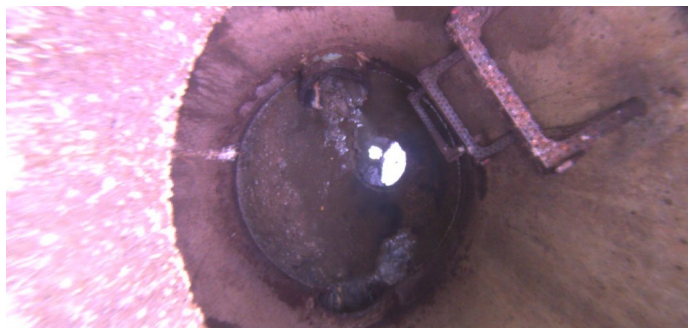
Code: **MGP**
Description: **General Photo**

Distance (ft): **.0**
Structural Grade: **0**
O&M Grade: **0**
Clock Start/From:
Clock To:
1st Value:
2nd Value:
Value Percent:
Step: **NO**
Remarks:

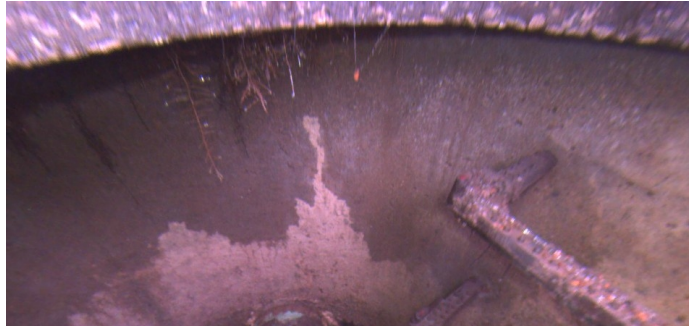
Code: **RFJ**
Description: **Roots Fine Joint**

Distance (ft): **.9**
Structural Grade: **0**
O&M Grade: **1**
Clock Start/From: **11**
Clock To:
1st Value:
2nd Value:
Value Percent:
Step: **NO**
Remarks:

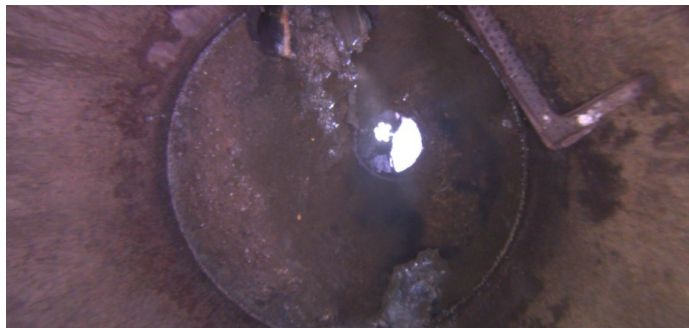
Code: **MGO**
Description: **General Observation**

Distance (ft): **2.1**
Structural Grade: **0**
O&M Grade: **0**
Clock Start/From:
Clock To:
1st Value:
2nd Value:
Value Percent:
Step: **NO**
Remarks: **Surcharge**

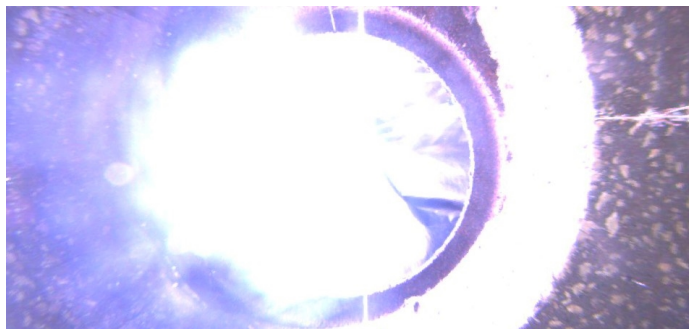
Code: **MGP**
Description: **General Photo**

Distance (ft): **2.3**
Structural Grade: **0**
O&M Grade: **0**
Clock Start/From:
Clock To:
1st Value:
2nd Value:
Value Percent:
Step: **NO**
Remarks:

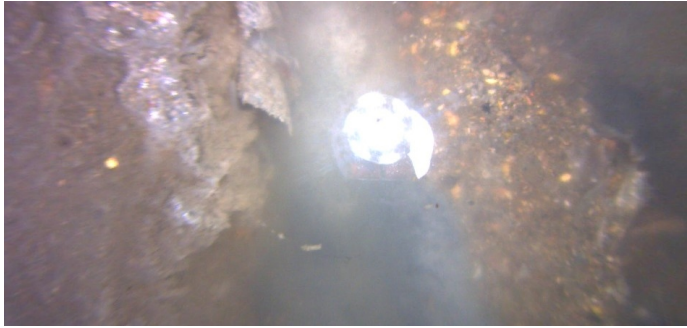
Code:	MGO
Description:	General Observation
Distance (ft):	4.6
Structural Grade:	0
O&M Grade:	0
Clock Start/From:	
Clock To:	
1st Value:	
2nd Value:	
Value Percent:	
Step:	NO
Remarks:	Ins. Comp.
