Manhole Inspection Report

Date:	04/18/2018	Weather:		Coding:	RZMACP
MH#:	M-708-007	Owner:	NA	Len. Surveyed:	5.1
P.O.#:		Surveyor:	John Kuglmaier	Rim to Invert:	5.2
Customer:		Cert. #:	U-1215-07002349	Wall Material:	Concrete (reinforced)

Street:	State St. 562' South of 14th St.	Project:	Hobart, IN
City:	Hobart, IN	GPS Northing:	2906166.736
Location:		GPS Easting:	2906166.736
Drain Area:	Southeast	GPS Accuracy:	Sub-Meter
Cover Shape:	Circular	Evidence of Surcharge:	No
Cover Size:	22.5	Potential for Runoff:	None
Comments:

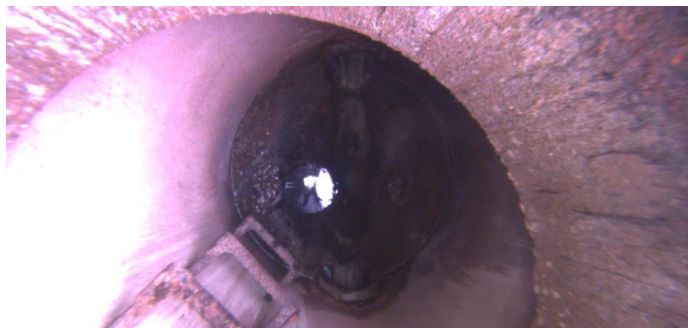
Code: **MGP**
 Description: **General Photo**

Distance (ft): **.0**
 Structural Grade: **0**
 O&M Grade: **0**
 Clock Start/From:
 Clock To:
 1st Value:
 2nd Value:
 Value Percent:
 Step: **NO**
 Remarks:

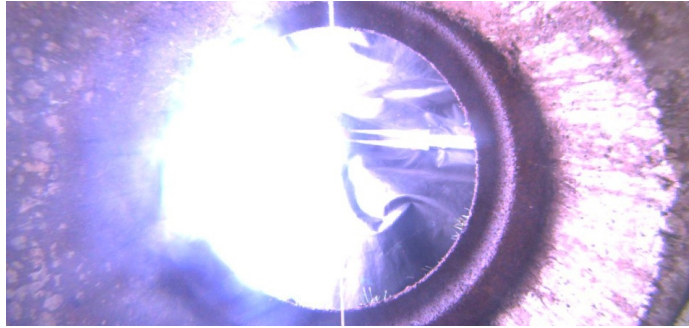
Code: **MGP**
Description: **General Photo**

Distance (ft): **2.3**
Structural Grade: **0**
O&M Grade: **0**
Clock Start/From:
Clock To:
1st Value:
2nd Value:
Value Percent:
Step: **NO**
Remarks:

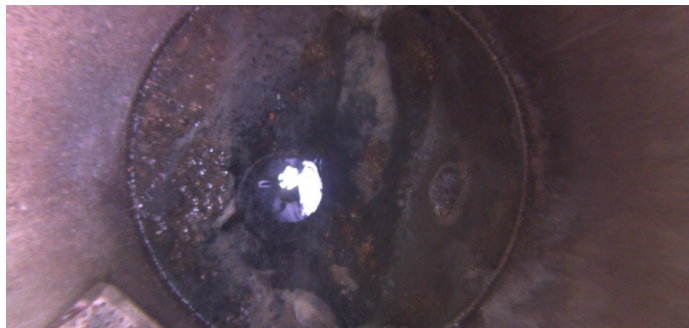
Code: **MGO**
Description: **General Observation**

Distance (ft): **2.4**
Structural Grade: **0**
O&M Grade: **0**
Clock Start/From:
Clock To:
1st Value:
2nd Value:
Value Percent:
Step: **NO**
Remarks: **Surcharge**

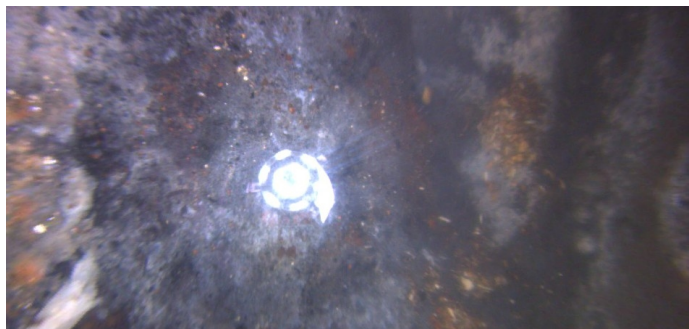
Code: **MGO**
Description: **General Observation**

Distance (ft): **4.4**
Structural Grade: **0**
O&M Grade: **0**
Clock Start/From:
Clock To:
1st Value:
2nd Value:
Value Percent:
Step: **NO**
Remarks: **Ins. Comp.**
