Manhole Inspection Report

Date:	04/18/2018	Weather:		Coding:	RZMACP
MH#:	M-708-008	Owner:	NA	Len. Surveyed:	4.6
P.O.#:		Surveyor:	John Kuglmaier	Rim to Invert:	4.6
Customer:		Cert. #:	U-1215-07002349	Wall Material:	Concrete (reinforced)

Street:	State St. 240' South of 14th St.	Project:	Hobart, IN
City:	Hobart, IN	GPS Northing:	2906171.765
Location:		GPS Easting:	2906171.765
Drain Area:	Southeast	GPS Accuracy:	Sub-Meter
Cover Shape:	Circular	Evidence of Surcharge:	No
Cover Size:	22.5	Potential for Runoff:	None
Comments:

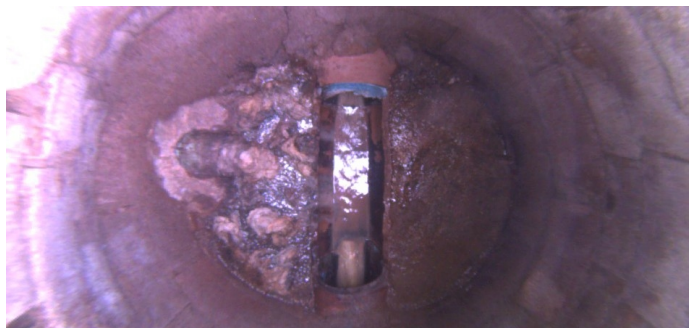
Code: **MGP**
Description: **General Photo**

Distance (ft): **.0**
Structural Grade: **0**
O&M Grade: **0**
Clock Start/From:
Clock To:
1st Value:
2nd Value:
Value Percent:
Step: **NO**
Remarks:

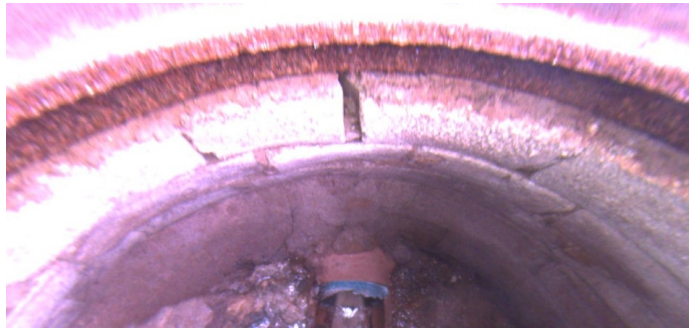
Code: **MMM**
Description: **Mortar Missing Medium**

Distance (ft): **.0**
Structural Grade: **3**
O&M Grade: **0**
Clock Start/From: **12**
Clock To: **12**
1st Value:
2nd Value:
Value Percent:
Step: **NO**
Remarks:

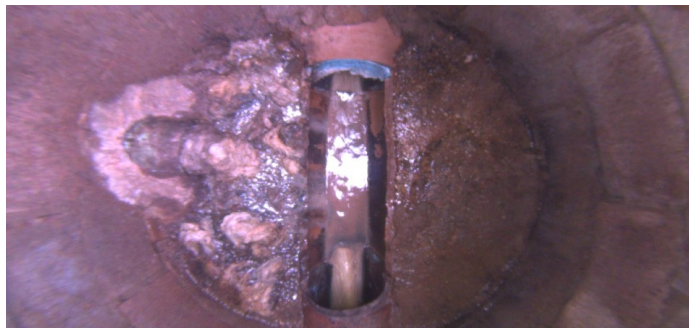
Code: **DAZ**
Description: **Deposits Attached Other**

Distance (ft): **.7**
Structural Grade: **0**
O&M Grade: **2**
Clock Start/From: **6**
Clock To: **12**
1st Value:
2nd Value:
Value Percent: **10.000**
Step: **NO**
Remarks: **Mixed materials**

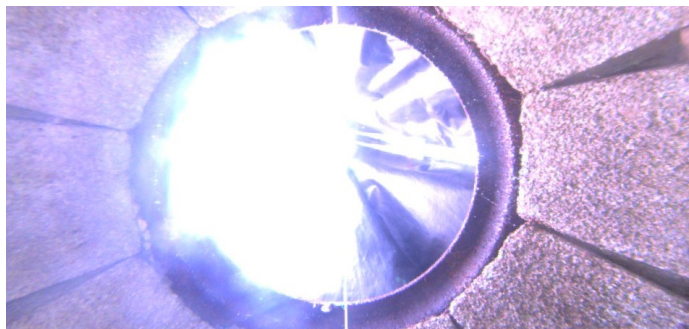
Code: **MGP**
Description: **General Photo**

Distance (ft): **2.2**
Structural Grade: **0**
O&M Grade: **0**
Clock Start/From:
Clock To:
1st Value:
2nd Value:
Value Percent:
Step: **NO**
Remarks:

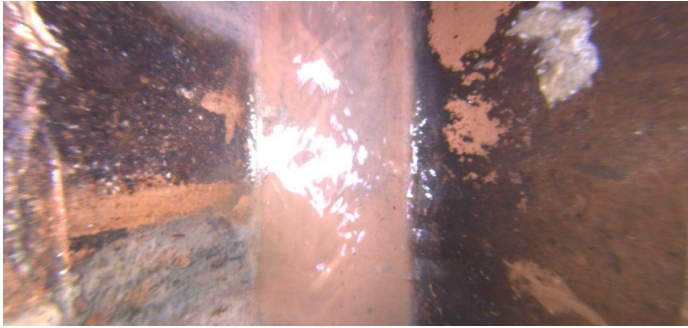
Code:	MGO
Description:	General Observation
Distance (ft):	3.8
Structural Grade:	0
O&M Grade:	0
Clock Start/From:	
Clock To:	
1st Value:	
2nd Value:	
Value Percent:	
Step:	NO
Remarks:	Ins. Comp.
