# Manhole Inspection Report

Date:	04/19/2018	Weather:		Coding:	RZMACP
MH#:	M-708-009	Owner:	NA	Len. Surveyed:	11.1
P.O.#:		Surveyor:	John Kuglmaier	Rim to Invert:	11.8
Customer:		Cert. #:	U-1215-07002349	Wall Material:	Concrete (reinforced)

Street:	Lake Park Ave. 61st Ave. to the East.	Project:	Hobart, IN
City:	Hobart, IN	GPS Northing:	2904705.666
Location:		GPS Easting:	2904705.666
Drain Area:	Southwest	GPS Accuracy:	Sub-Meter
Cover Shape:	Circular	Evidence of Surcharge:	Yes
Cover Size:	22.5	Potential for Runoff:	None
Comments:

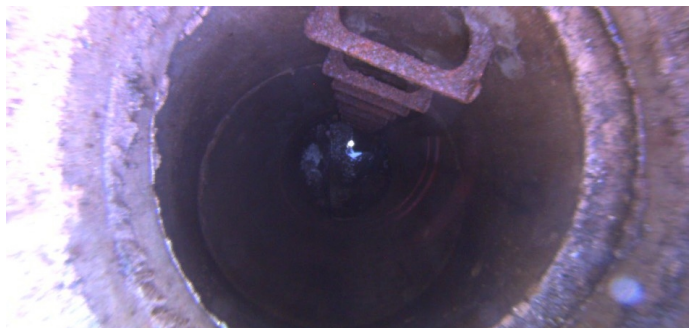
Code: **MGP**  
Description: **General Photo**

Distance (ft): **.0**  
Structural Grade: **0**  
O&M Grade: **0**  
Clock Start/From:  
Clock To:  
1st Value:  
2nd Value:  
Value Percent:  
Step: **NO**  
Remarks:

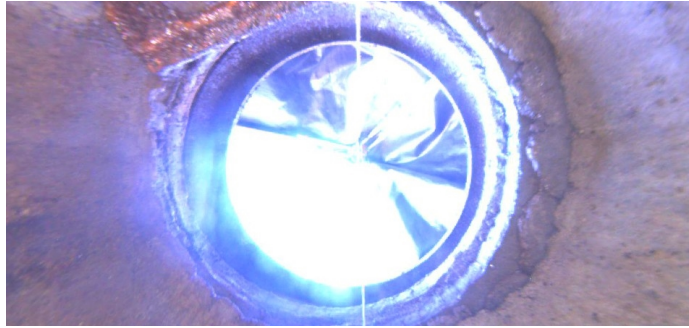
Code: **MGP**  
Description: **General Photo**

Distance (ft): **2.8**  
Structural Grade: **0**  
O&M Grade: **0**  
Clock Start/From:  
Clock To:  
1st Value:  
2nd Value:  
Value Percent:  
Step: **NO**  
Remarks:

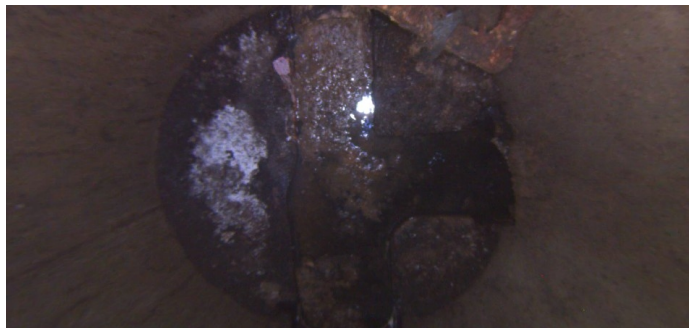
Code: **DSF**  
Description: **Deposits Settled Fine**

Distance (ft): **8.4**  
Structural Grade: **0**  
O&M Grade: **3**  
Clock Start/From: **12**  
Clock To: **12**  
1st Value:  
2nd Value:  
Value Percent: **15.000**  
Step: **NO**  
Remarks:

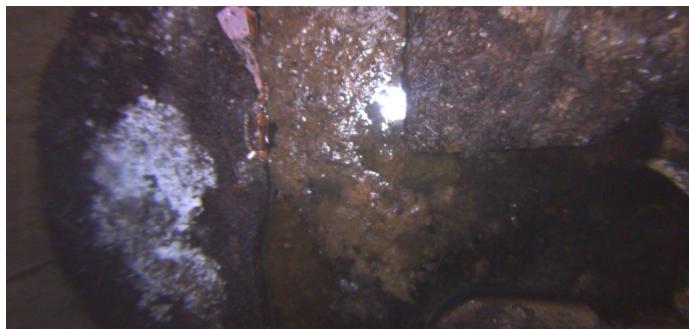
Code: **MGO**  
Description: **General Observation**

Distance (ft): **10.1**  
Structural Grade: **0**  
O&M Grade: **0**  
Clock Start/From:  
Clock To:  
1st Value:  
2nd Value:  
Value Percent:  
Step: **NO**  
Remarks: **Ins. Comp.**
