Manhole Inspection Report

Date:	04/20/2018	Weather:		Coding:	RZMACP
MH#:	M-708-012	Owner:	NA	Len. Surveyed:	10.7
P.O.#:		Surveyor:	John Kuglmaier	Rim to Invert:	11.3
Customer:		Cert. #:	U-1215-07002349	Wall Material:	Concrete (reinforced)

Street:	Lake Park Ave. 433' South of 14th St.	Project:	Hobart, IN
City:	Hobart, IN	GPS Northing:	2904713.146
Location:		GPS Easting:	2904713.146
Drain Area:	Southwest	GPS Accuracy:	Sub-Meter
Cover Shape:	Circular	Evidence of Surcharge:	No
Cover Size:	26.0	Potential for Runoff:	None
Comments:

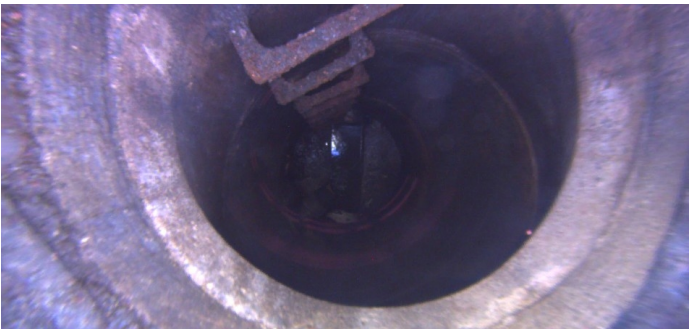
Code: **MGP**
Description: **General Photo**

Distance (ft): **.0**
Structural Grade: **0**
O&M Grade: **0**
Clock Start/From:
Clock To:
1st Value:
2nd Value:
Value Percent:
Step: **NO**
Remarks:

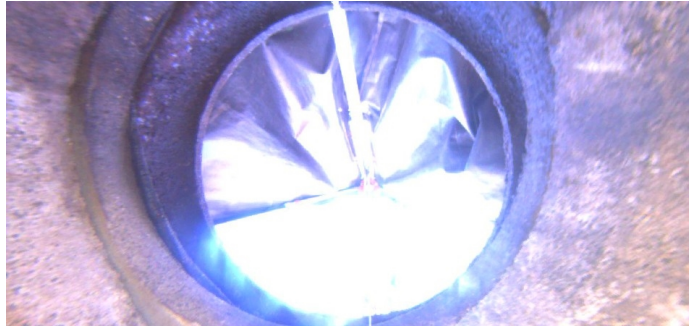
Code: **MGP**
Description: **General Photo**

Distance (ft): **2.5**
Structural Grade: **0**
O&M Grade: **0**
Clock Start/From:
Clock To:
1st Value:
2nd Value:
Value Percent:
Step: **NO**
Remarks:

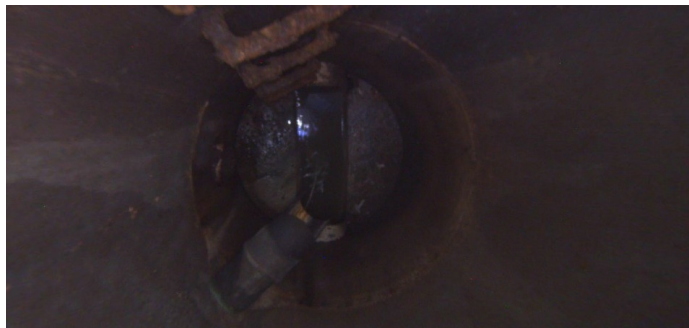
Code: **IS**
Description: **Infil Stain**

Distance (ft): **3.9**
Structural Grade: **0**
O&M Grade: **0**
Clock Start/From: **12**
Clock To: **12**
1st Value:
2nd Value:
Value Percent:
Step: **NO**
Remarks:

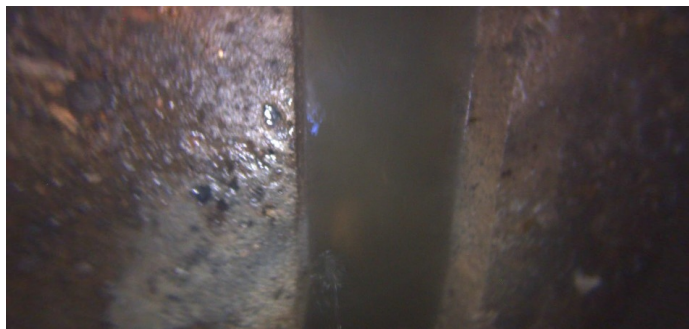
Code: **MGO**
Description: **General Observation**

Distance (ft): **9.4**
Structural Grade: **0**
O&M Grade: **0**
Clock Start/From:
Clock To:
1st Value:
2nd Value:
Value Percent:
Step: **NO**
Remarks: **Ins. Comp.**
