# Manhole Inspection Report

Date:	04/09/2018	Weather:		Coding:	RZMACP
MH#:	M-708-016	Owner:	NA	Len. Surveyed:	3.0
P.O.#:		Surveyor:	John Kuglmaier	Rim to Invert:	3.7
Customer:		Cert. #:	U-1215-07002349	Wall Material:	Concrete (reinforced)

Street:	Hidden Oak Trail. 348' North of Capi	Project:	Hobart, IN
City:	Hobart, IN	GPS Northing:	2907195.404
Location:		GPS Easting:	2907195.404
Drain Area:	Southwest	GPS Accuracy:	Sub-Meter
Cover Shape:	Circular	Evidence of Surcharge:	No
Cover Size:	22.5	Potential for Runoff:	None
Comments:

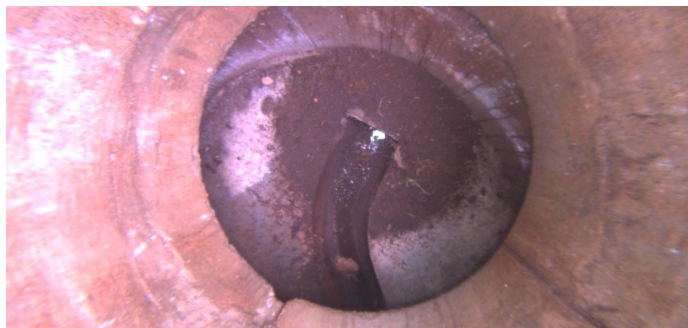
Code: **MGP**  
Description: **General Photo**

Distance (ft): **.0**  
Structural Grade: **0**  
O&M Grade: **0**  
Clock Start/From:  
Clock To:  
1st Value:  
2nd Value:  
Value Percent:  
Step: **NO**  
Remarks:

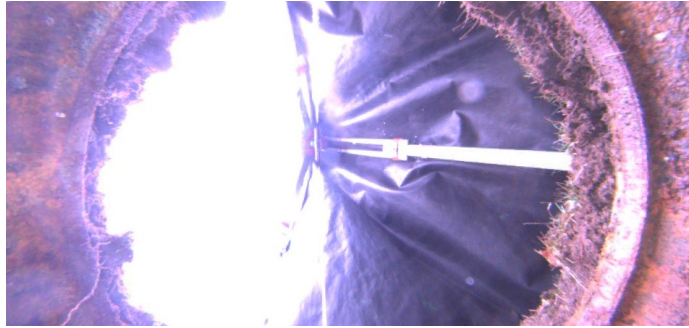
Code: **MGP**  
Description: **General Photo**

Distance (ft): **1.4**  
Structural Grade: **0**  
O&M Grade: **0**  
Clock Start/From:  
Clock To:  
1st Value:  
2nd Value:  
Value Percent:  
Step: **NO**  
Remarks:

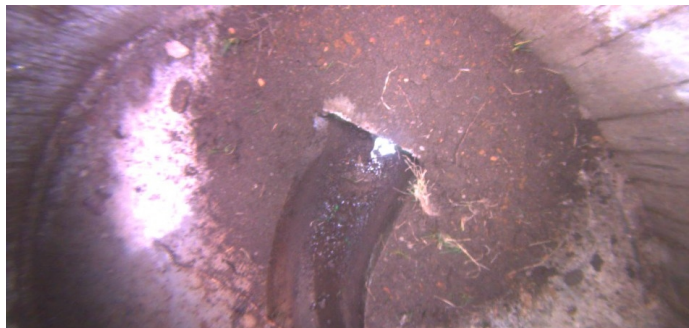
Code: **DSF**  
Description: **Deposits Settled Fine**

Distance (ft): **1.7**  
Structural Grade: **0**  
O&M Grade: **2**  
Clock Start/From: **12**  
Clock To: **12**  
1st Value:  
2nd Value:  
Value Percent: **5.000**  
Step: **NO**  
Remarks:

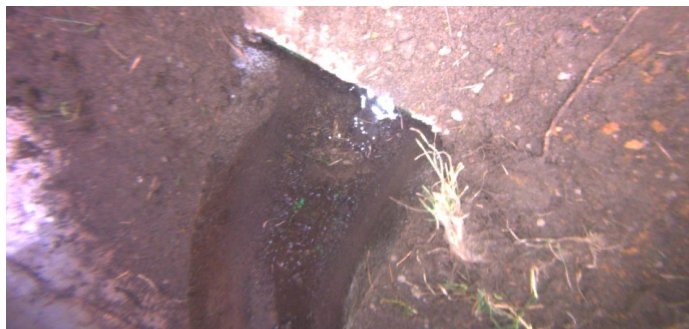
Code: **MGO**  
Description: **General Observation**

Distance (ft): **2.5**  
Structural Grade: **0**  
O&M Grade: **0**  
Clock Start/From:  
Clock To:  
1st Value:  
2nd Value:  
Value Percent:  
Step: **NO**  
Remarks: **Ins. Comp.**
