Manhole Inspection Report

Date:	09/20/2022	Weather:		Coding:	RZMACP
MH#:	M-708-020	Owner:	NA	Len. Surveyed:	2.1
P.O.#:		Surveyor:	Todd Machine	Rim to Invert:	3.1
Customer:		Cert. #:	P0038859-082022	Wall Material:	Other

Street:	196' Southeast of 14th St. and Hwy	Project:	Hobart, IN
City:	Hobart, IN	GPS Northing:	2282340.623
Location:	Main Highway - Suburban/Rural	GPS Easting:	2904844.284
Drain Area:	Southwest	GPS Accuracy:	Sub-Meter
Cover Shape:	Circular	Evidence of Surcharge:	
Cover Size:	24.0	Potential for Runoff:	
Comments:

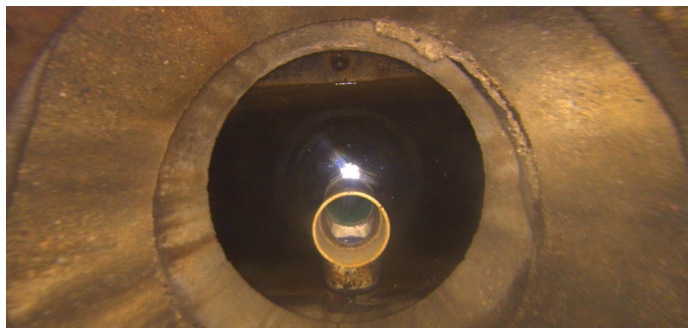
Code: **MGO**
Description: **General Observation**

Distance (ft): **.0**
Structural Grade: **0**
O&M Grade: **0**
Clock Start/From:
Clock To:
1st Value:
2nd Value:
Value Percent:
Step: **NO**
Remarks: **access mh**

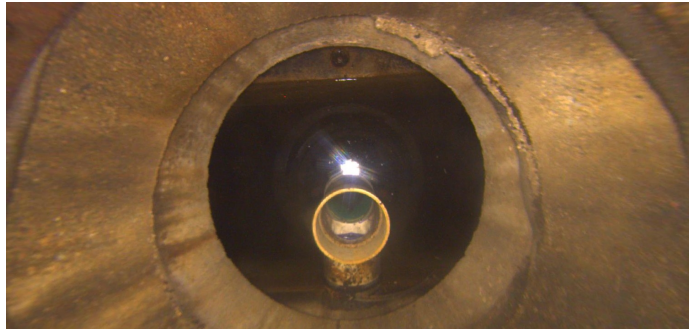
Code: **SRI**
Description: **Surface Roughness Increased**

Distance (ft): **.0**
Structural Grade: **1**
O&M Grade: **0**
Clock Start/From: **12**
Clock To: **12**
1st Value:
2nd Value:
Value Percent:
Step: **NO**
Remarks:

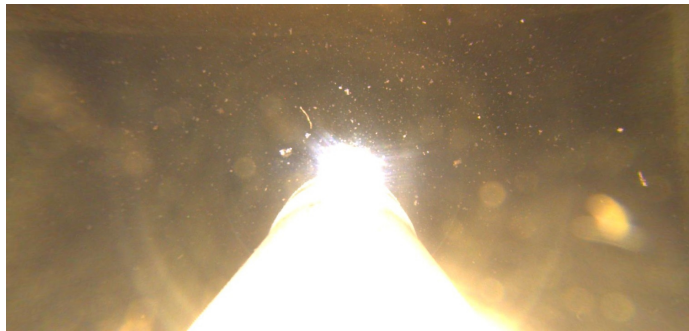
Code: **SRI**
Description: **Surface Roughness Increased**

Distance (ft): **2.0**
Structural Grade: **1**
O&M Grade: **0**
Clock Start/From: **12**
Clock To: **12**
1st Value:
2nd Value:
Value Percent:
Step: **NO**
Remarks:

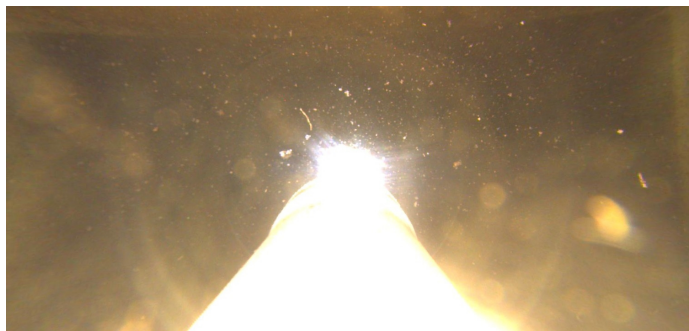
Code: **MSA**
Description: **Abandoned Survey**

Distance (ft): **2.0**
Structural Grade: **0**
O&M Grade: **0**
Clock Start/From:
Clock To:
1st Value:
2nd Value:
Value Percent:
Step: **NO**
Remarks: **Surcharged**
