Manhole Inspection Report

Date:	04/20/2018	Weather:		Coding:	RZMACP
MH#:	M-708-021	Owner:	NA	Len. Surveyed:	7.5
P.O.#:		Surveyor:	Jen Costello	Rim to Invert:	7.7
Customer:		Cert. #:	U-907-5518	Wall Material:	Concrete (reinforced)

Street:	249' Southeast of 14th St. and Hwy	Project:	Hobart, IN
City:	Hobart, IN	GPS Northing:	2904902.905
Location:		GPS Easting:	2904902.905
Drain Area:	Southwest	GPS Accuracy:	Sub-Meter
Cover Shape:	Circular	Evidence of Surcharge:	No
Cover Size:	22.5	Potential for Runoff:	None
Comments:

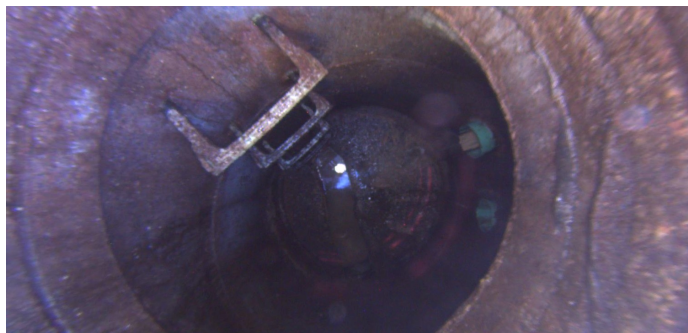
Code: **MGO**
Description: **General Observation**

Distance (ft): **.0**
Structural Grade: **0**
O&M Grade: **0**
Clock Start/From:
Clock To:
1st Value:
2nd Value:
Value Percent:
Step: **NO**
Remarks: **ACCESS MH**

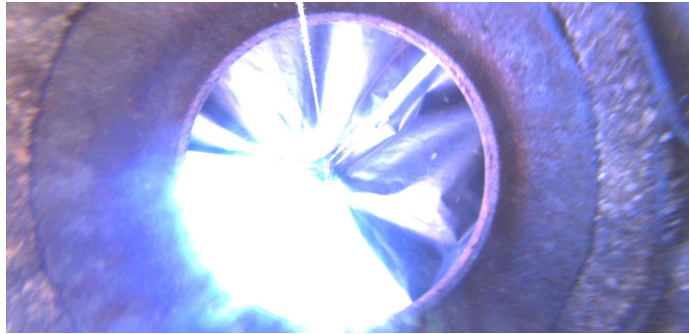
Code:	MGP
Description:	General Photo
Distance (ft):	1.6
Structural Grade:	0
O&M Grade:	0
Clock Start/From:	
Clock To:	
1st Value:	
2nd Value:	
Value Percent:	
Step:	NO
Remarks:	UNDERSIDE OF FRAME

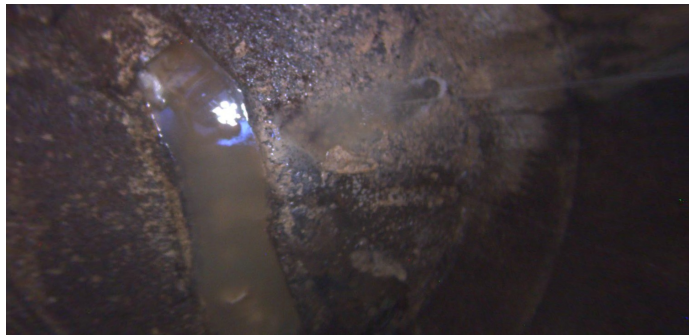
Code:	IW
Description:	Infil Weeper
Distance (ft):	4.9
Structural Grade:	0
O&M Grade:	2
Clock Start/From:	2
Clock To:	
1st Value:	
2nd Value:	
Value Percent:	
Step:	NO
Remarks:

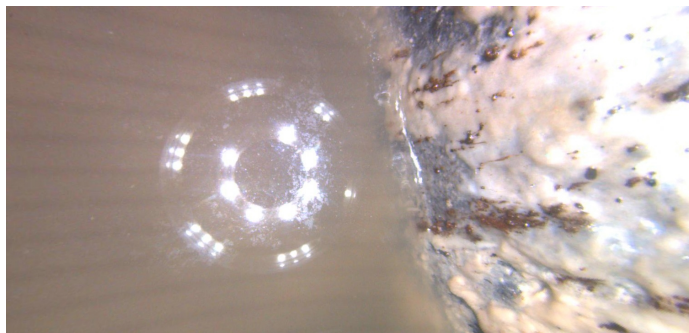
Code:	MGO
Description:	General Observation
Distance (ft):	7.5
Structural Grade:	0
O&M Grade:	0
Clock Start/From:	
Clock To:	
1st Value:	
2nd Value:	
Value Percent:	
Step:	NO
Remarks:	END SURVEY
