Manhole Inspection Report

Date:	04/20/2018	Weather:		Coding:	RZMACP
MH#:	M-708-022	Owner:	NA	Len. Surveyed:	5.9
P.O.#:		Surveyor:	John Kuglmaier	Rim to Invert:	8.0
Customer:		Cert. #:	U-1215-07002349	Wall Material:	Concrete (reinforced)

Street:	175' East of 14th St. and Hwy 51.	Project:	Hobart, IN
City:	Hobart, IN	GPS Northing:	0.0
Location:		GPS Easting:	0.0
Drain Area:	Southwest	GPS Accuracy:	Nearest Meter
Cover Shape:	Circular	Evidence of Surcharge:	No
Cover Size:	22.5	Potential for Runoff:	None
Comments:

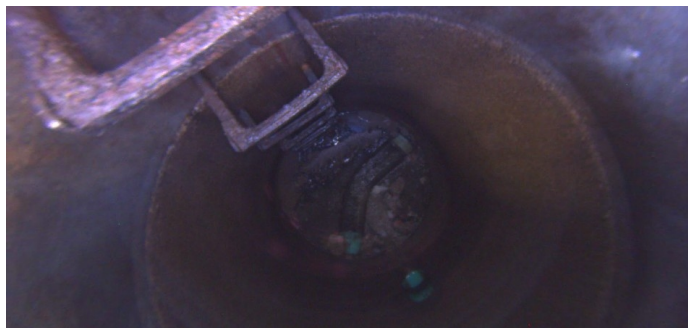
Code: **MGP**
Description: **General Photo**

Distance (ft): **.0**
Structural Grade: **0**
O&M Grade: **0**
Clock Start/From:
Clock To:
1st Value:
2nd Value:
Value Percent:
Step: **NO**
Remarks:

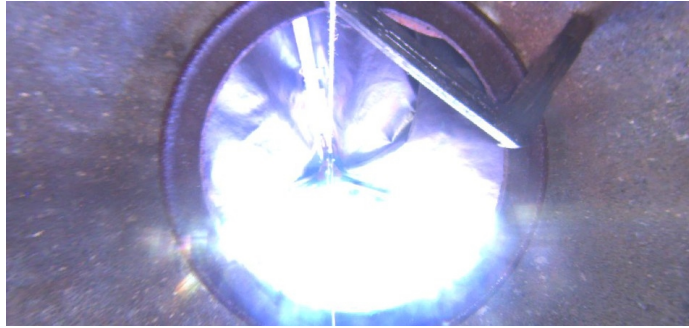
Code: **MGP**
Description: **General Photo**

Distance (ft): **2.2**
Structural Grade: **0**
O&M Grade: **0**
Clock Start/From:
Clock To:
1st Value:
2nd Value:
Value Percent:
Step: **NO**
Remarks:

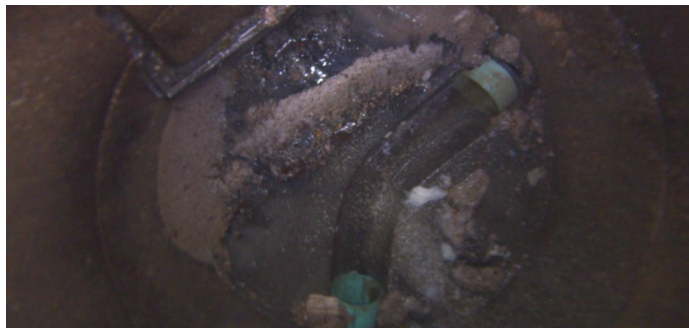
Code: **DAZ**
Description: **Deposits Attached Other**

Distance (ft): **4.8**
Structural Grade: **0**
O&M Grade: **2**
Clock Start/From: **12**
Clock To: **12**
1st Value:
2nd Value:
Value Percent: **10.000**
Step: **NO**
Remarks: **Mixed materials**

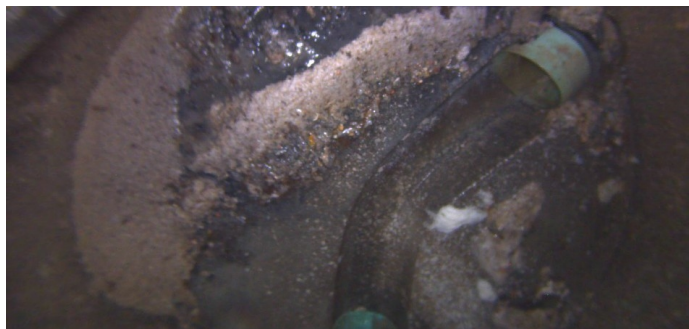
Code: **MGO**
Description: **General Observation**

Distance (ft): **5.7**
Structural Grade: **0**
O&M Grade: **0**
Clock Start/From:
Clock To:
1st Value:
2nd Value:
Value Percent:
Step: **NO**
Remarks: **Ins. Comp.**
