Manhole Inspection Report

Date:	04/19/2018	Weather:		Coding:	RZMACP
MH#:	M-708-023	Owner:	NA	Len. Surveyed:	10.3
P.O.#:		Surveyor:	Jen Costello	Rim to Invert:	11.1
Customer:		Cert. #:	U-907-5518	Wall Material:	Concrete (reinforced)

Street:	14th St. and Hwy 51. To the Southe	Project:	Hobart, IN
City:	Hobart, IN	GPS Northing:	2904706.018
Location:		GPS Easting:	2904706.018
Drain Area:	Southwest	GPS Accuracy:	Sub-Meter
Cover Shape:	Circular	Evidence of Surcharge:	No
Cover Size:	22.5	Potential for Runoff:	None
Comments:

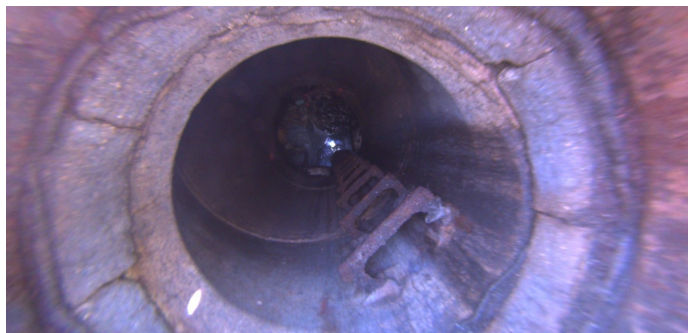
Code: **MGO**
Description: **General Observation**

Distance (ft): **.0**
Structural Grade: **0**
O&M Grade: **0**
Clock Start/From:
Clock To:
1st Value:
2nd Value:
Value Percent:
Step: **NO**
Remarks: **ACCESS MH**

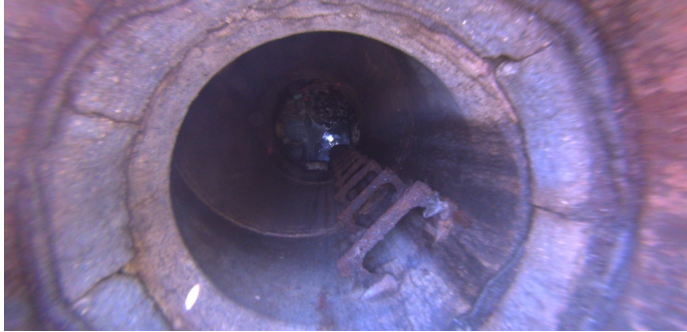
Code: **FM**
Description: **Fracture Multiple**

Distance (ft): **.0**
Structural Grade: **4**
O&M Grade: **0**
Clock Start/From: **12**
Clock To: **12**
1st Value:
2nd Value:
Value Percent:
Step: **NO**
Remarks:

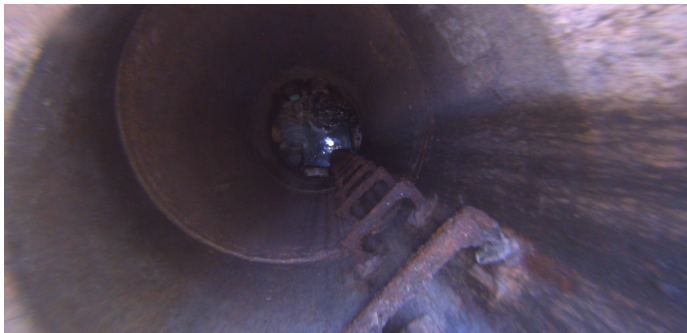
Code: **IW**
Description: **Infil Weeper**

Distance (ft): **.8**
Structural Grade: **0**
O&M Grade: **2**
Clock Start/From: **3**
Clock To: **5**
1st Value:
2nd Value:
Value Percent:
Step: **NO**
Remarks:

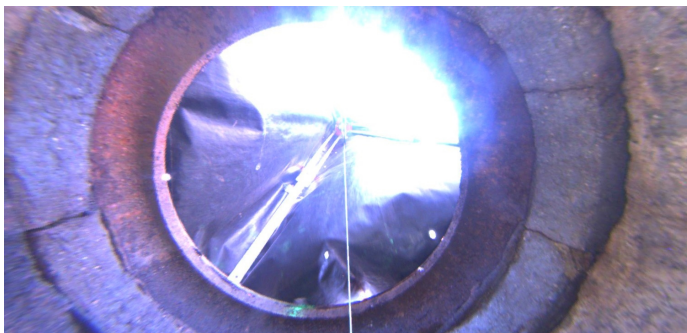
Code: **MGO**
Description: **General Observation**

Distance (ft): **1.7**
Structural Grade: **0**
O&M Grade: **0**
Clock Start/From:
Clock To:
1st Value:
2nd Value:
Value Percent:
Step: **NO**
Remarks: **UNDERSIDE OF FRAME**

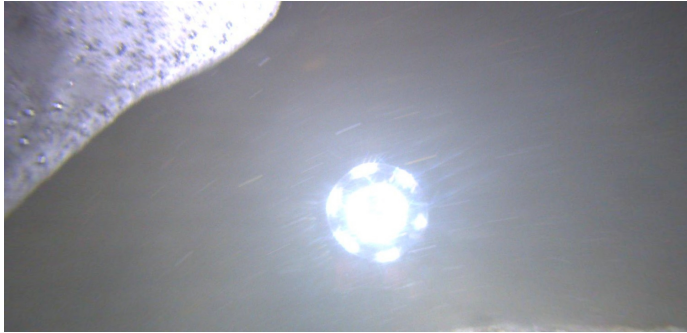
Code:	MGO
Description:	General Observation
Distance (ft):	10.3
Structural Grade:	0
O&M Grade:	0
Clock Start/From:	
Clock To:	
1st Value:	
2nd Value:	
Value Percent:	
Step:	NO
Remarks:	END SURVEY
