Manhole Inspection Report

Date:	04/22/2018	Weather:		Coding:	RZMACP
MH#:	M-708-024	Owner:	NA	Len. Surveyed:	9.8
P.O.#:		Surveyor:	John Kuglmaier	Rim to Invert:	10.7
Customer:	8.7	Cert. #:	U-1215-07002349	Wall Material:	Concrete (reinforced)

Street:	137' South of 14th St. and Hwy 51.	Project:	Hobart, IN
City:	Hobart, IN	GPS Northing:	0.0
Location:		GPS Easting:	0.0
Drain Area:	Southwest	GPS Accuracy:	Nearest Meter
Cover Shape:	Circular	Evidence of Surcharge:	Yes
Cover Size:	26.0	Potential for Runoff:	None
Comments:

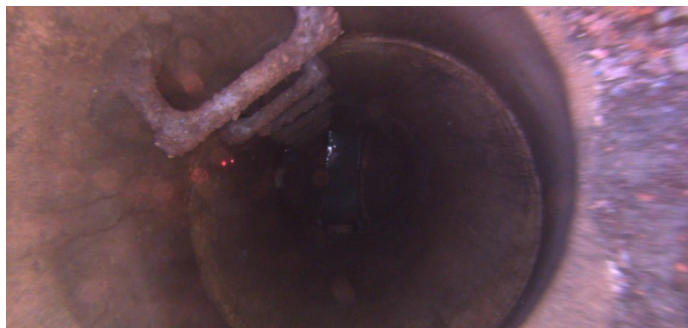
Code: **MGP**
 Description: **General Photo**

Distance (ft): **.0**
 Structural Grade: **0**
 O&M Grade: **0**
 Clock Start/From:
 Clock To:
 1st Value:
 2nd Value:
 Value Percent:
 Step: **NO**
 Remarks:

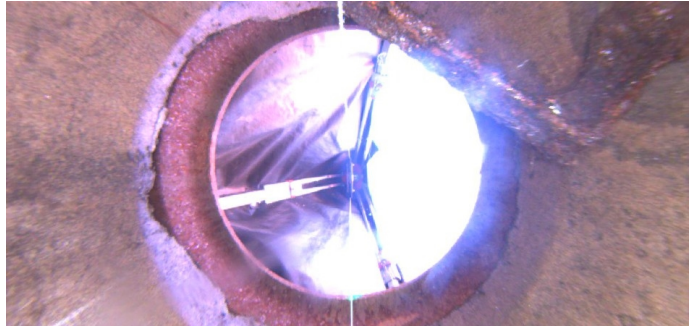
Code: **MGP**
Description: **General Photo**

Distance (ft): **2.9**
Structural Grade: **0**
O&M Grade: **0**
Clock Start/From:
Clock To:
1st Value:
2nd Value:
Value Percent:
Step: **NO**
Remarks:

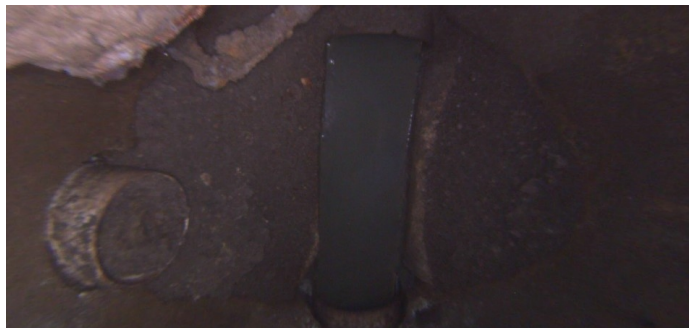
Code: **DSF**
Description: **Deposits Settled Fine**

Distance (ft): **7.0**
Structural Grade: **0**
O&M Grade: **3**
Clock Start/From: **12**
Clock To: **12**
1st Value:
2nd Value:
Value Percent: **15.000**
Step: **NO**
Remarks:

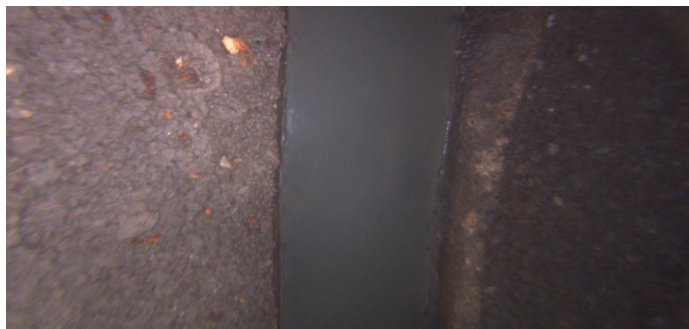
Code: **MGO**
Description: **General Observation**

Distance (ft): **8.9**
Structural Grade: **0**
O&M Grade: **0**
Clock Start/From:
Clock To:
1st Value:
2nd Value:
Value Percent:
Step: **NO**
Remarks: **Ins. Comp.**
