Manhole Inspection Report

Date:	04/20/2018	Weather:		Coding:	RZMACP
MH#:	M-708-026	Owner:	NA	Len. Surveyed:	1.9
P.O.#:		Surveyor:	Jen Costello	Rim to Invert:	6.2
Customer:		Cert. #:	U-907-5518	Wall Material:	Concrete (reinforced)

Street:	438' North of Bracken Pky. 92' East	Project:	Hobart, IN
City:	Hobart, IN	GPS Northing:	2904758.755
Location:		GPS Easting:	2904758.755
Drain Area:	Southwest	GPS Accuracy:	Sub-Meter
Cover Shape:	Circular	Evidence of Surcharge:	No
Cover Size:	22.5	Potential for Runoff:	None
Comments:

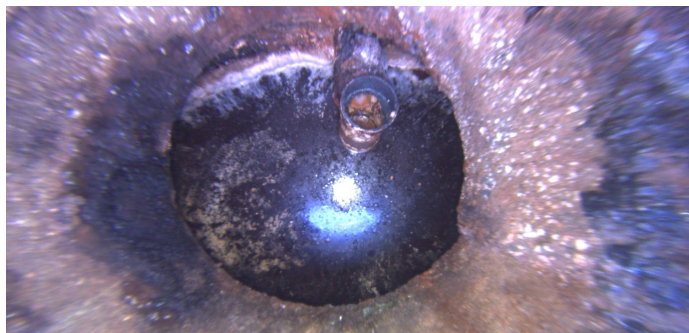
Code: **MGO**
Description: **General Observation**

Distance (ft): **.0**
Structural Grade: **0**
O&M Grade: **0**
Clock Start/From:
Clock To:
1st Value:
2nd Value:
Value Percent:
Step: **NO**
Remarks: **access mh**

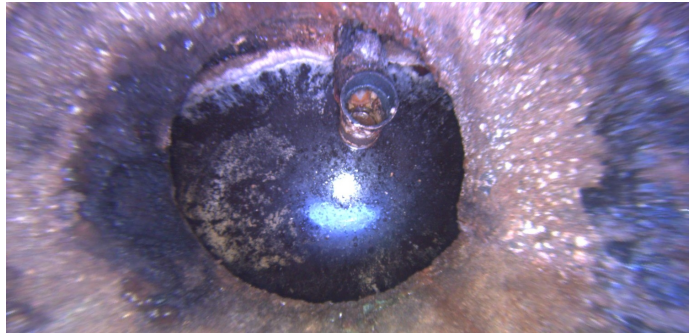
Code: **SAP**
Description: **Surface Aggregate Projecting**

Distance (ft): **.0**
Structural Grade: **3**
O&M Grade: **0**
Clock Start/From: **12**
Clock To: **12**
1st Value:
2nd Value:
Value Percent:
Step: **NO**
Remarks:

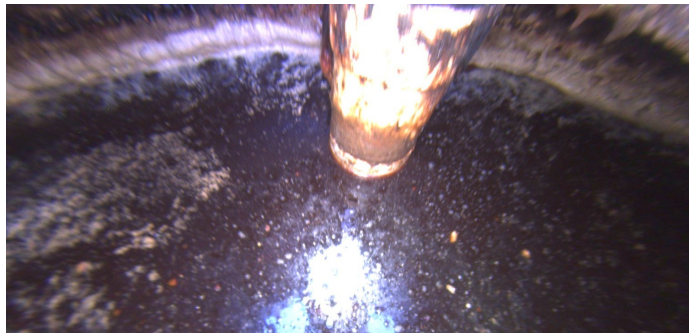
Code: **OBP**
Description: **Obstacle External Pipe or Cable**

Distance (ft): **1.2**
Structural Grade: **0**
O&M Grade: **2**
Clock Start/From: **12**
Clock To:
1st Value:
2nd Value:
Value Percent: **10.000**
Step: **NO**
Remarks:

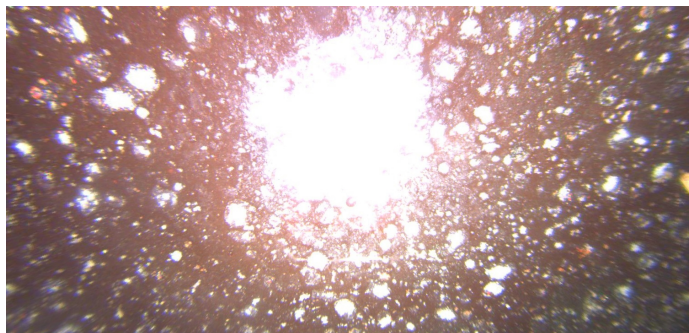
Code: **MSA**
Description: **Abandoned Survey**

Distance (ft): **1.9**
Structural Grade: **0**
O&M Grade: **0**
Clock Start/From:
Clock To:
1st Value:
2nd Value:
Value Percent:
Step: **NO**
Remarks: **bench is submerged**
