Manhole Inspection Report

Date:	04/20/2018	Weather:		Coding:	RZMACP
MH#:	M-708-027	Owner:	NA	Len. Surveyed:	1.9
P.O.#:		Surveyor:	John Kuglmaier	Rim to Invert:	5.9
Customer:		Cert. #:	U-1215-07002349	Wall Material:	Concrete (reinforced)

Street:	438' North of Bracken Pky. 87' East	Project:	Hobart, IN
City:	Hobart, IN	GPS Northing:	2904755.251
Location:		GPS Easting:	2904755.251
Drain Area:	Southwest	GPS Accuracy:	Sub-Meter
Cover Shape:	Circular	Evidence of Surcharge:	Yes
Cover Size:	22.5	Potential for Runoff:	None
Comments:

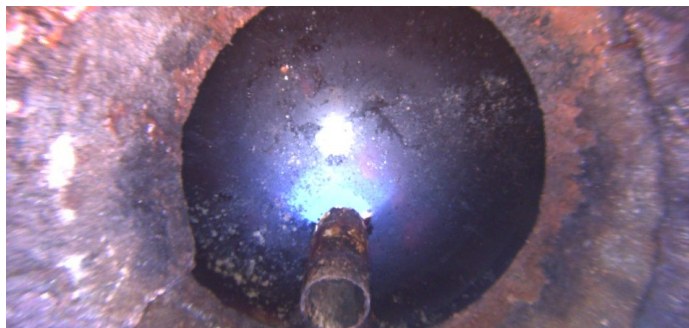
Code: **MGP**
Description: **General Photo**

Distance (ft): **.0**
Structural Grade: **0**
O&M Grade: **0**
Clock Start/From:
Clock To:
1st Value:
2nd Value:
Value Percent:
Step: **NO**
Remarks:

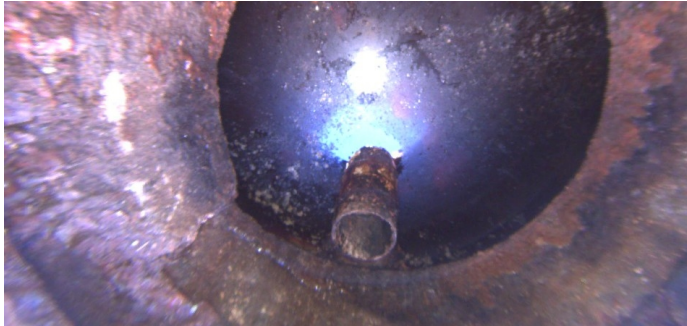
Code: **FL**
Description: **Fracture Longitudinal**

Distance (ft): **.0**
Structural Grade: **3**
O&M Grade: **0**
Clock Start/From: **8**
Clock To:
1st Value:
2nd Value:
Value Percent:
Step: **NO**
Remarks:

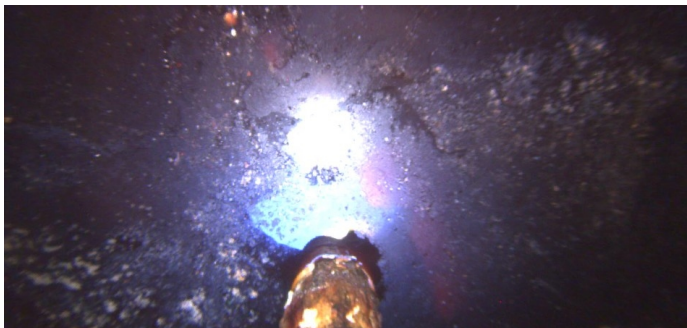
Code: **MGO**
Description: **General Observation**

Distance (ft): **.9**
Structural Grade: **0**
O&M Grade: **0**
Clock Start/From:
Clock To:
1st Value:
2nd Value:
Value Percent:
Step: **NO**
Remarks: **Surcharge**

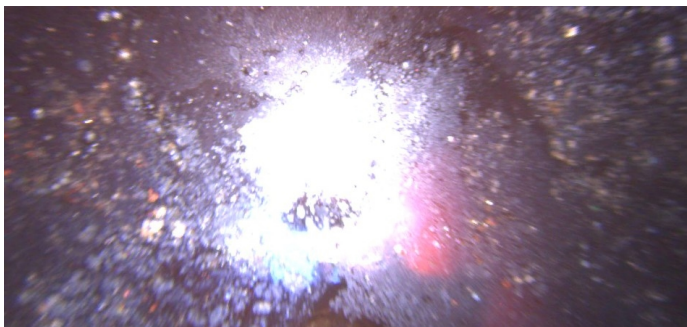
Code: **MSA**
Description: **Abandoned Survey**

Distance (ft): **1.6**
Structural Grade: **0**
O&M Grade: **0**
Clock Start/From:
Clock To:
1st Value:
2nd Value:
Value Percent:
Step: **NO**
Remarks: **Surcharge**
