Manhole Inspection Report

Date:	04/19/2018	Weather:		Coding:	RZMACP
MH#:	M-708-028	Owner:	NA	Len. Surveyed:	4.7
P.O.#:		Surveyor:	John Kuglmaier	Rim to Invert:	5.3
Customer:		Cert. #:	U-1215-07002349	Wall Material:	Concrete (reinforced)

Street:	203' North of Bracken Pky. 460' East	Project:	Hobart, IN
City:	Hobart, IN	GPS Northing:	2905124.784
Location:		GPS Easting:	2905124.784
Drain Area:	Southwest	GPS Accuracy:	Sub-Meter
Cover Shape:	Circular	Evidence of Surcharge:	No
Cover Size:	22.5	Potential for Runoff:	None
Comments:

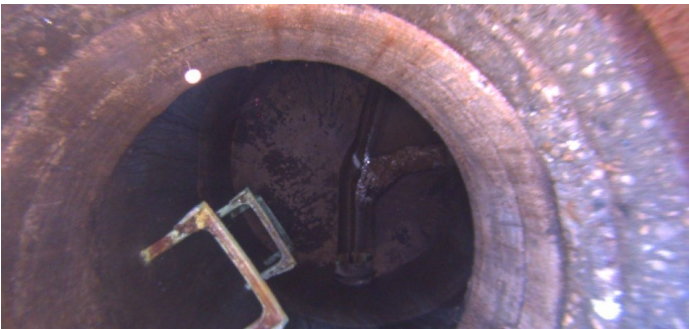
Code: **MGP**
 Description: **General Photo**

Distance (ft): **.0**
 Structural Grade: **0**
 O&M Grade: **0**
 Clock Start/From:
 Clock To:
 1st Value:
 2nd Value:
 Value Percent:
 Step: **NO**
 Remarks:

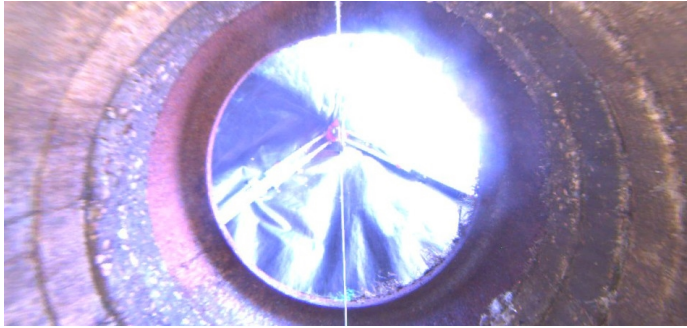
Code: **MGP**
Description: **General Photo**

Distance (ft): **2.2**
Structural Grade: **0**
O&M Grade: **0**
Clock Start/From:
Clock To:
1st Value:
2nd Value:
Value Percent:
Step: **NO**
Remarks:

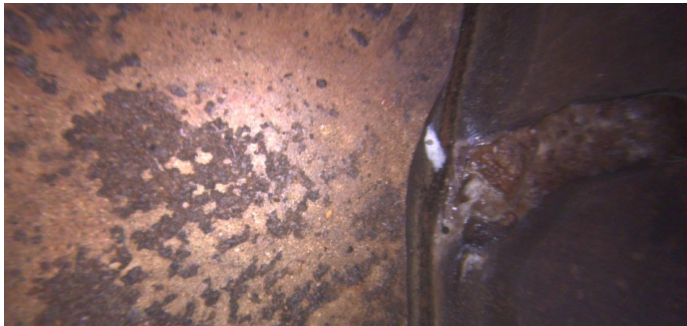
Code: **MGO**
Description: **General Observation**

Distance (ft): **3.9**
Structural Grade: **0**
O&M Grade: **0**
Clock Start/From:
Clock To:
1st Value:
2nd Value:
Value Percent:
Step: **NO**
Remarks: **Ins. Comp.**
