Manhole Inspection Report

Date:	04/19/2018	Weather:		Coding:	RZMACP
MH#:	M-708-102	Owner:	NA	Len. Surveyed:	8.7
P.O.#:		Surveyor:	Jen Costello	Rim to Invert:	9.9
Customer:		Cert. #:	U-907-5518	Wall Material:	Concrete (reinforced)

Street:	Bracken Parkway. 313' East of Lake	Project:	Hobart, IN
City:	Hobart, IN	GPS Northing:	2904984.703
Location:		GPS Easting:	2904984.703
Drain Area:	Southwest	GPS Accuracy:	Sub-Meter
Cover Shape:	Circular	Evidence of Surcharge:	No
Cover Size:	22.5	Potential for Runoff:	None
Comments:

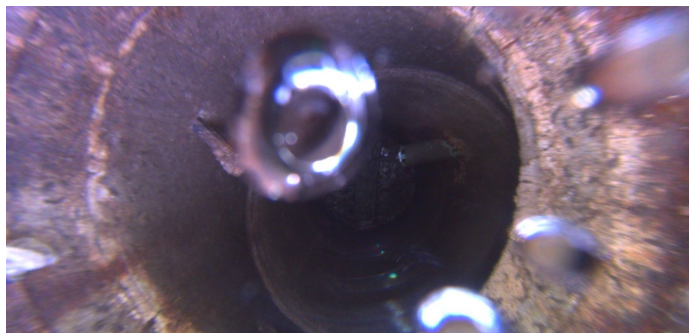
Code: **MGO**
Description: **General Observation**

Distance (ft): **.0**
Structural Grade: **0**
O&M Grade: **0**
Clock Start/From:
Clock To:
1st Value:
2nd Value:
Value Percent:
Step: **NO**
Remarks: **ACCESS MH**

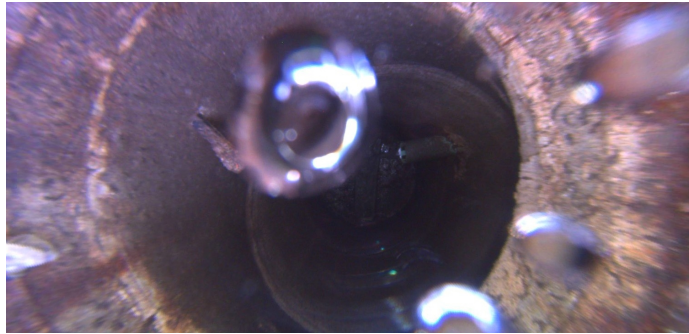
Code: **SAV**
Description: **Surface Aggregate Visible**

Distance (ft): **.0**
Structural Grade: **3**
O&M Grade: **0**
Clock Start/From: **12**
Clock To: **12**
1st Value:
2nd Value:
Value Percent:
Step: **NO**
Remarks:

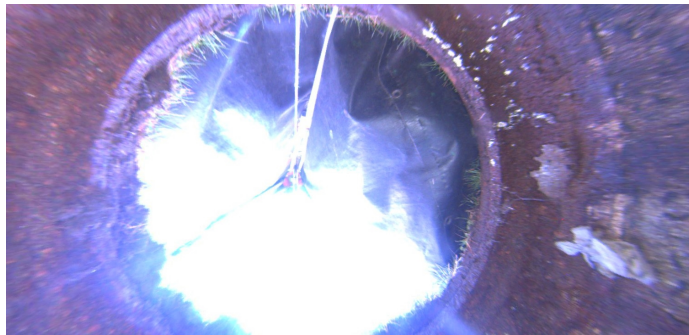
Code: **MGO**
Description: **General Observation**

Distance (ft): **1.5**
Structural Grade: **0**
O&M Grade: **0**
Clock Start/From:
Clock To:
1st Value:
2nd Value:
Value Percent:
Step: **NO**
Remarks: **UNDERSIDE OF FRAME**

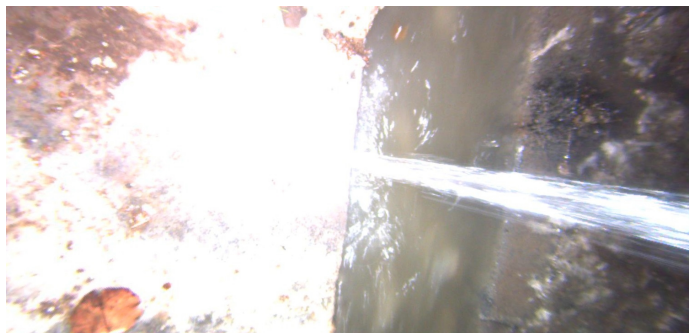
Code: **MGO**
Description: **General Observation**

Distance (ft): **8.7**
Structural Grade: **0**
O&M Grade: **0**
Clock Start/From:
Clock To:
1st Value:
2nd Value:
Value Percent:
Step: **NO**
Remarks: **END SURVEY**
