Manhole Inspection Report

| MH#: | M-708-104 | Owner: | NA | Len. Surveyed: | 8.7 |

| Street: | Bracken Parkway. 144' Northwest of | Project: | Hobart, IN |

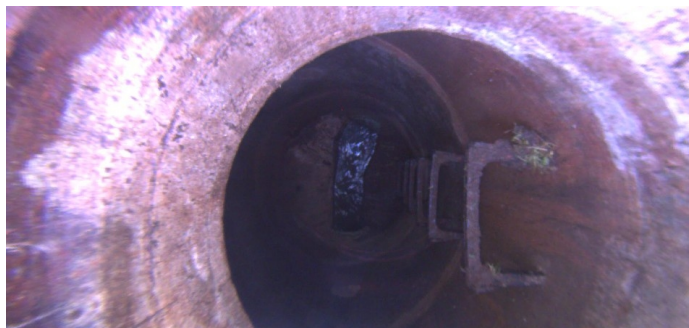
Code: **MGP**
Description: **General Photo**

Distance (ft): **.0**
Structural Grade: **0**
O&M Grade: **0**
Clock Start/From:
Clock To:
1st Value:
2nd Value:
Value Percent:
Step: **NO**
Remarks:

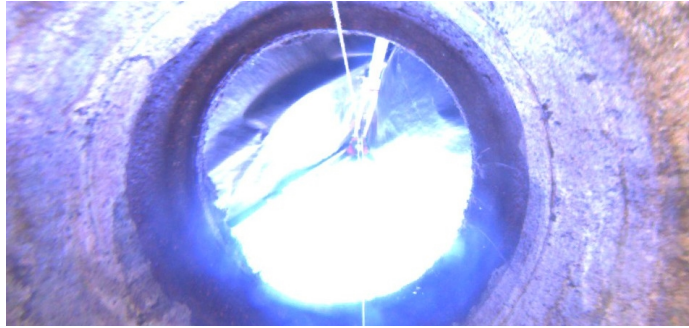
Code: **MGP**
Description: **General Photo**

Distance (ft): **2.3**
Structural Grade: **0**
O&M Grade: **0**
Clock Start/From:
Clock To:
1st Value:
2nd Value:
Value Percent:
Step: **NO**
Remarks:

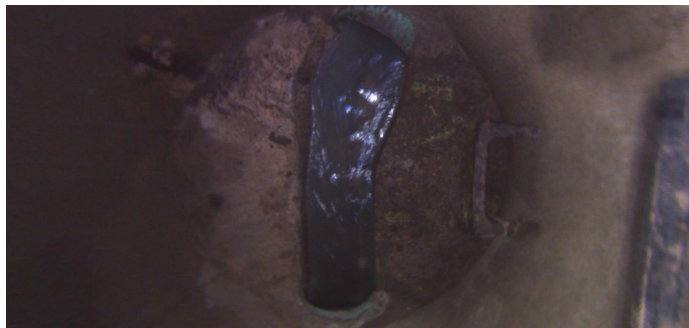
Code: **DSF**
Description: **Deposits Settled Fine**

Distance (ft): **5.6**
Structural Grade: **0**
O&M Grade: **2**
Clock Start/From: **1**
Clock To: **6**
1st Value:
2nd Value:
Value Percent: **5.000**
Step: **NO**
Remarks:

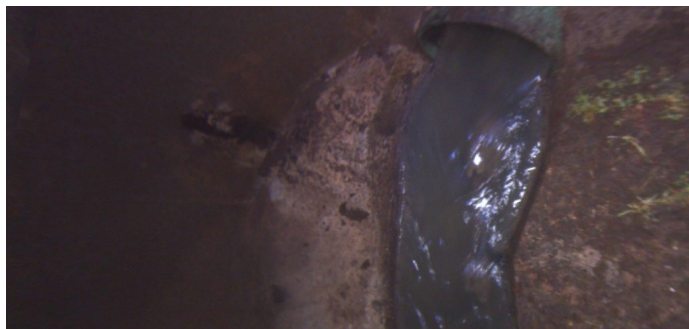
Code: **IS**
Description: **Infil Stain**

Distance (ft): **6.9**
Structural Grade: **0**
O&M Grade: **0**
Clock Start/From: **10**
Clock To:
1st Value:
2nd Value:
Value Percent:
Step: **NO**
Remarks:

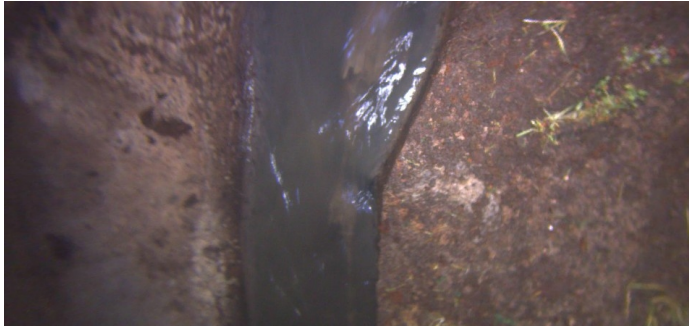
| Code: | MGO |
| Description: | General Observation |
| Distance (ft): | 7.7 |
| Remarks: | Ins. Comp. |
