Manhole Inspection Report

Date:	04/19/2018	Weather:		Coding:	RZMACP
MH#:	M-708-105	Owner:	NA	Len. Surveyed:	9.4
P.O.#:		Surveyor:	John Kuglmaier	Rim to Invert:	9.7
Customer:		Cert. #:	U-1215-07002349	Wall Material:	Concrete (reinforced)

Street:	Bracken Parkway. and Lake St.	Project:	Hobart, IN
City:	Hobart, IN	GPS Northing:	2905606.02
Location:		GPS Easting:	2905606.02
Drain Area:	Southwest	GPS Accuracy:	Sub-Meter
Cover Shape:	Circular	Evidence of Surcharge:	No
Cover Size:	22.5	Potential for Runoff:	None
Comments:

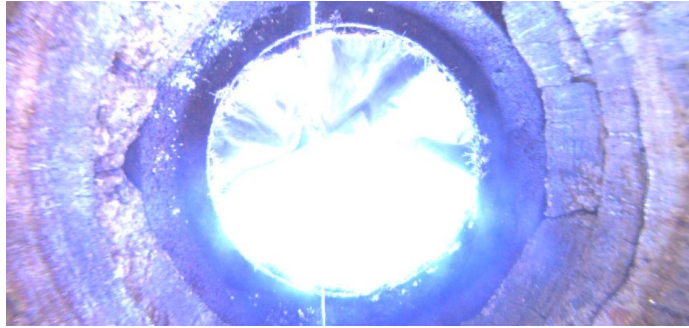
Code: **MGP**
Description: **General Photo**

Distance (ft): **2.5**
Structural Grade: **0**
O&M Grade: **0**
Clock Start/From:
Clock To:
1st Value:
2nd Value:
Value Percent:
Step: **NO**
Remarks:

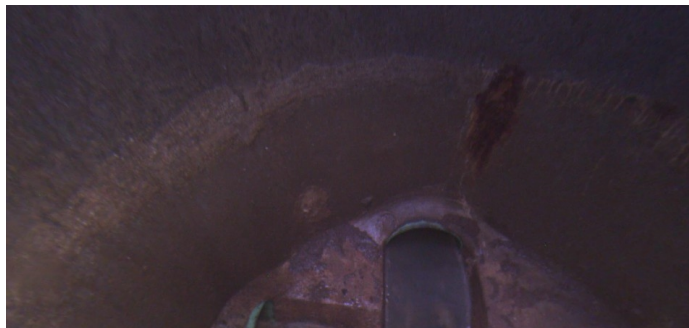
Code: **IS**
Description: **Infil Stain**

Distance (ft): **6.3**
Structural Grade: **0**
O&M Grade: **0**
Clock Start/From: **1**
Clock To:
1st Value:
2nd Value:
Value Percent:
Step: **NO**
Remarks:

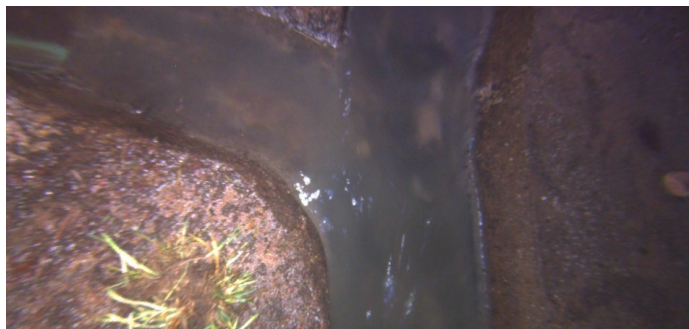
Code: **MGO**
Description: **General Observation**

Distance (ft): **8.4**
Structural Grade: **0**
O&M Grade: **0**
Clock Start/From:
Clock To:
1st Value:
2nd Value:
Value Percent:
Step: **NO**
Remarks: **Ins. Comp.**
