Manhole Inspection Report

Date:	11/07/2022	Weather:		Coding:	RZMACP
MH#:	M-708-107	Owner:	NA	Len. Surveyed:	6.8
P.O.#:		Surveyor:	Jen Costello	Rim to Invert:	7.8
Customer:		Cert. #:	U-907-5518	Wall Material:	Concrete (non-reinforced)

Street:	Bracken Parkway. 196' South of Tam	Project:	Missing GPS
City:	Hobart, IN	GPS Northing:	2280853.545
Location:		GPS Easting:	2905871.18
Drain Area:	Southwest	GPS Accuracy:	Sub-Meter
Cover Shape:	Circular	Evidence of Surcharge:	No
Cover Size:	24.0	Potential for Runoff:	None
Comments:

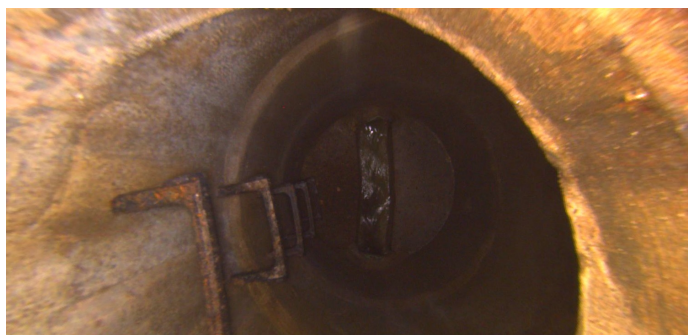
Code: **MGO**
Description: **General Observation**

Distance (ft): **.0**
Structural Grade: **0**
O&M Grade: **0**
Clock Start/From:
Clock To:
1st Value:
2nd Value:
Value Percent:
Step: **NO**
Remarks: **access mh**

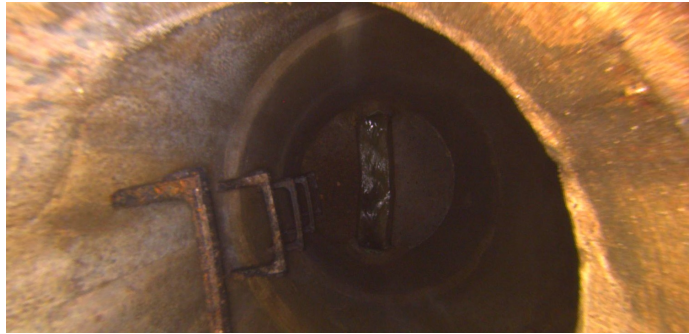
Code: **SRI**
Description: **Surface Roughness Increased**

Distance (ft): **.0**
Structural Grade: **1**
O&M Grade: **0**
Clock Start/From: **12**
Clock To: **12**
1st Value:
2nd Value:
Value Percent:
Step: **NO**
Remarks:

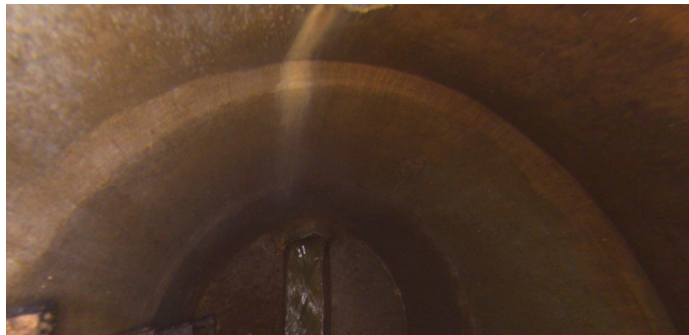
Code: **IW**
Description: **Infil Weeper**

Distance (ft): **1.3**
Structural Grade: **0**
O&M Grade: **2**
Clock Start/From: **12**
Clock To:
1st Value:
2nd Value:
Value Percent:
Step: **NO**
Remarks:

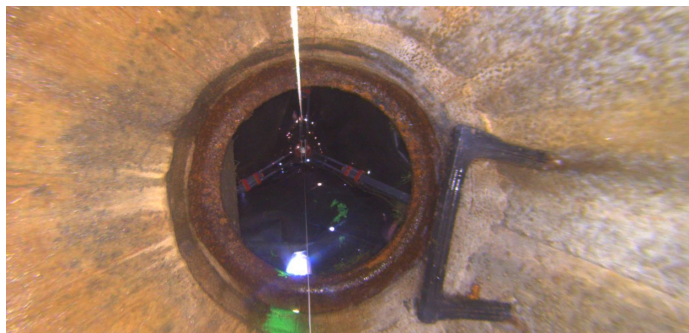
Code: **MGO**
Description: **General Observation**

Distance (ft): **2.8**
Structural Grade: **0**
O&M Grade: **0**
Clock Start/From:
Clock To:
1st Value:
2nd Value:
Value Percent:
Step: **NO**
Remarks: **underside of frame**

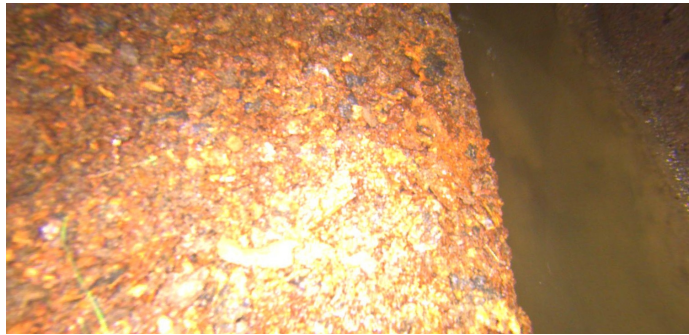
Code: **DSGV**
Description: **Deposits Settled Gravel**

Distance (ft): **6.8**
Structural Grade: **0**
O&M Grade: **2**
Clock Start/From: **12**
Clock To: **12**
1st Value:
2nd Value:
Value Percent: **5.000**
Step: **NO**
Remarks:

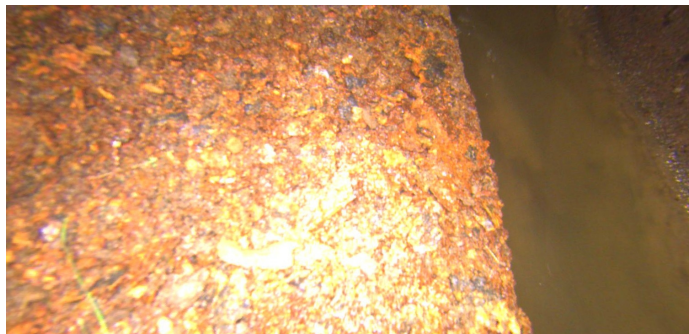
Code: **SRI**
Description: **Surface Roughness Increased**

Distance (ft): **6.8**
Structural Grade: **1**
O&M Grade: **0**
Clock Start/From: **12**
Clock To: **12**
1st Value:
2nd Value:
Value Percent:
Step: **NO**
Remarks:

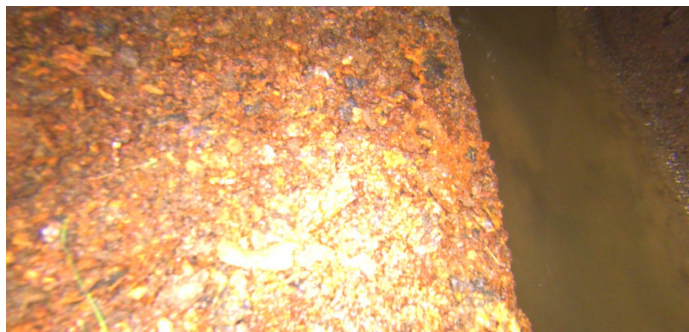
Code: **MGO**
Description: **General Observation**

Distance (ft): **6.8**
Structural Grade: **0**
O&M Grade: **0**
Clock Start/From:
Clock To:
1st Value:
2nd Value:
Value Percent:
Step: **NO**
Remarks: **end of survey**

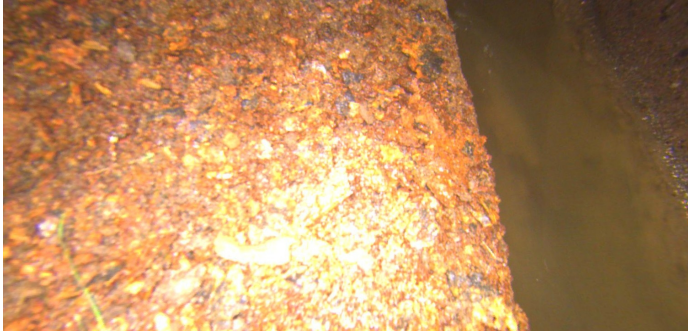
Code:	SAV
Description:	Surface Aggregate Visible
Distance (ft):	6.8
Structural Grade:	3
O&M Grade:	0
Clock Start/From:	3
Clock To:	9
1st Value:	
2nd Value:	
Value Percent:	
Step:	NO
Remarks:
