Manhole Inspection Report

Date:	11/07/2022	Weather:		Coding:	RZMACP
MH#:	M-708-108	Owner:	NA	Len. Surveyed:	6.8
P.O.#:		Surveyor:	Jen Costello	Rim to Invert:	8.1
Customer:		Cert. #:	U-907-5518	Wall Material:	Concrete (non-reinforced)

Street:	Bracken Parkway. 569' West of Linc	Project:	Missing GPS
City:	Hobart, IN	GPS Northing:	2280767.111
Location:		GPS Easting:	2905991.476
Drain Area:	Southwest	GPS Accuracy:	Sub-Meter
Cover Shape:	Circular	Evidence of Surcharge:	No
Cover Size:	24.0	Potential for Runoff:	None
Comments:

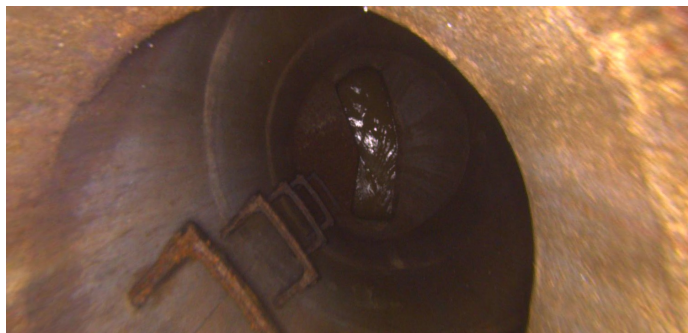
Code: **SRI**
Description: **Surface Roughness Increased**

Distance (ft): **.0**
Structural Grade: **1**
O&M Grade: **0**
Clock Start/From: **12**
Clock To: **12**
1st Value:
2nd Value:
Value Percent:
Step: **NO**
Remarks:

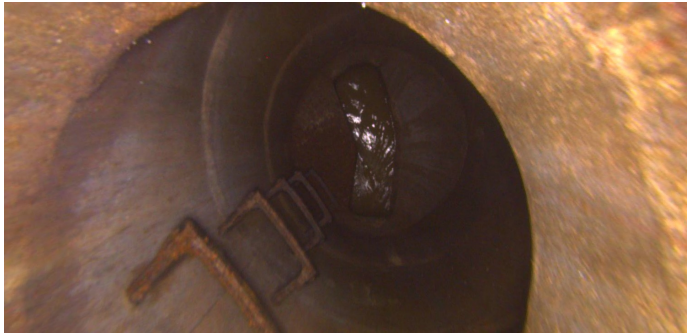
Code: **MGO**
Description: **General Observation**

Distance (ft): **.0**
Structural Grade: **0**
O&M Grade: **0**
Clock Start/From:
Clock To:
1st Value:
2nd Value:
Value Percent:
Step: **NO**
Remarks: **access mh**

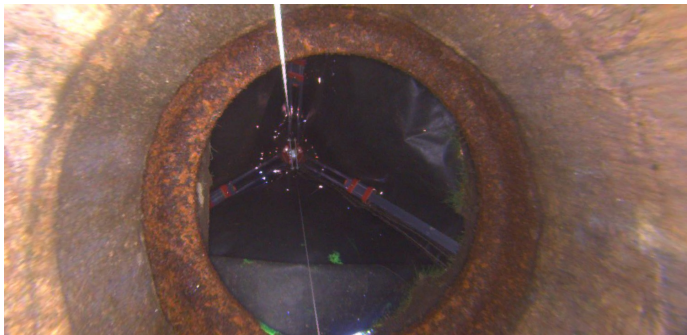
Code: **MGO**
Description: **General Observation**

Distance (ft): **2.3**
Structural Grade: **0**
O&M Grade: **0**
Clock Start/From:
Clock To:
1st Value:
2nd Value:
Value Percent:
Step: **NO**
Remarks: **underside of frame**

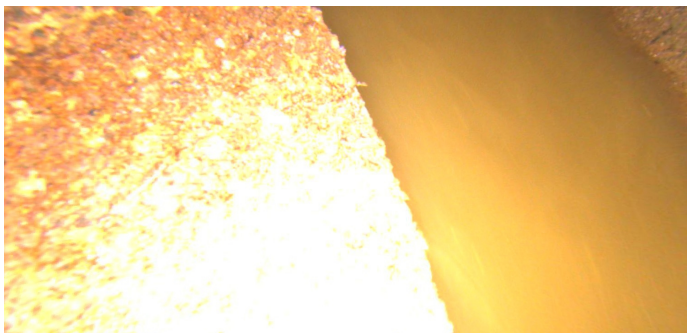
Code: **SRI**
Description: **Surface Roughness Increased**

Distance (ft): **6.8**
Structural Grade: **1**
O&M Grade: **0**
Clock Start/From: **3**
Clock To: **9**
1st Value:
2nd Value:
Value Percent:
Step: **NO**
Remarks:

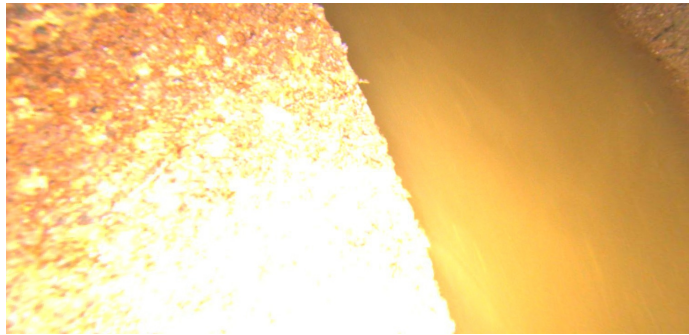
Code:	SAV
Description:	Surface Aggregate Visible
Distance (ft):	6.8
Structural Grade:	3
O&M Grade:	0
Clock Start/From:	12
Clock To:	12
1st Value:	
2nd Value:	
Value Percent:	
Step:	NO
Remarks:

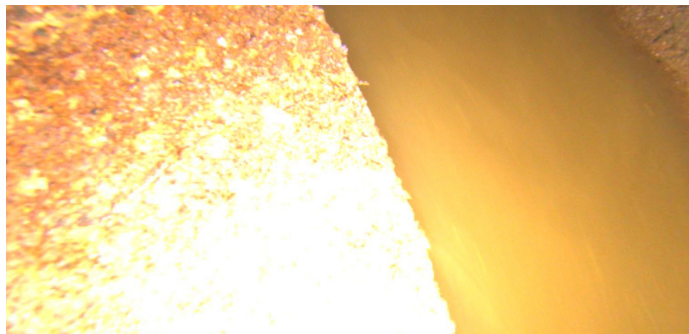
Code:	SRI
Description:	Surface Roughness Increased
Distance (ft):	6.8
Structural Grade:	1
O&M Grade:	0
Clock Start/From:	12
Clock To:	12
1st Value:	
2nd Value:	
Value Percent:	
Step:	NO
Remarks:

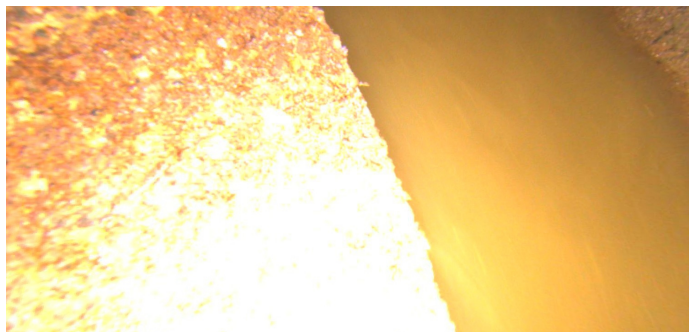
Code:	DSF
Description:	Deposits Settled Fine
Distance (ft):	6.8
Structural Grade:	0
O&M Grade:	2
Clock Start/From:	12
Clock To:	12
1st Value:	
2nd Value:	
Value Percent:	5.000
Step:	NO
Remarks:
