# Manhole Inspection Report

Date:	<b>04/10/2018</b>	Weather:		Coding:	<b>RZMACP</b>
MH#:	<b>M-708-111</b>	Owner:	<b>NA</b>	Len. Surveyed:	<b>7.9</b>
P.O.#:		Surveyor:	<b>John Kuglmaier</b>	Rim to Invert:	<b>8.2</b>
Customer:		Cert. #:	<b>U-1215-07002349</b>	Wall Material:	<b>Concrete (reinforced)</b>

Street:	<b>Intersection of Bracken Parkway. an</b>	Project:	<b>Hobart, IN</b>
City:	<b>Hobart, IN</b>	GPS Northing:	<b>2906564.338</b>
Location:		GPS Easting:	<b>2906564.338</b>
Drain Area:	<b>Southwest</b>	GPS Accuracy:	<b>Sub-Meter</b>
Cover Shape:	<b>Circular</b>	Evidence of Surcharge:	<b>No</b>
Cover Size:	<b>22.5</b>	Potential for Runoff:	<b>None</b>
Comments:

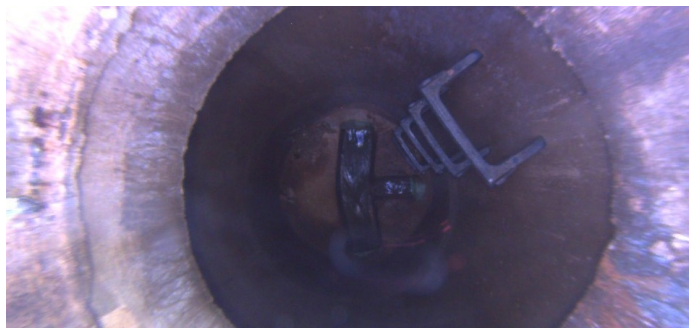
Code: **MGP**  
Description: **General Photo**

Distance (ft): **.0**  
Structural Grade: **0**  
O&M Grade: **0**  
Clock Start/From:  
Clock To:  
1st Value:  
2nd Value:  
Value Percent:  
Step: **NO**  
Remarks:

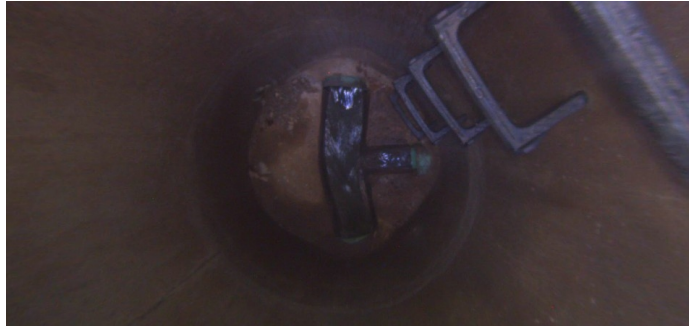
Code: **IS**  
Description: **Infil Stain**

Distance (ft): **1.8**  
Structural Grade: **0**  
O&M Grade: **0**  
Clock Start/From: **12**  
Clock To: **12**  
1st Value:  
2nd Value:  
Value Percent:  
Step: **NO**  
Remarks:

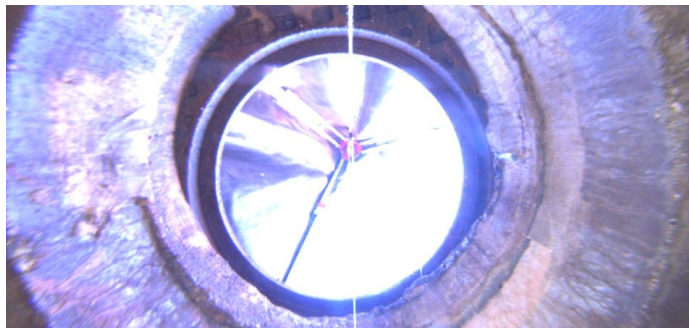
Code: **MGP**  
Description: **General Photo**

Distance (ft): **2.6**  
Structural Grade: **0**  
O&M Grade: **0**  
Clock Start/From:  
Clock To:  
1st Value:  
2nd Value:  
Value Percent:  
Step: **NO**  
Remarks:

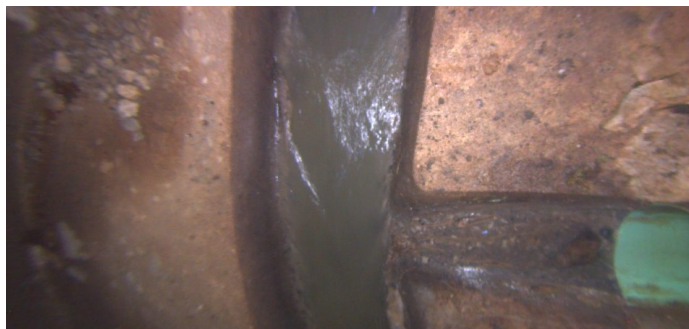
Code: **MGO**  
Description: **General Observation**

Distance (ft): **6.5**  
Structural Grade: **0**  
O&M Grade: **0**  
Clock Start/From:  
Clock To:  
1st Value:  
2nd Value:  
Value Percent:  
Step: **NO**  
Remarks: **Ins. Comp.**
