Manhole Inspection Report

Date:	04/10/2018	Weather:		Coding:	RZMACP
MH#:	M-708-112	Owner:	NA	Len. Surveyed:	7.0
P.O.#:		Surveyor:	John Kuglmaier	Rim to Invert:	8.0
Customer:		Cert. #:	U-1215-07002349	Wall Material:	Concrete (reinforced)

Street:	Bracken Parkway. 166' East of Lincol	Project:	Hobart, IN
City:	Hobart, IN	GPS Northing:	2906694.942
Location:		GPS Easting:	2906694.942
Drain Area:	Southwest	GPS Accuracy:	Sub-Meter
Cover Shape:	Circular	Evidence of Surcharge:	No
Cover Size:	22.5	Potential for Runoff:	None
Comments:

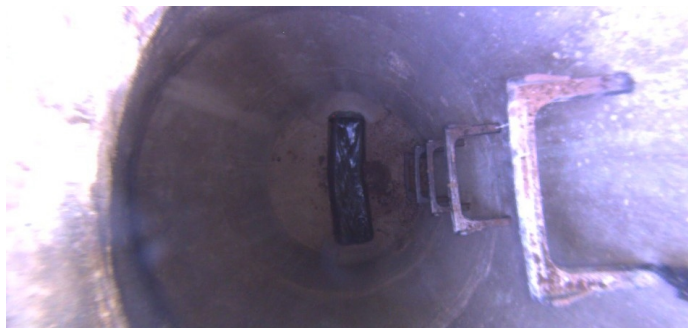
Code: **MGP**
Description: **General Photo**

Distance (ft): **.0**
Structural Grade: **0**
O&M Grade: **0**
Clock Start/From:
Clock To:
1st Value:
2nd Value:
Value Percent:
Step: **NO**
Remarks:

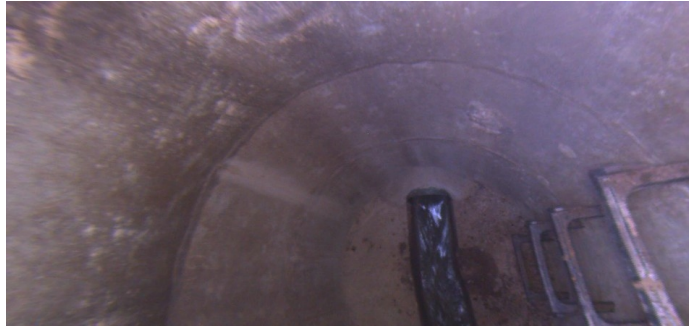
Code: **IS**
Description: **Infil Stain**

Distance (ft): **1.0**
Structural Grade: **0**
O&M Grade: **0**
Clock Start/From: **10**
Clock To:
1st Value:
2nd Value:
Value Percent:
Step: **NO**
Remarks:

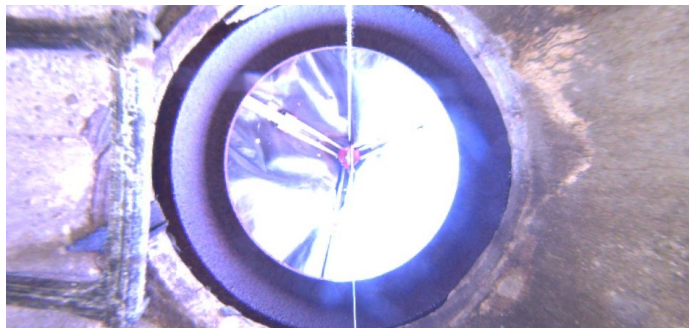
Code: **MGP**
Description: **General Photo**

Distance (ft): **2.5**
Structural Grade: **0**
O&M Grade: **0**
Clock Start/From:
Clock To:
1st Value:
2nd Value:
Value Percent:
Step: **NO**
Remarks:

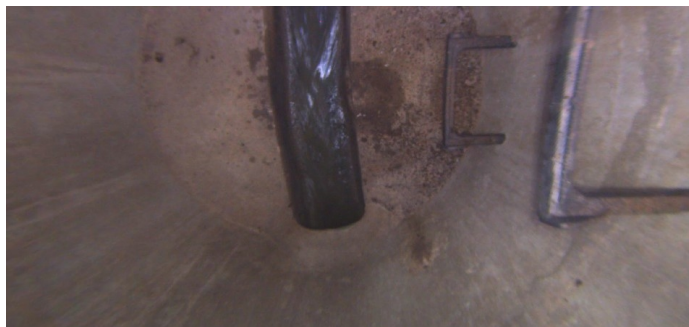
Code: **IS**
Description: **Infil Stain**

Distance (ft): **4.0**
Structural Grade: **0**
O&M Grade: **0**
Clock Start/From: **5**
Clock To:
1st Value:
2nd Value:
Value Percent:
Step: **NO**
Remarks:

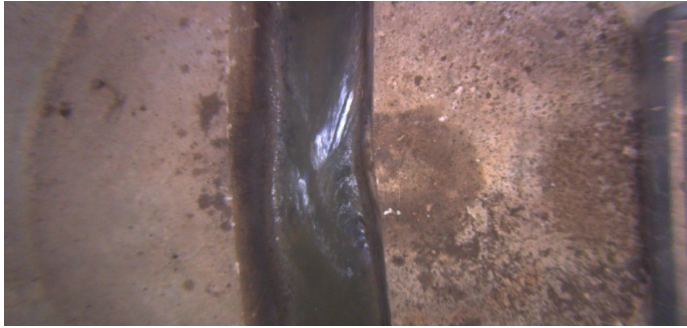
Code:	MGO
Description:	General Observation
Distance (ft):	5.8
Structural Grade:	0
O&M Grade:	0
Clock Start/From:	
Clock To:	
1st Value:	
2nd Value:	
Value Percent:	
Step:	NO
Remarks:	Ins. Comp.
