Manhole Inspection Report

Date:	04/10/2018	Weather:		Coding:	RZMACP
MH#:	M-708-113	Owner:	NA	Len. Surveyed:	6.5
P.O.#:		Surveyor:	John Kuglmaier	Rim to Invert:	7.1
Customer:		Cert. #:	U-1215-07002349	Wall Material:	Concrete (reinforced)

Street:	Bracken Parkway. Woodward Trail.	Project:	Hobart, IN
City:	Hobart, IN	GPS Northing:	2906833.41
Location:		GPS Easting:	2906833.41
Drain Area:	Southwest	GPS Accuracy:	Sub-Meter
Cover Shape:	Circular	Evidence of Surcharge:	Yes
Cover Size:	22.5	Potential for Runoff:	None
Comments:

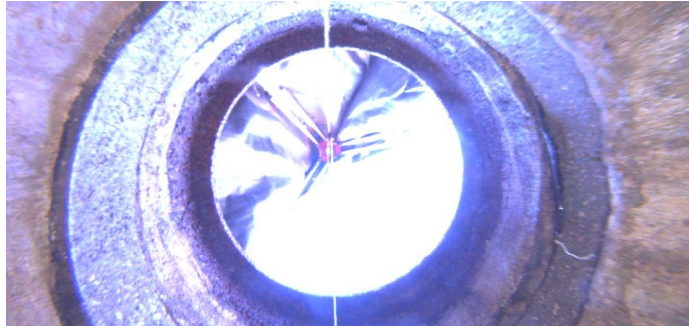
Code:	MGP
Description:	General Photo

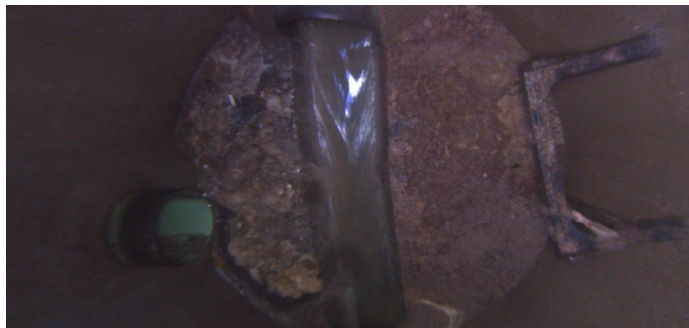
Code: **MGP**
Description: **General Photo**

Distance (ft): **2.6**
Structural Grade: **0**
O&M Grade: **0**
Clock Start/From:
Clock To:
1st Value:
2nd Value:
Value Percent:
Step: **NO**
Remarks:

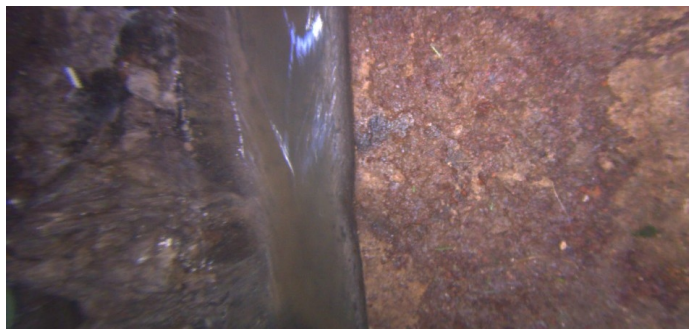
Code: **DAZ**
Description: **Deposits Attached Other**

Distance (ft): **4.0**
Structural Grade: **0**
O&M Grade: **2**
Clock Start/From: **12**
Clock To: **12**
1st Value:
2nd Value:
Value Percent: **10.000**
Step: **NO**
Remarks: **Mixed materials**
