Manhole Inspection Report

Date:	04/10/2018	Weather:		Coding:	RZMACP
MH#:	M-708-114	Owner:	NA	Len. Surveyed:	6.3
P.O.#:		Surveyor:	John Kuglmaier	Rim to Invert:	7.0
Customer:		Cert. #:	U-1215-07002349	Wall Material:	Concrete (reinforced)

Street:	Bracken Pky. 148' North of Capitol D	Project:	Hobart, IN
City:	Hobart, IN	GPS Northing:	2906942.61
Location:		GPS Easting:	2906942.61
Drain Area:	Southwest	GPS Accuracy:	Sub-Meter
Cover Shape:	Circular	Evidence of Surcharge:	No
Cover Size:	22.5	Potential for Runoff:	None
Comments:

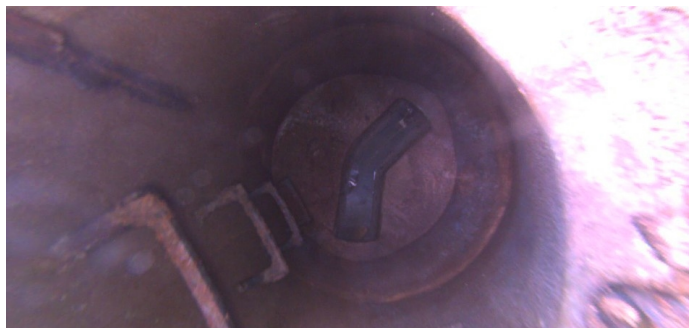
Code: **MGP**
Description: **General Photo**

Distance (ft): **.0**
Structural Grade: **0**
O&M Grade: **0**
Clock Start/From:
Clock To:
1st Value:
2nd Value:
Value Percent:
Step: **NO**
Remarks:

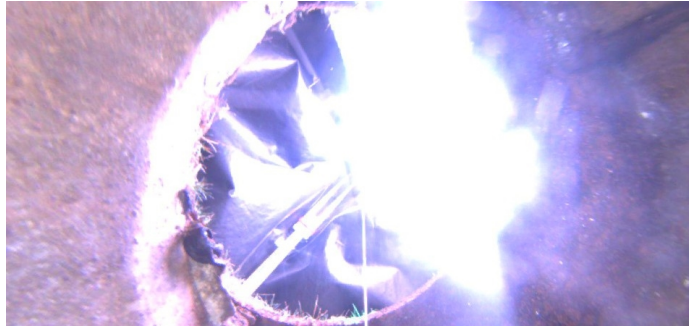
Code: **MGP**
Description: **General Photo**

Distance (ft): **2.1**
Structural Grade: **0**
O&M Grade: **0**
Clock Start/From:
Clock To:
1st Value:
2nd Value:
Value Percent:
Step: **NO**
Remarks:

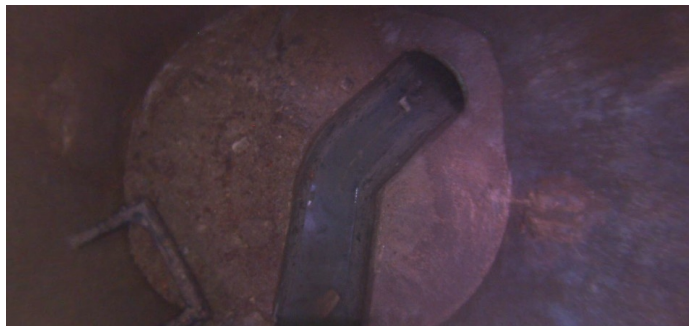
Code: **DSF**
Description: **Deposits Settled Fine**

Distance (ft): **3.3**
Structural Grade: **0**
O&M Grade: **2**
Clock Start/From: **6**
Clock To: **2**
1st Value:
2nd Value:
Value Percent: **5.000**
Step: **NO**
Remarks:

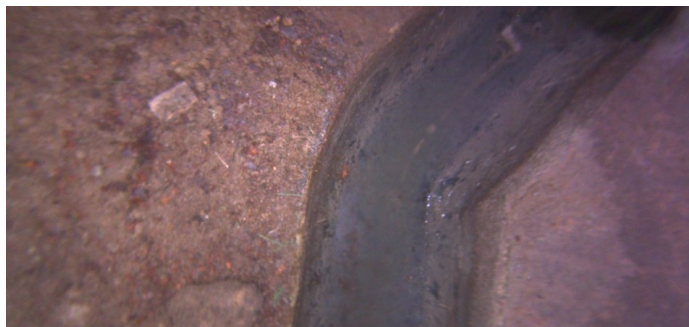
Code: **MGO**
Description: **General Observation**

Distance (ft): **5.2**
Structural Grade: **0**
O&M Grade: **0**
Clock Start/From:
Clock To:
1st Value:
2nd Value:
Value Percent:
Step: **NO**
Remarks: **Ins. Comp.**
