Manhole Inspection Report

Date:	04/10/2018	Weather:		Coding:	RZMACP
MH#:	M-708-115	Owner:	NA	Len. Surveyed:	3.6
P.O.#:		Surveyor:	John Kuglmaier	Rim to Invert:	7.2
Customer:		Cert. #:	U-1215-07002349	Wall Material:	Concrete (reinforced)

Street:	Bracken Pky. and Capitol Dr. Northw	Project:	Hobart, IN
City:	Hobart, IN	GPS Northing:	2906957.701
Location:		GPS Easting:	2906957.701
Drain Area:	Southwest	GPS Accuracy:	Sub-Meter
Cover Shape:	Circular	Evidence of Surcharge:	Yes
Cover Size:	22.5	Potential for Runoff:	None
Comments:

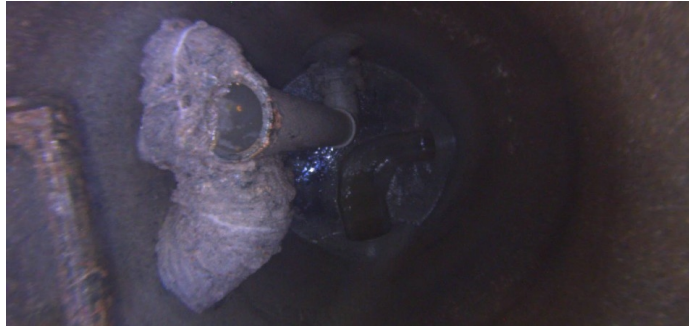
Code: **OBZ**
Description: **Obstacle Other**

Distance (ft): **.7**
Structural Grade: **0**
O&M Grade: **5**
Clock Start/From: **7**
Clock To: **10**
1st Value:
2nd Value:
Value Percent: **35.000**
Step: **YES**
Remarks: **Mixed materials**

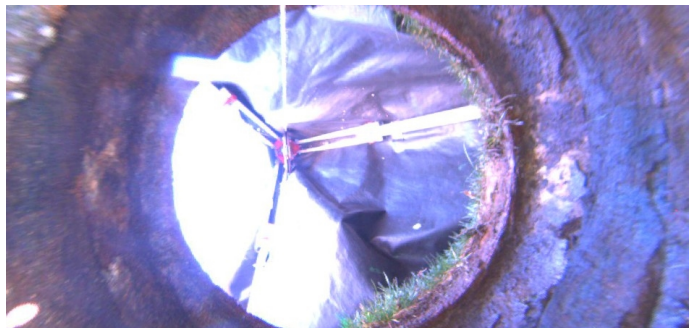
Code: **MGP**
Description: **General Photo**

Distance (ft): **1.9**
Structural Grade: **0**
O&M Grade: **0**
Clock Start/From:
Clock To:
1st Value:
2nd Value:
Value Percent:
Step: **NO**
Remarks:

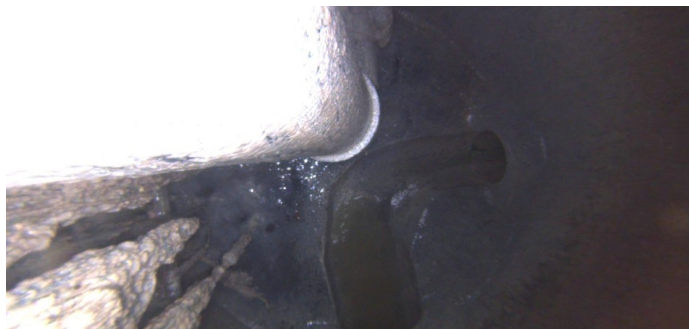
Code: **MGO**
Description: **General Observation**

Distance (ft): **3.6**
Structural Grade: **0**
O&M Grade: **0**
Clock Start/From:
Clock To:
1st Value:
2nd Value:
Value Percent:
Step: **NO**
Remarks: **Ins. Comp.**
