Manhole Inspection Report

Date:	04/10/2018	Weather:		Coding:	RZMACP
MH#:	M-708-120	Owner:	NA	Len. Surveyed:	6.9
P.O.#:		Surveyor:	John Kuglmaier	Rim to Invert:	7.5
Customer:		Cert. #:	U-1215-07002349	Wall Material:	Concrete (reinforced)

Street:	16th St. and Magnolia St.	Project:	Hobart, IN
City:	Hobart, IN	GPS Northing:	2905665.511
Location:		GPS Easting:	2905665.511
Drain Area:	Southwest	GPS Accuracy:	Sub-Meter
Cover Shape:	Circular	Evidence of Surcharge:	No
Cover Size:	22.5	Potential for Runoff:	None
Comments:

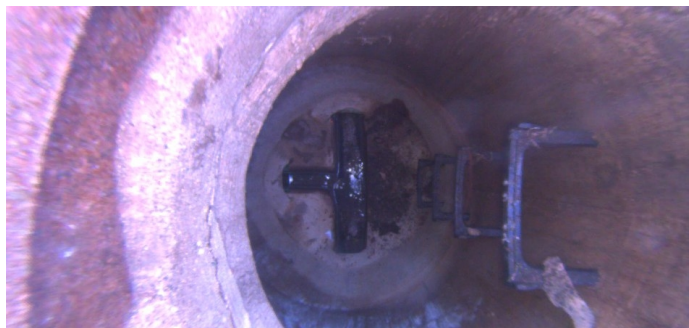
Code: **MGP**
Description: **General Photo**

Distance (ft): **.0**
Structural Grade: **0**
O&M Grade: **0**
Clock Start/From:
Clock To:
1st Value:
2nd Value:
Value Percent:
Step: **NO**
Remarks:

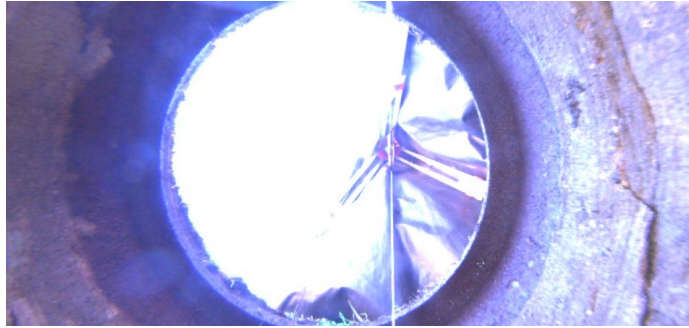
Code: **MGP**
Description: **General Photo**

Distance (ft): **1.9**
Structural Grade: **0**
O&M Grade: **0**
Clock Start/From:
Clock To:
1st Value:
2nd Value:
Value Percent:
Step: **NO**
Remarks:

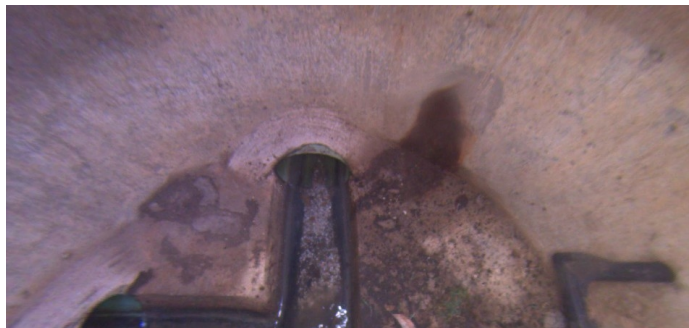
Code: **IS**
Description: **Infil Stain**

Distance (ft): **4.6**
Structural Grade: **0**
O&M Grade: **0**
Clock Start/From: **1**
Clock To:
1st Value:
2nd Value:
Value Percent:
Step: **NO**
Remarks:

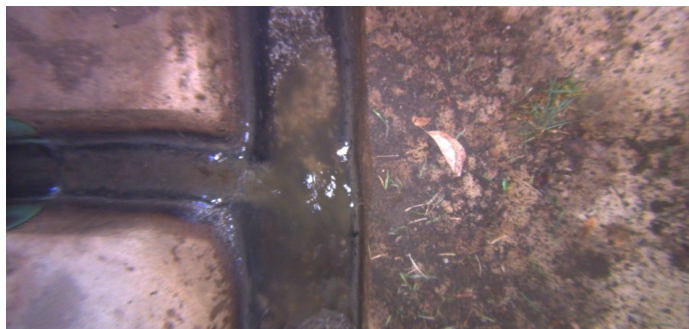
Code: **MGO**
Description: **General Observation**

Distance (ft): **5.8**
Structural Grade: **0**
O&M Grade: **0**
Clock Start/From:
Clock To:
1st Value:
2nd Value:
Value Percent:
Step: **NO**
Remarks: **Ins. Comp.**
