Manhole Inspection Report

Date:	04/10/2018	Weather:		Coding:	RZMACP
MH#:	M-708-123	Owner:	NA	Len. Surveyed:	6.6
P.O.#:		Surveyor:	John Kuglmaier	Rim to Invert:	7.9
Customer:		Cert. #:	U-1215-07002349	Wall Material:	Concrete (reinforced)

Street:	Intersection of Redbud Dr. and Tam	Project:	Hobart, IN
City:	Hobart, IN	GPS Northing:	2905154.198
Location:		GPS Easting:	2905154.198
Drain Area:	Southwest	GPS Accuracy:	Sub-Meter
Cover Shape:	Circular	Evidence of Surcharge:	No
Cover Size:	22.5	Potential for Runoff:	None
Comments:

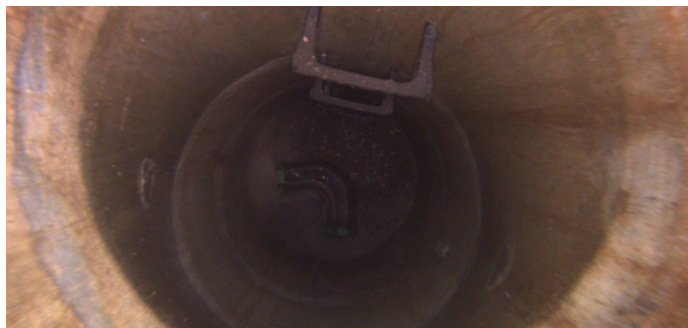
Code: **MGP**
Description: **General Photo**

Distance (ft): **.0**
Structural Grade: **0**
O&M Grade: **0**
Clock Start/From:
Clock To:
1st Value:
2nd Value:
Value Percent:
Step: **NO**
Remarks:

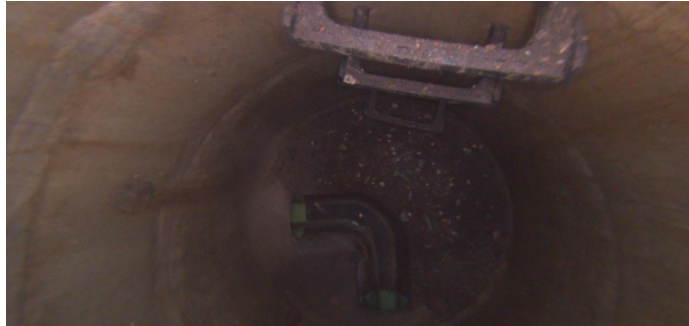
Code: **IS**
Description: **Infil Stain**

Distance (ft): **2.5**
Structural Grade: **0**
O&M Grade: **0**
Clock Start/From: **9**
Clock To:
1st Value:
2nd Value:
Value Percent:
Step: **NO**
Remarks:

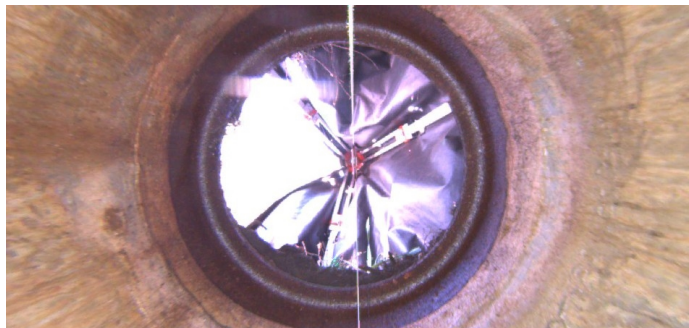
Code: **MGP**
Description: **General Photo**

Distance (ft): **2.7**
Structural Grade: **0**
O&M Grade: **0**
Clock Start/From:
Clock To:
1st Value:
2nd Value:
Value Percent:
Step: **NO**
Remarks:

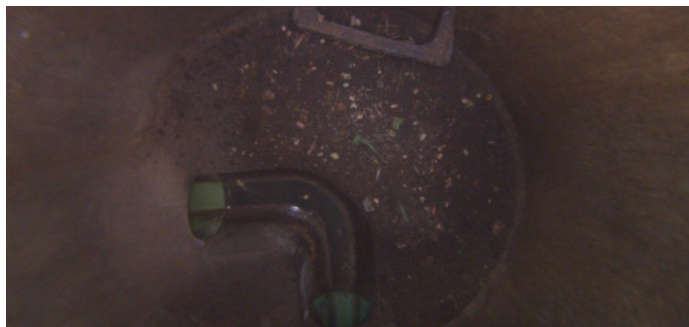
Code: **DSF**
Description: **Deposits Settled Fine**

Distance (ft): **4.4**
Structural Grade: **0**
O&M Grade: **2**
Clock Start/From: **12**
Clock To: **12**
1st Value:
2nd Value:
Value Percent: **5.000**
Step: **NO**
Remarks:

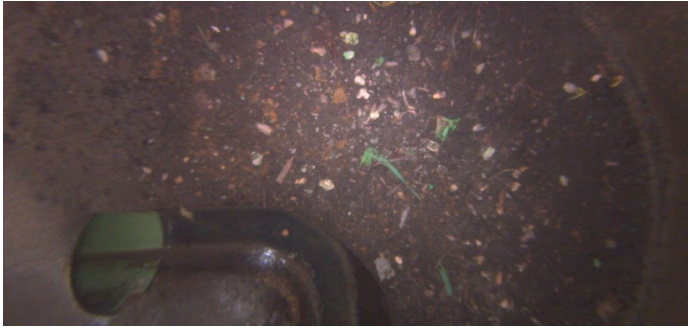
Code:	MGO
Description:	General Observation
Distance (ft):	5.7
Structural Grade:	0
O&M Grade:	0
Clock Start/From:	
Clock To:	
1st Value:	
2nd Value:	
Value Percent:	
Step:	NO
Remarks:	Ins. Comp.
