Manhole Inspection Report

Date:	04/10/2018	Weather:		Coding:	RZMACP
MH#:	M-708-124	Owner:	NA	Len. Surveyed:	5.2
P.O.#:		Surveyor:	John Kuglmaier	Rim to Invert:	6.2
Customer:		Cert. #:	U-1215-07002349	Wall Material:	Concrete (reinforced)

Street:	Redbud Dr. 72' North of Heather Ln.	Project:	Hobart, IN
City:	Hobart, IN	GPS Northing:	2905161.519
Location:		GPS Easting:	2905161.519
Drain Area:	Southwest	GPS Accuracy:	Sub-Meter
Cover Shape:	Circular	Evidence of Surcharge:	Yes
Cover Size:	22.5	Potential for Runoff:	None
Comments:

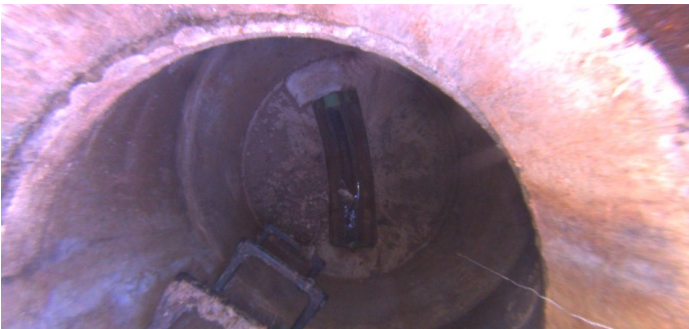
Code: **MGP**
Description: **General Photo**

Distance (ft): **.0**
Structural Grade: **0**
O&M Grade: **0**
Clock Start/From:
Clock To:
1st Value:
2nd Value:
Value Percent:
Step: **NO**
Remarks:

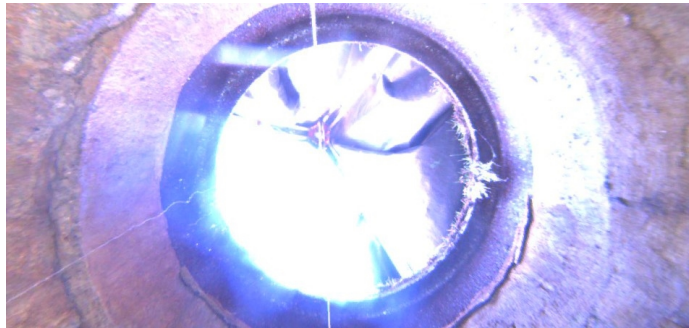
Code: **MGP**
Description: **General Photo**

Distance (ft): **2.3**
Structural Grade: **0**
O&M Grade: **0**
Clock Start/From:
Clock To:
1st Value:
2nd Value:
Value Percent:
Step: **NO**
Remarks:

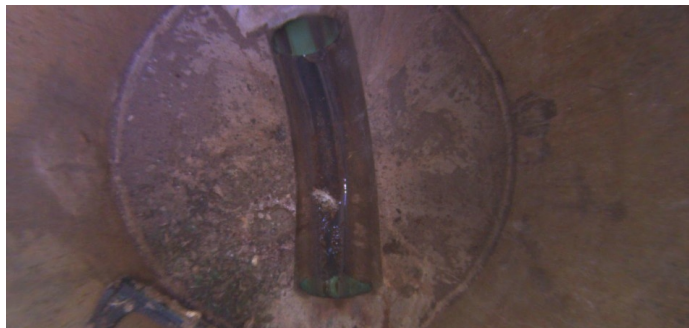
Code: **DSF**
Description: **Deposits Settled Fine**

Distance (ft): **2.6**
Structural Grade: **0**
O&M Grade: **2**
Clock Start/From: **6**
Clock To: **11**
1st Value:
2nd Value:
Value Percent: **5.000**
Step: **NO**
Remarks:

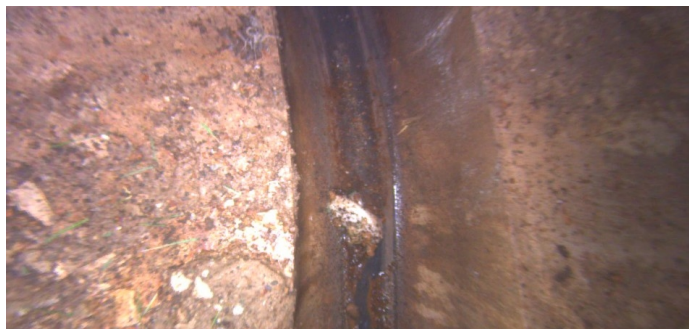
Code: **MGO**
Description: **General Observation**

Distance (ft): **4.5**
Structural Grade: **0**
O&M Grade: **0**
Clock Start/From:
Clock To:
1st Value:
2nd Value:
Value Percent:
Step: **NO**
Remarks: **Ins. Comp.**
