# Manhole Inspection Report

| MH#: | <b>M-708-125</b> | Owner: | <b>NA</b> | Len. Surveyed: | <b>5.1</b> |

| Street: | <b>Intersection of Heather Ln. and Red</b> | Project: | <b>Hobart, IN</b> |

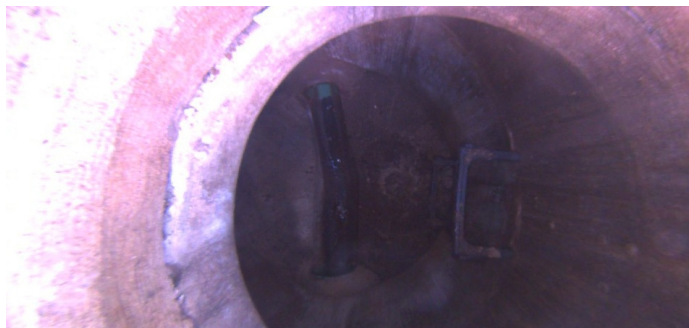
Code: **MGP**  
Description: **General Photo**

Distance (ft): **.0**  
Structural Grade: **0**  
O&M Grade: **0**  
Clock Start/From:  
Clock To:  
1st Value:  
2nd Value:  
Value Percent:  
Step: **NO**  
Remarks:

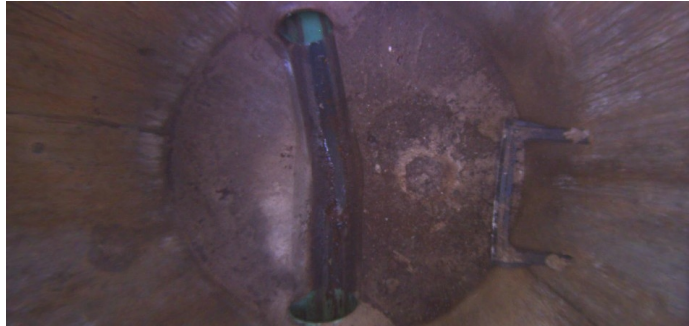
| | Position | Code | Observation | Video (sec) | Grade |
|--|---|---|---|---|---|
| | 2.3 | DSF | Deposits Settled Fine | 26 | M 2 |

Code: **DSF**  
Description: **Deposits Settled Fine**

Distance (ft): **2.3**  
Structural Grade: **0**  
O&M Grade: **2**  
Clock Start/From: **12**  
Clock To: **6**  
1st Value:  
2nd Value:  
Value Percent: **5.000**  
Step: **NO**  
Remarks:

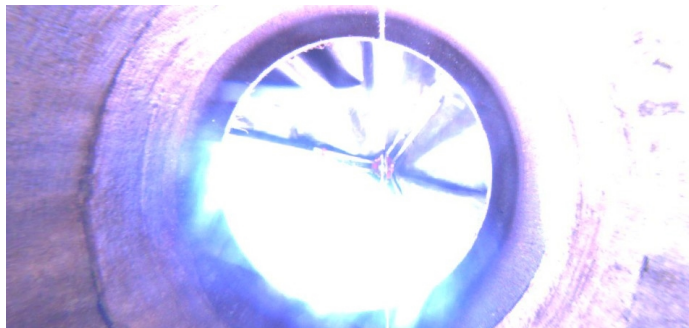
Code: **MGP**  
Description: **General Photo**

Distance (ft): **2.4**  
Structural Grade: **0**  
O&M Grade: **0**  
Clock Start/From:  
Clock To:  
1st Value:  
2nd Value:  
Value Percent:  
Step: **NO**  
Remarks:

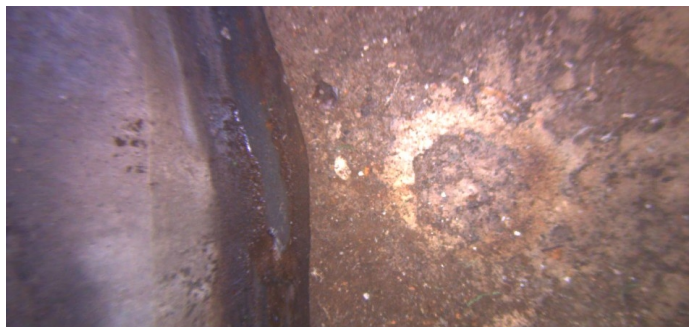
Code: **MGO**  
Description: **General Observation**

Distance (ft): **4.2**  
Structural Grade: **0**  
O&M Grade: **0**  
Clock Start/From:  
Clock To:  
1st Value:  
2nd Value:  
Value Percent:  
Step: **NO**  
Remarks: **Ins. Comp.**
