Manhole Inspection Report

Date:	04/10/2018	Weather:		Coding:	RZMACP
MH#:	M-708-126	Owner:	NA	Len. Surveyed:	5.0
P.O.#:		Surveyor:	John Kuglmaier	Rim to Invert:	5.8
Customer:		Cert. #:	U-1215-07002349	Wall Material:	Concrete (reinforced)

Street:	Redbud Dr. 150' South of Heather Ln	Project:	Hobart, IN
City:	Hobart, IN	GPS Northing:	2905253.934
Location:		GPS Easting:	2905253.934
Drain Area:	Southwest	GPS Accuracy:	Sub-Meter
Cover Shape:	Circular	Evidence of Surcharge:	Yes
Cover Size:	22.5	Potential for Runoff:	None
Comments:

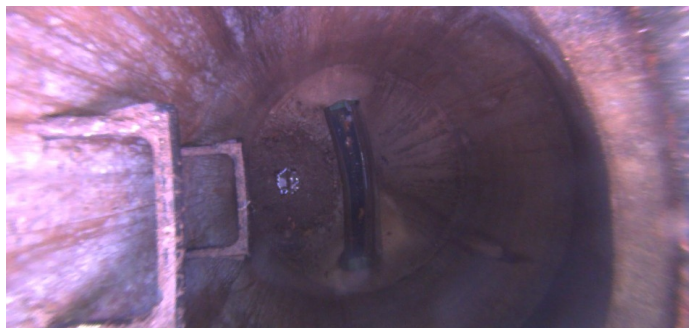
Code: **MGP**
Description: **General Photo**

Distance (ft): **.0**
Structural Grade: **0**
O&M Grade: **0**
Clock Start/From:
Clock To:
1st Value:
2nd Value:
Value Percent:
Step: **NO**
Remarks:

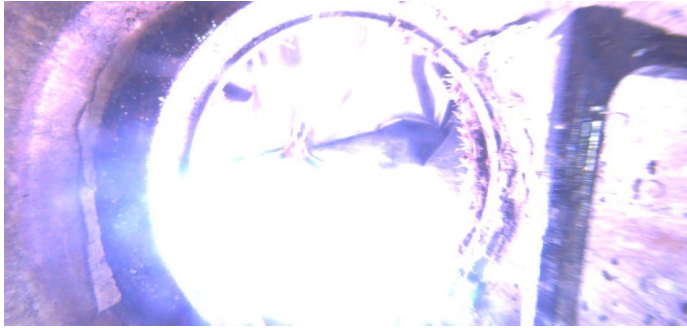
Code: **MGP**
Description: **General Photo**

Distance (ft): **2.0**
Structural Grade: **0**
O&M Grade: **0**
Clock Start/From:
Clock To:
1st Value:
2nd Value:
Value Percent:
Step: **NO**
Remarks:

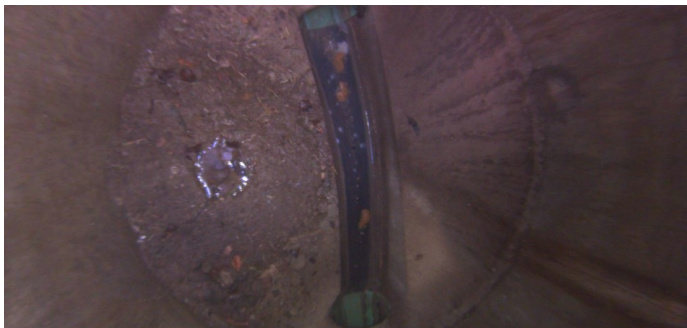
Code: **DSF**
Description: **Deposits Settled Fine**

Distance (ft): **2.8**
Structural Grade: **0**
O&M Grade: **2**
Clock Start/From: **6**
Clock To: **11**
1st Value:
2nd Value:
Value Percent: **5.000**
Step: **NO**
Remarks:

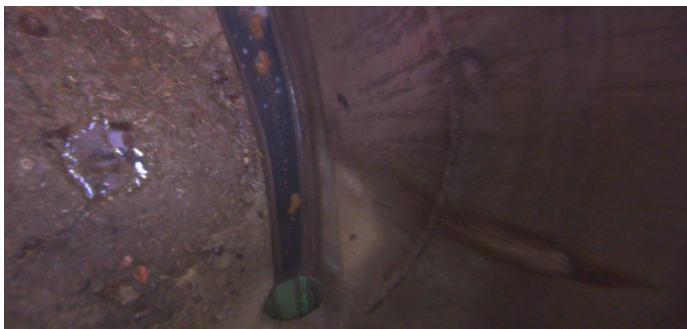
Code: **IS**
Description: **Infil Stain**

Distance (ft): **3.2**
Structural Grade: **0**
O&M Grade: **0**
Clock Start/From: **4**
Clock To:
1st Value:
2nd Value:
Value Percent:
Step: **NO**
Remarks:

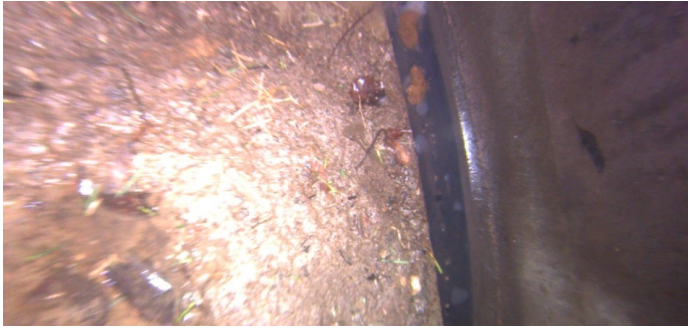
Code:	MGO
Description:	General Observation
Distance (ft):	4.5
Structural Grade:	0
O&M Grade:	0
Clock Start/From:	
Clock To:	
1st Value:	
2nd Value:	
Value Percent:	
Step:	NO
Remarks:	Ins. Comp.
