Manhole Inspection Report

| MH#: | M-708-127 | Owner: | NA | Len. Surveyed: | 4.6 |

| Street: | Redbud Dr. 234' South of Heather Ln | Project: | Missing GPS |
| City: | Hobart, IN | GPS Northing: | 2280330.026 |

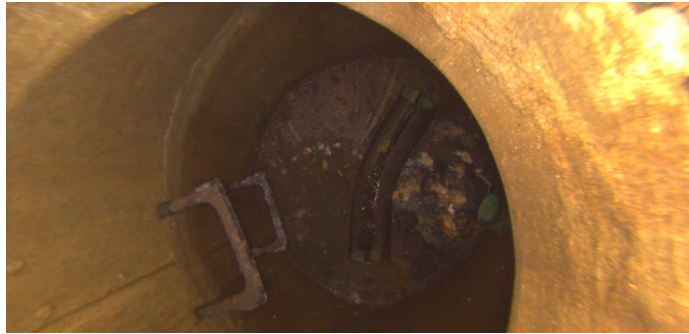
| Code: | SRI |
| Description: | Surface Roughness Increased |
| Distance (ft): | .0 |
| Structural Grade: | 1 |
| O&M Grade: | 0 |
| Clock Start/From: | 12 |
| Clock To: | 12 |

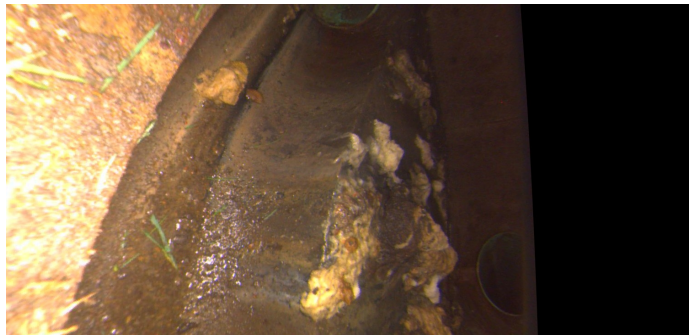
| Code: | DSZ |
| Description: | Deposits Settled Other |
| Distance (ft): | 4.2 |
| O&M Grade: | 2 |
| Value Percent: | 10.000 |
| Remarks: | paper products |

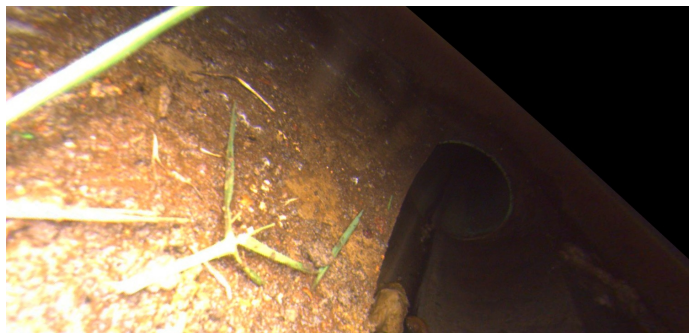
| Code: | DSF |
| Description: | Deposits Settled Fine |
| Distance (ft): | 4.6 |
| O&M Grade: | 2 |
| Value Percent: | 5.000 |

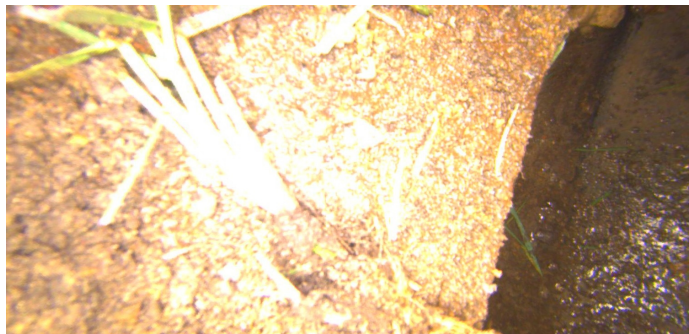
Code: **SRI**
Description: **Surface Roughness Increased**

Distance (ft): **4.6**
Structural Grade: **1**
O&M Grade: **0**
Clock Start/From: **3**
Clock To: **9**
1st Value:
2nd Value:
Value Percent:
Step: **NO**
Remarks:

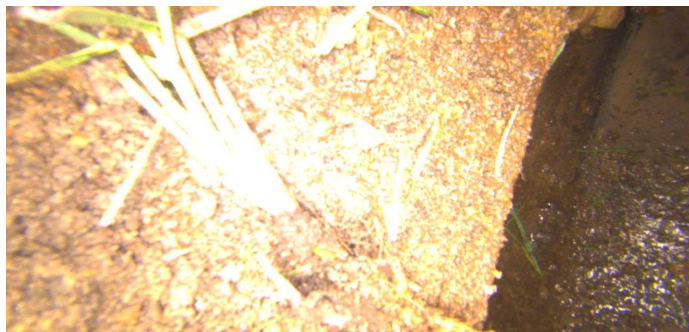
Code: **SRI**
Description: **Surface Roughness Increased**

Distance (ft): **4.6**
Structural Grade: **1**
O&M Grade: **0**
Clock Start/From: **12**
Clock To: **12**
1st Value:
2nd Value:
Value Percent:
Step: **NO**
Remarks:
