Manhole Inspection Report

Date:	04/10/2018	Weather:		Coding:	RZMACP
MH#:	M-708-129	Owner:	NA	Len. Surveyed:	3.8
P.O.#:		Surveyor:	John Kuglmaier	Rim to Invert:	4.4
Customer:		Cert. #:	U-1215-07002349	Wall Material:	Concrete (reinforced)

Street:	Azalea Dr. 248' East of Redbud Dr.	Project:	Hobart, IN
City:	Hobart, IN	GPS Northing:	2905541.831
Location:		GPS Easting:	2905541.831
Drain Area:	Southwest	GPS Accuracy:	Sub-Meter
Cover Shape:	Circular	Evidence of Surcharge:	No
Cover Size:	22.5	Potential for Runoff:	None
Comments:

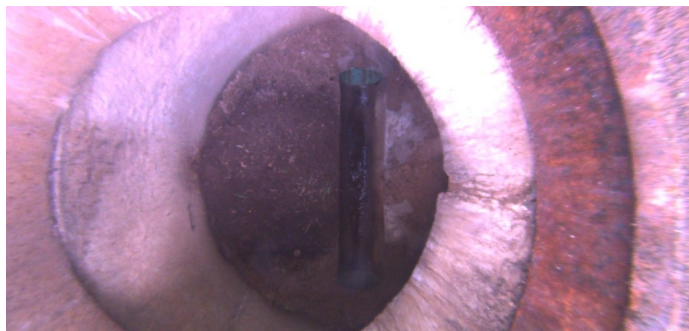
Code: **MGP**
Description: **General Photo**

Distance (ft): **.0**
Structural Grade: **0**
O&M Grade: **0**
Clock Start/From:
Clock To:
1st Value:
2nd Value:
Value Percent:
Step: **NO**
Remarks:

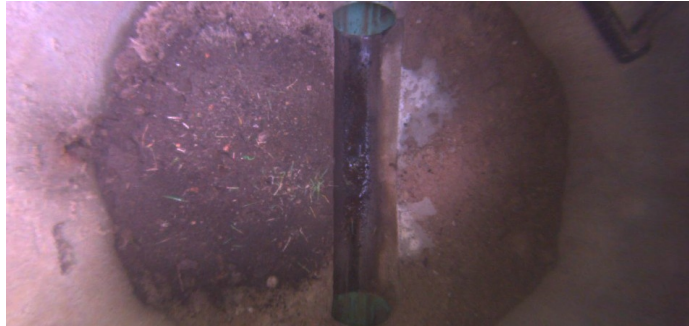
Code:	DSF
Description:	Deposits Settled Fine
Distance (ft):	1.4
Structural Grade:	0
O&M Grade:	2
Clock Start/From:	6
Clock To:	12
1st Value:	
2nd Value:	
Value Percent:	5.000
Step:	NO
Remarks:

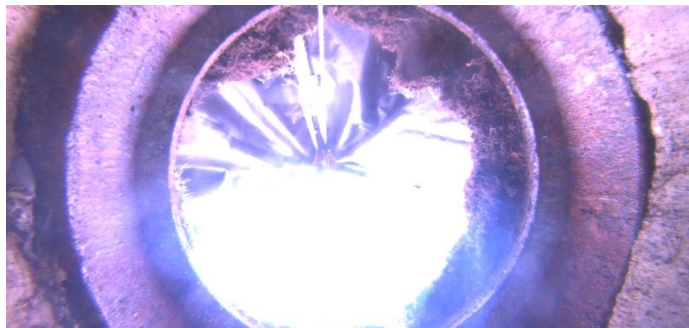
Code:	MGP
Description:	General Photo
Distance (ft):	2.0
Structural Grade:	0
O&M Grade:	0
Clock Start/From:	
Clock To:	
1st Value:	
2nd Value:	
Value Percent:	
Step:	NO
Remarks:

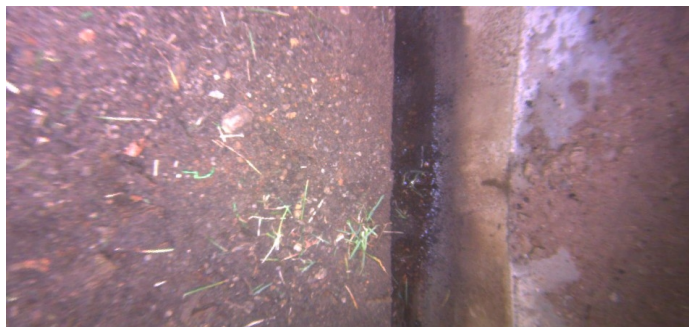
Code:	MGO
Description:	General Observation
Distance (ft):	3.0
Structural Grade:	0
O&M Grade:	0
Clock Start/From:	
Clock To:	
1st Value:	
2nd Value:	
Value Percent:	
Step:	NO
Remarks:	Ins. Comp.
