# Manhole Inspection Report

Date:	<b>09/21/2022</b>	Weather:		Coding:	<b>RZMACP</b>
MH#:	<b>M-708-131</b>	Owner:	<b>NA</b>	Len. Surveyed:	<b>6.6</b>
P.O.#:		Surveyor:	<b>Jen Costello</b>	Rim to Invert:	<b>7.7</b>
Customer:		Cert. #:	<b>U-907-5518</b>	Wall Material:	<b>Concrete (cast in place)</b>

Street:	<b>16th St. 171' South on Magnolia St.</b>	Project:	<b>Hobart, IN</b>
City:	<b>Hobart, IN</b>	GPS Northing:	<b>2280820.511</b>
Location:	<b>Local Rural Streets</b>	GPS Easting:	<b>2905742.279</b>
Drain Area:	<b>Southwest</b>	GPS Accuracy:	<b>Sub-Meter</b>
Cover Shape:	<b>Circular</b>	Evidence of Surcharge:	<b>No</b>
Cover Size:	<b>24.0</b>	Potential for Runoff:	<b>None</b>
Comments:

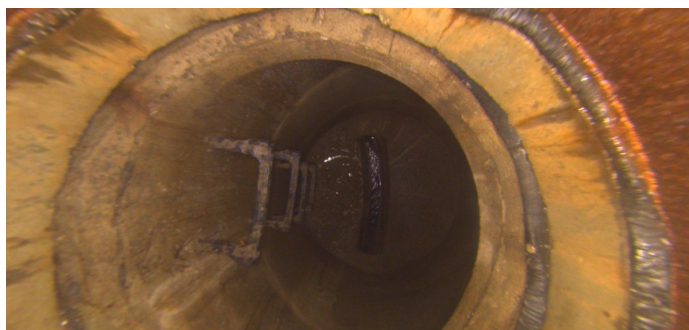
Code: **MGO**  
Description: **General Observation**

Distance (ft): **.0**  
Structural Grade: **0**  
O&M Grade: **0**  
Clock Start/From:  
Clock To:  
1st Value:  
2nd Value:  
Value Percent:  
Step: **NO**  
Remarks: **access mh**

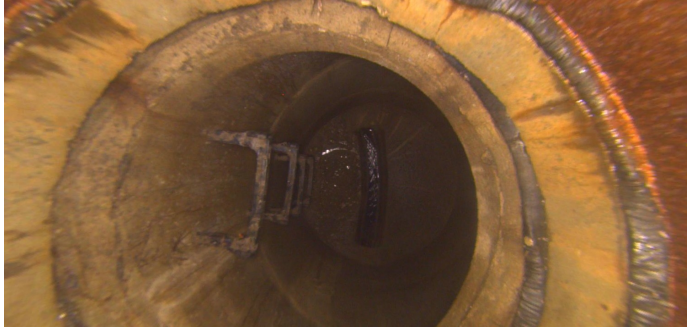
Code:	<b>ISGT</b>
Description:	<b>Intruding Sealing Grout</b>
Distance (ft):	<b>.0</b>
Structural Grade:	<b>0</b>
O&M Grade:	<b>2</b>
Clock Start/From:	<b>12</b>
Clock To:	<b>12</b>
1st Value:	
2nd Value:	
Value Percent:	<b>5.000</b>
Step:	<b>NO</b>
Remarks:

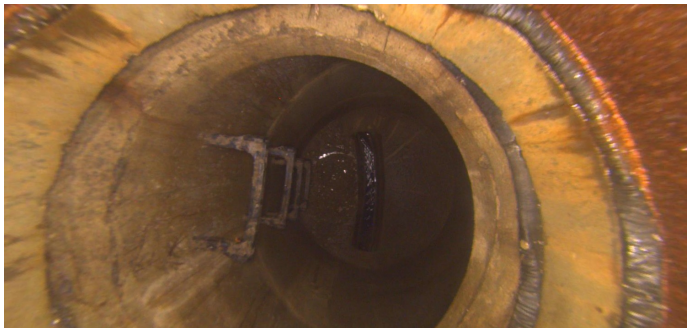
Code:	<b>IW</b>
Description:	<b>Infil Weeper</b>
Distance (ft):	<b>.0</b>
Structural Grade:	<b>0</b>
O&M Grade:	<b>2</b>
Clock Start/From:	<b>12</b>
Clock To:	<b>12</b>
1st Value:	
2nd Value:	
Value Percent:	
Step:	<b>NO</b>
Remarks:

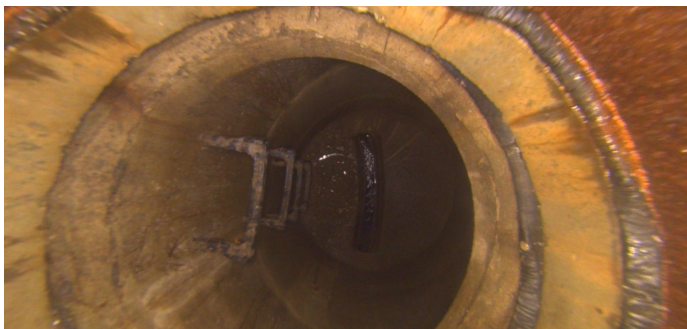
Code:	<b>SRI</b>
Description:	<b>Surface Roughness Increased</b>
Distance (ft):	<b>.0</b>
Structural Grade:	<b>1</b>
O&M Grade:	<b>0</b>
Clock Start/From:	<b>12</b>
Clock To:	<b>12</b>
1st Value:	
2nd Value:	
Value Percent:	
Step:	<b>NO</b>
Remarks:

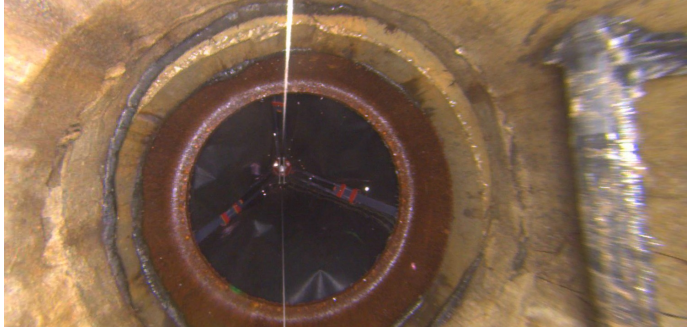
Code: **MGO**  
Description: **General Observation**

Distance (ft): **2.8**  
Structural Grade: **0**  
O&M Grade: **0**  
Clock Start/From:  
Clock To:  
1st Value:  
2nd Value:  
Value Percent:  
Step: **NO**  
Remarks: **underside of frame**

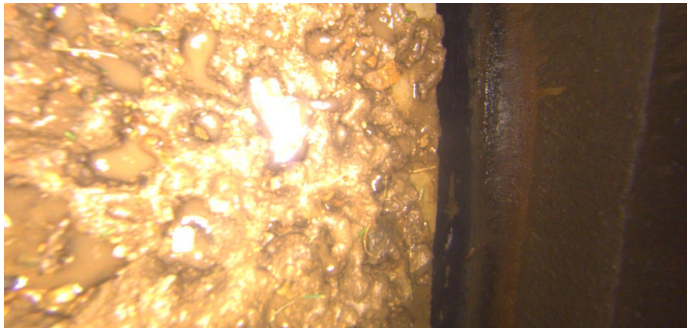
Code: **DSF**  
Description: **Deposits Settled Fine**

Distance (ft): **6.5**  
Structural Grade: **0**  
O&M Grade: **2**  
Clock Start/From: **12**  
Clock To: **12**  
1st Value:  
2nd Value:  
Value Percent: **5.000**  
Step: **NO**  
Remarks:

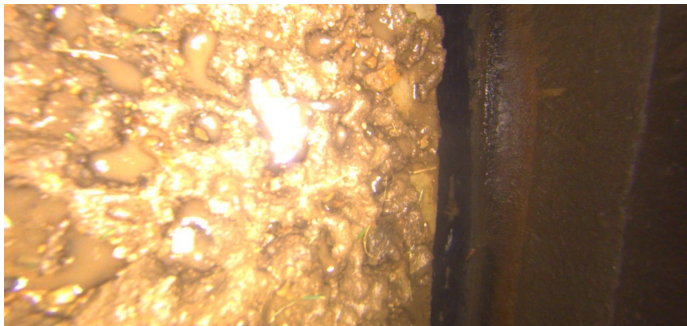
Code: **MGO**  
Description: **General Observation**

Distance (ft): **6.5**  
Structural Grade: **0**  
O&M Grade: **0**  
Clock Start/From:  
Clock To:  
1st Value:  
2nd Value:  
Value Percent:  
Step: **NO**  
Remarks: **end of survey**

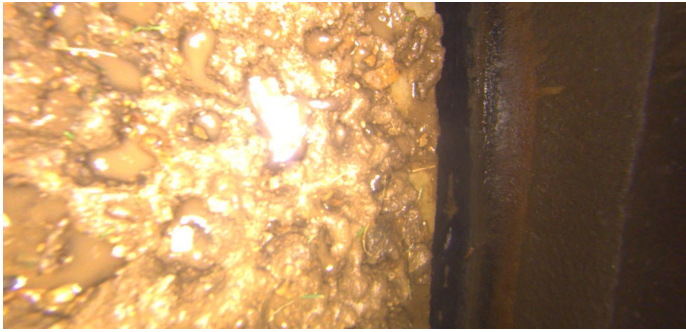
Code:	<b>SRI</b>
Description:	<b>Surface Roughness Increased</b>
Distance (ft):	<b>6.5</b>
Structural Grade:	<b>1</b>
O&M Grade:	<b>0</b>
Clock Start/From:	<b>12</b>
Clock To:	<b>12</b>
1st Value:	
2nd Value:	
Value Percent:	
Step:	<b>NO</b>
Remarks:
