Manhole Inspection Report

Date:	04/10/2018	Weather:		Coding:	RZMACP
MH#:	M-708-133	Owner:	NA	Len. Surveyed:	6.4
P.O.#:		Surveyor:	John Kuglmaier	Rim to Invert:	6.9
Customer:		Cert. #:	U-1215-07002349	Wall Material:	Concrete (reinforced)

Street:	Magnolia Dr. 151' Southeast of Heat	Project:	Hobart, IN
City:	Hobart, IN	GPS Northing:	2905920.983
Location:		GPS Easting:	2905920.983
Drain Area:	Southwest	GPS Accuracy:	Sub-Meter
Cover Shape:	Circular	Evidence of Surcharge:	No
Cover Size:	22.5	Potential for Runoff:	None
Comments:

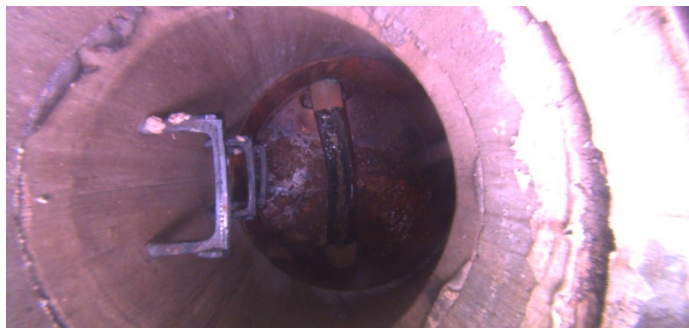
Code: **MGP**
Description: **General Photo**

Distance (ft): **.0**
Structural Grade: **0**
O&M Grade: **0**
Clock Start/From:
Clock To:
1st Value:
2nd Value:
Value Percent:
Step: **NO**
Remarks:

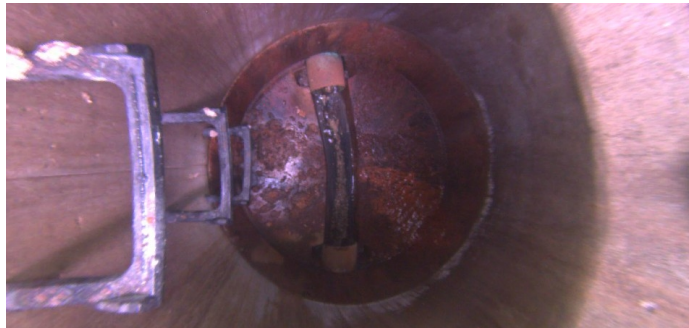
Code: **IS**
Description: **Infil Stain**

Distance (ft): **1.1**
Structural Grade: **0**
O&M Grade: **0**
Clock Start/From: **12**
Clock To: **12**
1st Value:
2nd Value:
Value Percent:
Step: **NO**
Remarks:

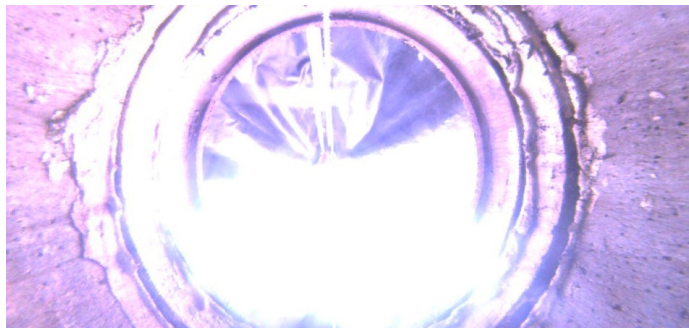
Code: **MGP**
Description: **General Photo**

Distance (ft): **2.4**
Structural Grade: **0**
O&M Grade: **0**
Clock Start/From:
Clock To:
1st Value:
2nd Value:
Value Percent:
Step: **NO**
Remarks:

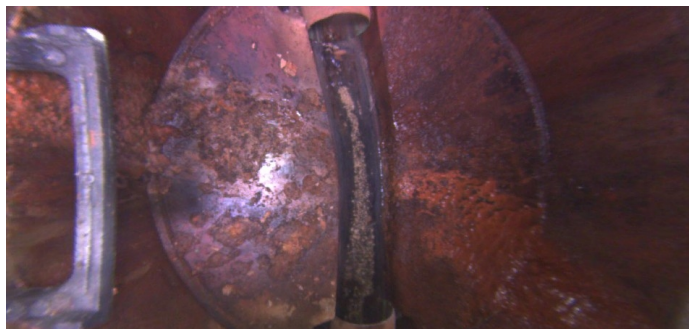
Code: **DAZ**
Description: **Deposits Attached Other**

Distance (ft): **3.8**
Structural Grade: **0**
O&M Grade: **2**
Clock Start/From: **12**
Clock To: **12**
1st Value:
2nd Value:
Value Percent: **5.000**
Step: **NO**
Remarks: **Mixed materials**

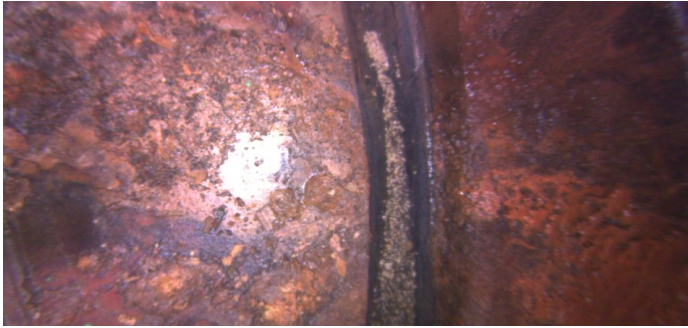
Code:	MGO
Description:	General Observation
Distance (ft):	5.2
Structural Grade:	0
O&M Grade:	0
Clock Start/From:	
Clock To:	
1st Value:	
2nd Value:	
Value Percent:	
Step:	NO
Remarks:	Ins. Comp.
