Manhole Inspection Report

Date:	04/10/2018	Weather:		Coding:	RZMACP
MH#:	M-708-138	Owner:	NA	Len. Surveyed:	5.6
P.O.#:		Surveyor:	John Kuglmaier	Rim to Invert:	6.5
Customer:		Cert. #:	U-1215-07002349	Wall Material:	Concrete (reinforced)

Street:	Heather Ln. 288' West of Magnolia	Project:	Hobart, IN
City:	Hobart, IN	GPS Northing:	2905543.41
Location:		GPS Easting:	2905543.41
Drain Area:	Southwest	GPS Accuracy:	Sub-Meter
Cover Shape:	Circular	Evidence of Surcharge:	No
Cover Size:	22.5	Potential for Runoff:	None
Comments:

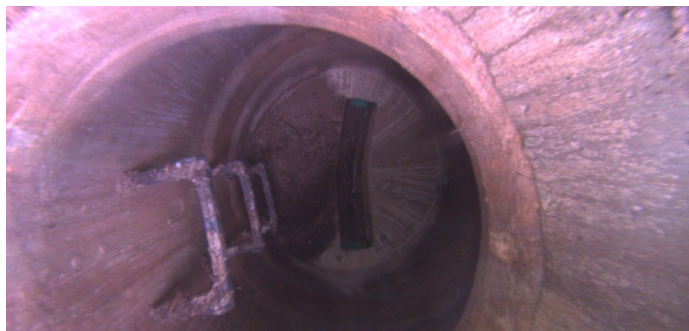
Code: **MGP**
Description: **General Photo**

Distance (ft): **.0**
Structural Grade: **0**
O&M Grade: **0**
Clock Start/From:
Clock To:
1st Value:
2nd Value:
Value Percent:
Step: **NO**
Remarks:

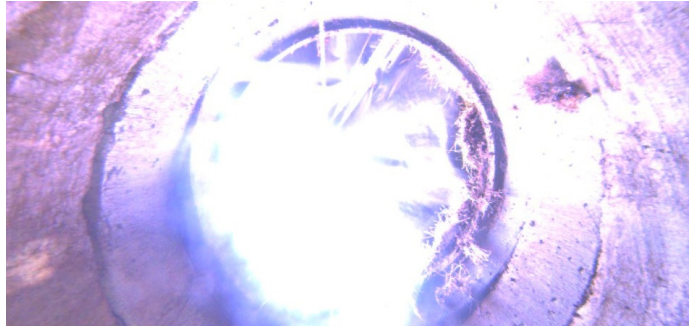
Code: **MGP**
Description: **General Photo**

Distance (ft): **2.3**
Structural Grade: **0**
O&M Grade: **0**
Clock Start/From:
Clock To:
1st Value:
2nd Value:
Value Percent:
Step: **NO**
Remarks:

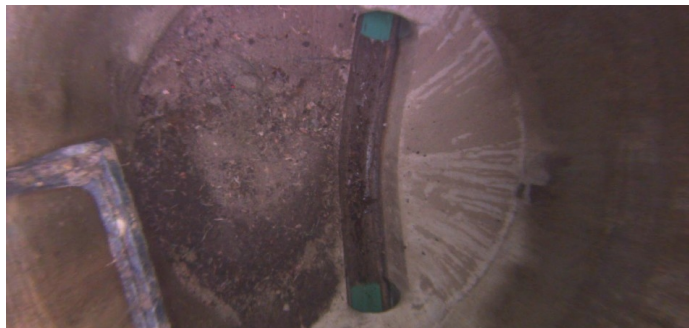
Code: **DSF**
Description: **Deposits Settled Fine**

Distance (ft): **3.2**
Structural Grade: **0**
O&M Grade: **2**
Clock Start/From: **6**
Clock To: **1**
1st Value:
2nd Value:
Value Percent: **5.000**
Step: **NO**
Remarks:

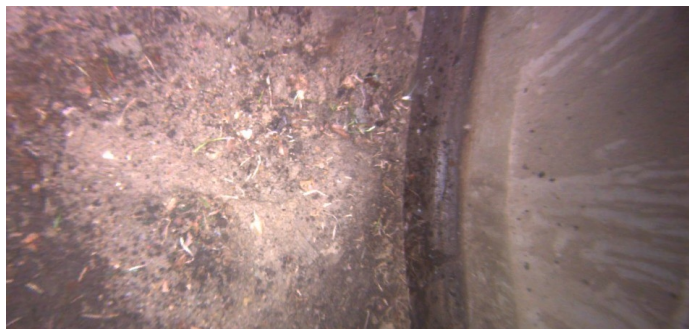
Code: **MGO**
Description: **General Observation**

Distance (ft): **4.8**
Structural Grade: **0**
O&M Grade: **0**
Clock Start/From:
Clock To:
1st Value:
2nd Value:
Value Percent:
Step: **NO**
Remarks: **Ins. Comp.**
