Manhole Inspection Report

Date:	11/07/2022	Weather:		Coding:	RZMACP
MH#:	M-708-139	Owner:	NA	Len. Surveyed:	5.0
P.O.#:		Surveyor:	Jen Costello	Rim to Invert:	5.9
Customer:		Cert. #:	U-907-5518	Wall Material:	Concrete (non-reinforced)

Street:	Heather Ln. 237' East of Redbud Dr.	Project:	Missing GPS
City:	Hobart, IN	GPS Northing:	2280578.376
Location:		GPS Easting:	2905394.573
Drain Area:	Southwest	GPS Accuracy:	Sub-Meter
Cover Shape:	Circular	Evidence of Surcharge:	No
Cover Size:	24.0	Potential for Runoff:	None
Comments:

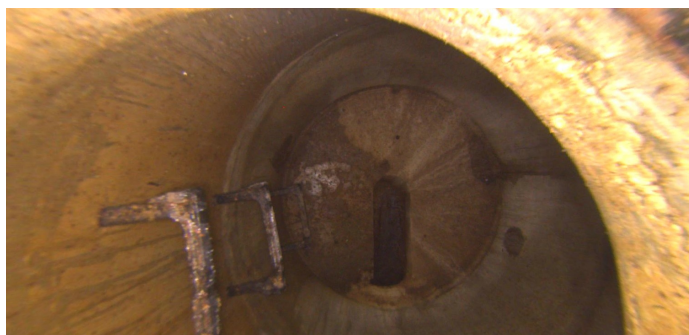
Code: **MGO**
Description: **General Observation**

Distance (ft): **.0**
Structural Grade: **0**
O&M Grade: **0**
Clock Start/From:
Clock To:
1st Value:
2nd Value:
Value Percent:
Step: **NO**
Remarks: **access mh**

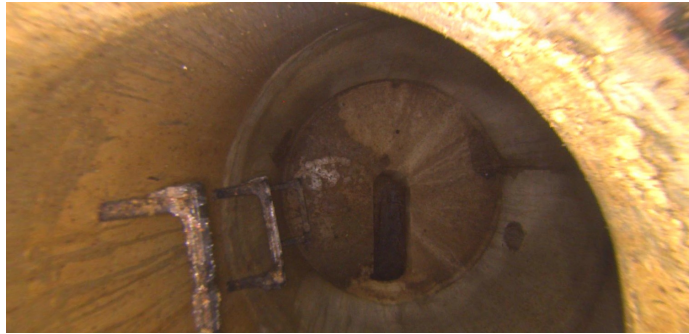
Code: **SRI**
Description: **Surface Roughness Increased**

Distance (ft): **.0**
Structural Grade: **1**
O&M Grade: **0**
Clock Start/From: **12**
Clock To: **12**
1st Value:
2nd Value:
Value Percent:
Step: **NO**
Remarks:

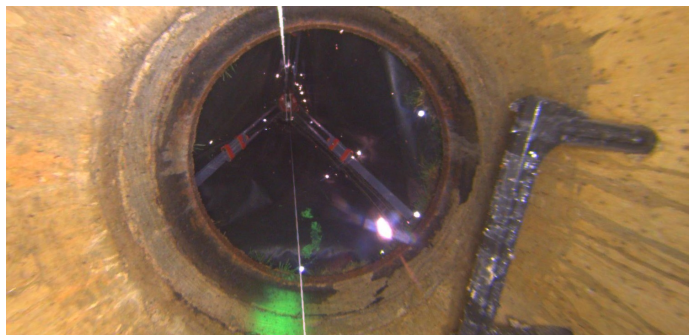
Code: **MGO**
Description: **General Observation**

Distance (ft): **2.1**
Structural Grade: **0**
O&M Grade: **0**
Clock Start/From:
Clock To:
1st Value:
2nd Value:
Value Percent:
Step: **NO**
Remarks: **underside of frame**

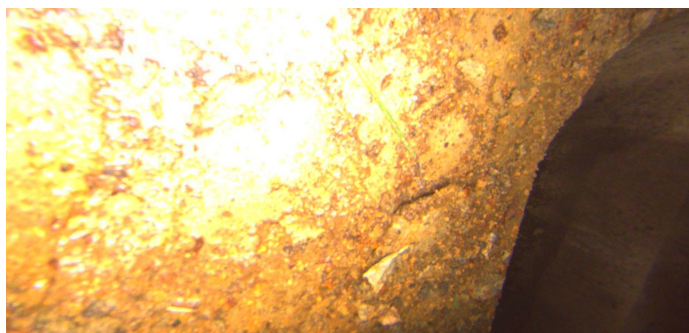
Code: **SRI**
Description: **Surface Roughness Increased**

Distance (ft): **5.0**
Structural Grade: **1**
O&M Grade: **0**
Clock Start/From: **3**
Clock To: **9**
1st Value:
2nd Value:
Value Percent:
Step: **NO**
Remarks:

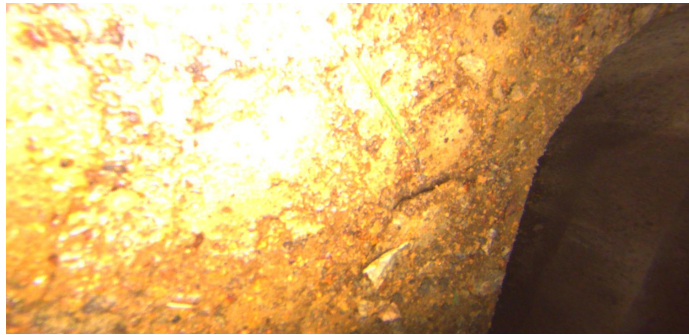
Code: **SRI**
Description: **Surface Roughness Increased**

Distance (ft): **5.0**
Structural Grade: **1**
O&M Grade: **0**
Clock Start/From: **12**
Clock To: **12**
1st Value:
2nd Value:
Value Percent:
Step: **NO**
Remarks:

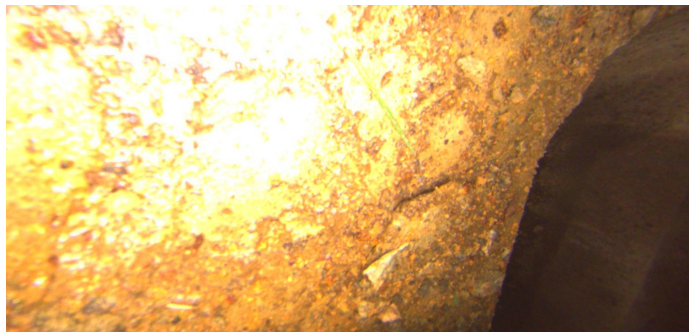
Code: **MGO**
Description: **General Observation**

Distance (ft): **5.0**
Structural Grade: **0**
O&M Grade: **0**
Clock Start/From:
Clock To:
1st Value:
2nd Value:
Value Percent:
Step: **NO**
Remarks: **end of survey**

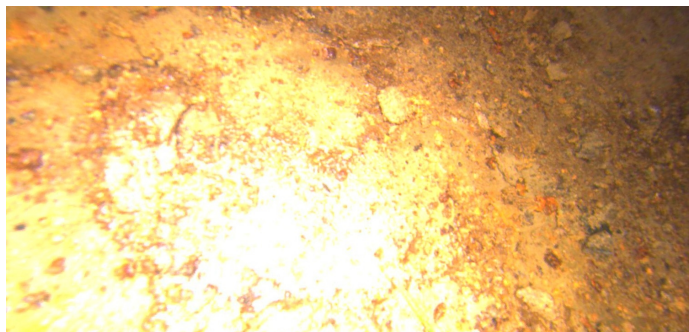
Code: **SAV**
Description: **Surface Aggregate Visible**

Distance (ft): **5.0**
Structural Grade: **3**
O&M Grade: **0**
Clock Start/From: **12**
Clock To: **12**
1st Value:
2nd Value:
Value Percent:
Step: **NO**
Remarks:

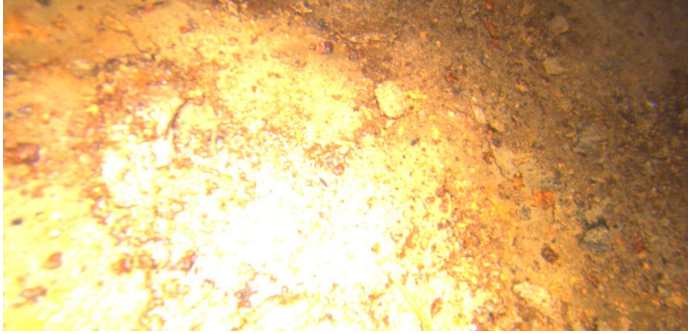
Code:	DSF
Description:	Deposits Settled Fine
Distance (ft):	5.0
Structural Grade:	0
O&M Grade:	2
Clock Start/From:	12
Clock To:	12
1st Value:	
2nd Value:	
Value Percent:	5.000
Step:	NO
Remarks:
