# Manhole Inspection Report

Date:	<b>11/07/2022</b>	Weather:		Coding:	<b>RZMACP</b>
MH#:	<b>M-708-140</b>	Owner:	<b>NA</b>	Len. Surveyed:	<b>7.1</b>
P.O.#:		Surveyor:	<b>Jen Costello</b>	Rim to Invert:	<b>8.4</b>
Customer:		Cert. #:	<b>U-907-5518</b>	Wall Material:	<b>Concrete (non-reinforced)</b>

Street:	<b>Lake St. 129' East of Bracken Parkwa</b>	Project:	<b>Missing GPS</b>
City:	<b>Hobart, IN</b>	GPS Northing:	<b>2281446.678</b>
Location:		GPS Easting:	<b>2905761.353</b>
Drain Area:	<b>Southwest</b>	GPS Accuracy:	<b>Sub-Meter</b>
Cover Shape:	<b>Circular</b>	Evidence of Surcharge:	<b>No</b>
Cover Size:	<b>24.0</b>	Potential for Runoff:	<b>None</b>
Comments:

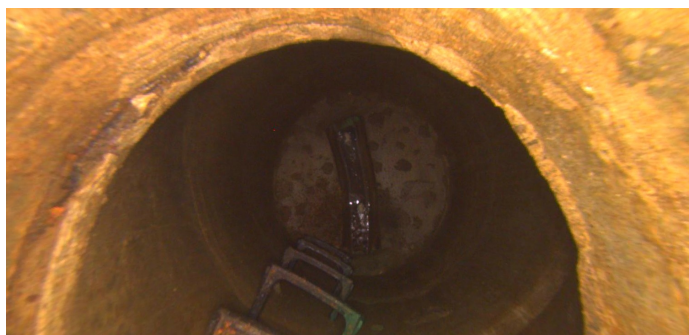
Code: **SRI**  
Description: **Surface Roughness Increased**

Distance (ft): **.0**  
Structural Grade: **1**  
O&M Grade: **0**  
Clock Start/From: **12**  
Clock To: **12**  
1st Value:  
2nd Value:  
Value Percent:  
Step: **NO**  
Remarks:

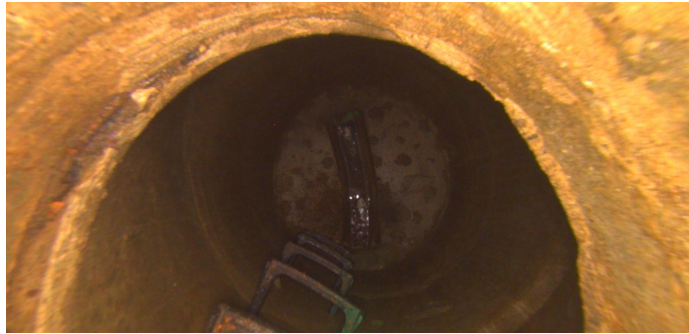
Code: **MGO**  
Description: **General Observation**

Distance (ft): **.0**  
Structural Grade: **0**  
O&M Grade: **0**  
Clock Start/From:  
Clock To:  
1st Value:  
2nd Value:  
Value Percent:  
Step: **NO**  
Remarks: **access mh**

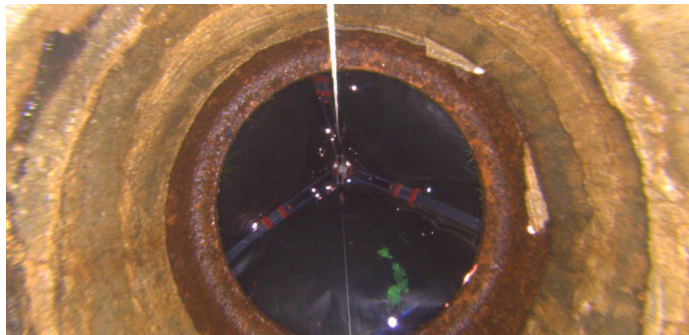
Code: **MGO**  
Description: **General Observation**

Distance (ft): **2.3**  
Structural Grade: **0**  
O&M Grade: **0**  
Clock Start/From:  
Clock To:  
1st Value:  
2nd Value:  
Value Percent:  
Step: **NO**  
Remarks: **underside of frame**

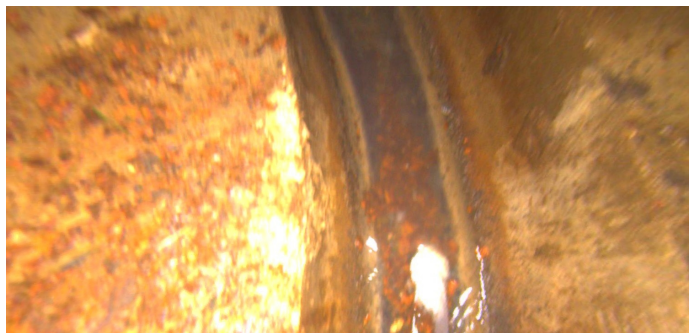
Code: **SRI**  
Description: **Surface Roughness Increased**

Distance (ft): **6.7**  
Structural Grade: **1**  
O&M Grade: **0**  
Clock Start/From: **12**  
Clock To: **12**  
1st Value:  
2nd Value:  
Value Percent:  
Step: **NO**  
Remarks:

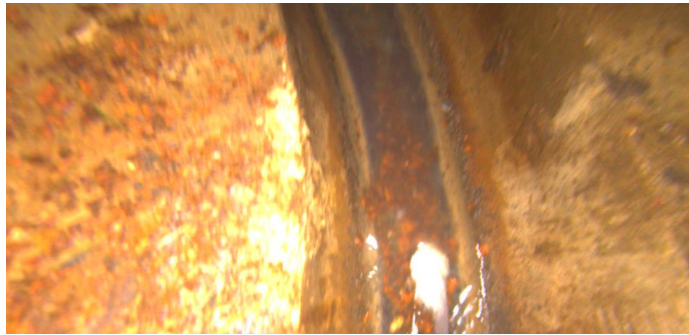
Code: **MGO**  
Description: **General Observation**

Distance (ft): **6.7**  
Structural Grade: **0**  
O&M Grade: **0**  
Clock Start/From:  
Clock To:  
1st Value:  
2nd Value:  
Value Percent:  
Step: **NO**  
Remarks: **end of survey**

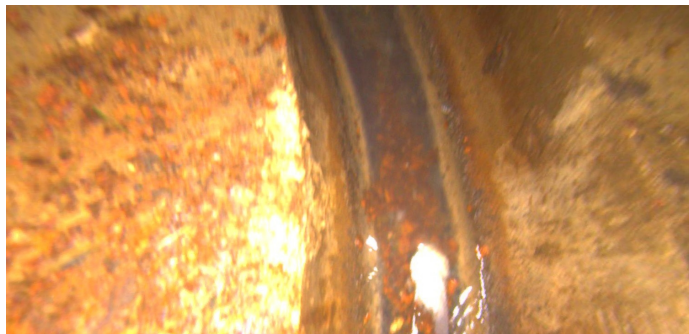
Code: **SRI**  
Description: **Surface Roughness Increased**

Distance (ft): **6.7**  
Structural Grade: **1**  
O&M Grade: **0**  
Clock Start/From: **3**  
Clock To: **9**  
1st Value:  
2nd Value:  
Value Percent:  
Step: **NO**  
Remarks:

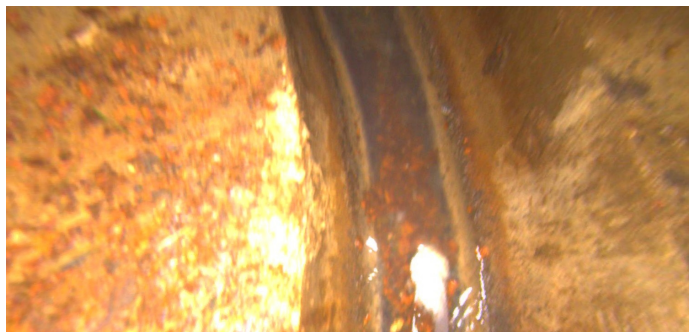
Code: **DSF**  
Description: **Deposits Settled Fine**

Distance (ft): **6.7**  
Structural Grade: **0**  
O&M Grade: **2**  
Clock Start/From: **12**  
Clock To: **12**  
1st Value:  
2nd Value:  
Value Percent: **5.000**  
Step: **NO**  
Remarks:

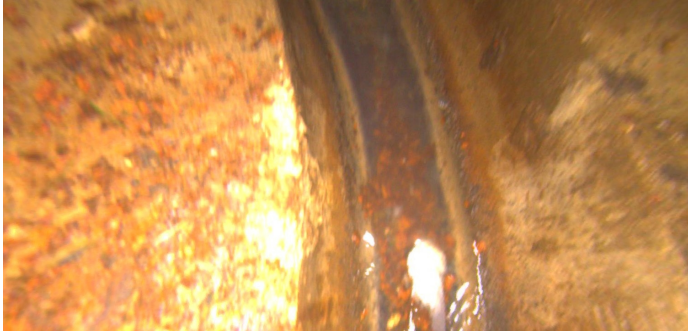
Code:	<b>SRI</b>
Description:	<b>Surface Roughness Increased</b>
Distance (ft):	<b>6.7</b>
Structural Grade:	<b>1</b>
O&M Grade:	<b>0</b>
Clock Start/From:	<b>12</b>
Clock To:	<b>12</b>
1st Value:	
2nd Value:	
Value Percent:	
Step:	<b>NO</b>
Remarks:
