Manhole Inspection Report

Date:	04/19/2018	Weather:		Coding:	RZMACP
MH#:	M-708-141	Owner:	NA	Len. Surveyed:	5.7
P.O.#:		Surveyor:	John Kuglmaier	Rim to Invert:	7.7
Customer:		Cert. #:	U-1215-07002349	Wall Material:	Concrete (reinforced)

Street:	Lake St. 224' East of Bracken Parkwa	Project:	Hobart, IN
City:	Hobart, IN	GPS Northing:	2905827.938
Location:		GPS Easting:	2905827.938
Drain Area:	Southwest	GPS Accuracy:	Sub-Meter
Cover Shape:	Circular	Evidence of Surcharge:	No
Cover Size:	22.5	Potential for Runoff:	None
Comments:

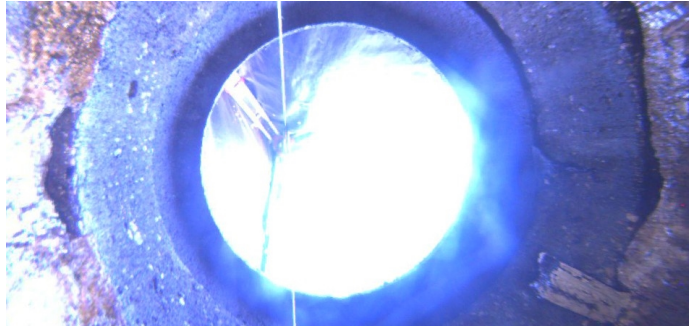
Code: **MGP**
Description: **General Photo**

Distance (ft): **2.4**
Structural Grade: **0**
O&M Grade: **0**
Clock Start/From:
Clock To:
1st Value:
2nd Value:
Value Percent:
Step: **NO**
Remarks:

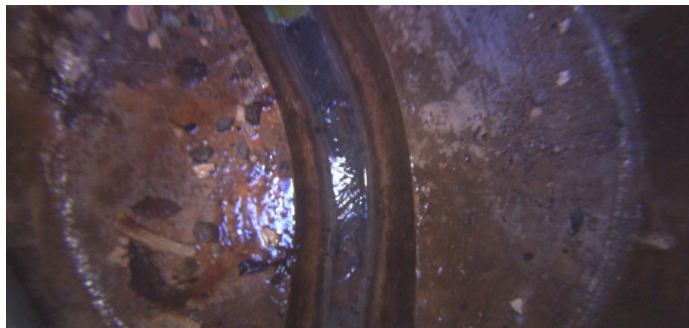
Code: **MGO**
Description: **General Observation**

Distance (ft): **5.4**
Structural Grade: **0**
O&M Grade: **0**
Clock Start/From:
Clock To:
1st Value:
2nd Value:
Value Percent:
Step: **NO**
Remarks: **Ins. Comp.**
