Manhole Inspection Report

Street:	Lake St. 124' South of Coral Cove.	Project:	Hobart, IN
City:	Hobart, IN	GPS Northing:	2905849.763
Location:		GPS Easting:	2905849.763
Drain Area:	Southwest	GPS Accuracy:	Sub-Meter
Cover Shape:	Circular	Evidence of Surcharge:	No
Cover Size:	22.5	Potential for Runoff:	None
Comments:

M-708-143

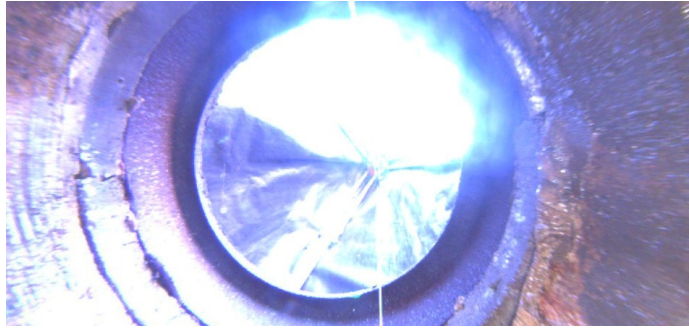
Code:	MGP
Description:	General Photo

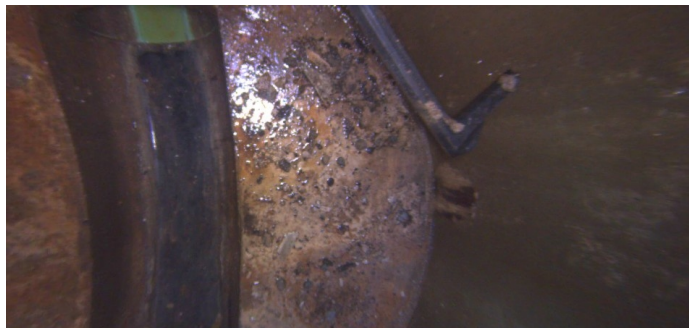
Code: **MGP**
Description: **General Photo**

Distance (ft): **2.4**
Structural Grade: **0**
O&M Grade: **0**
Clock Start/From:
Clock To:
1st Value:
2nd Value:
Value Percent:
Step: **NO**
Remarks:

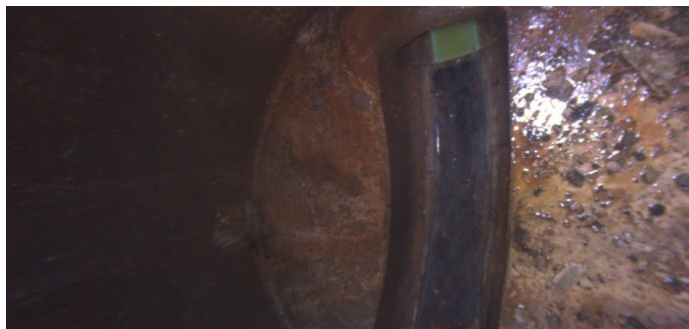
Code: **IS**
Description: **Infil Stain**

Distance (ft): **4.7**
Structural Grade: **0**
O&M Grade: **0**
Clock Start/From: **3**
Clock To:
1st Value:
2nd Value:
Value Percent:
Step: **NO**
Remarks:

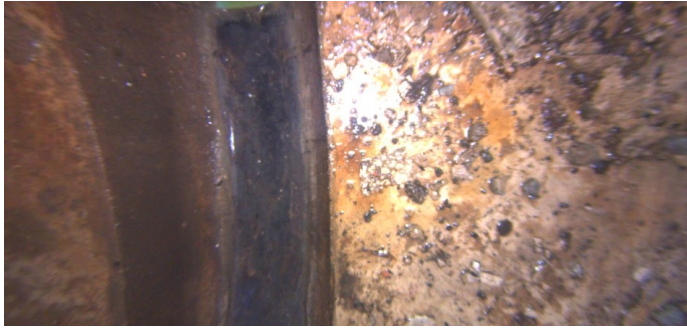
Code: **IS**
Description: **Infil Stain**

Distance (ft): **4.7**
Structural Grade: **0**
O&M Grade: **0**
Clock Start/From: **9**
Clock To:
1st Value:
2nd Value:
Value Percent:
Step: **NO**
Remarks:
